## Ship Structure Committee Case Study

### *PRESTIGE: Complete hull failure in a single-hull tanker*

Flooding in the ship's starboard #2 aft and #3 wing tanks caused a 25 degree list, which was counter-ballasted by flooding #2 aft port and #3 port ballast tanks. This resulted in an overstressed hull girder which failed after 6 days of exposure to heavy seas, causing the ship to break in two and sink.

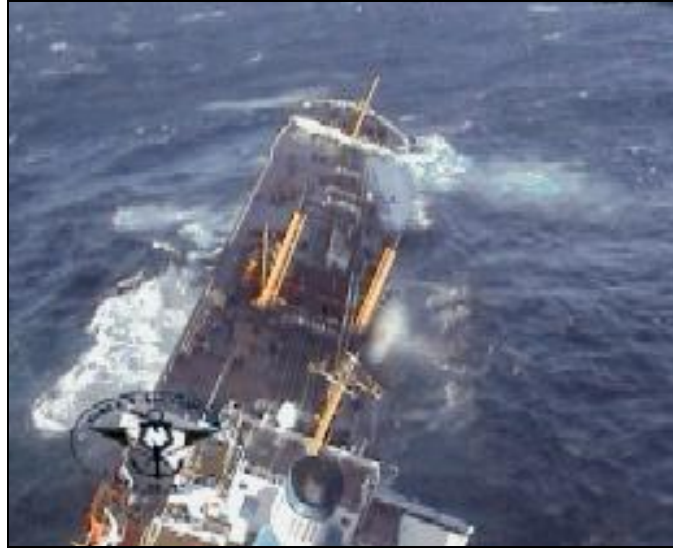
On November 13, 2002, the PRESTIGE was 30 miles off the Northwest coast of Spain, underway from St. Petersburg to discharge in Singapore when she developed a list of approximately 25 degrees to starboard. The list was a result of the #2 starboard aft and #3 starboard wing tanks flooding. The crew reported that the flooding was preceded by a sudden vibration or severe shudder.

**Figure 3.** PRESTIGE with significant list.

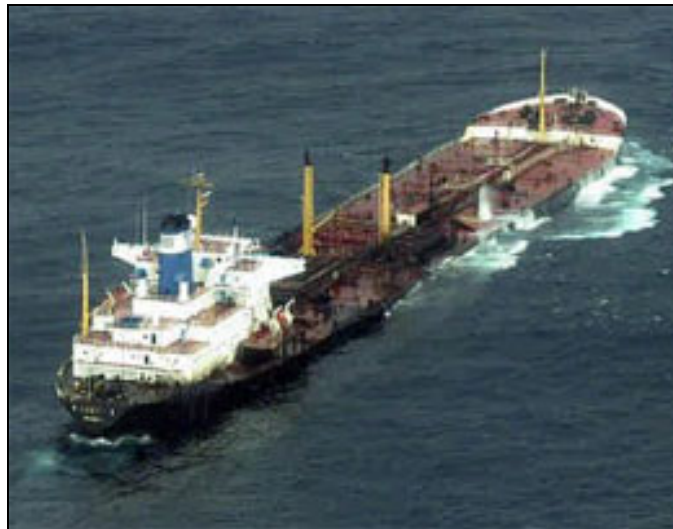
With such significant list, the PRESTIGE lost propulsion and began to drift. Three hours after the starboard tanks flooded, #2 and #3 port wing tanks were counter-flooded. This brought the vessel to a list of three degrees to starboard.

**Figure 4.** Prestige after counter-ballasting.

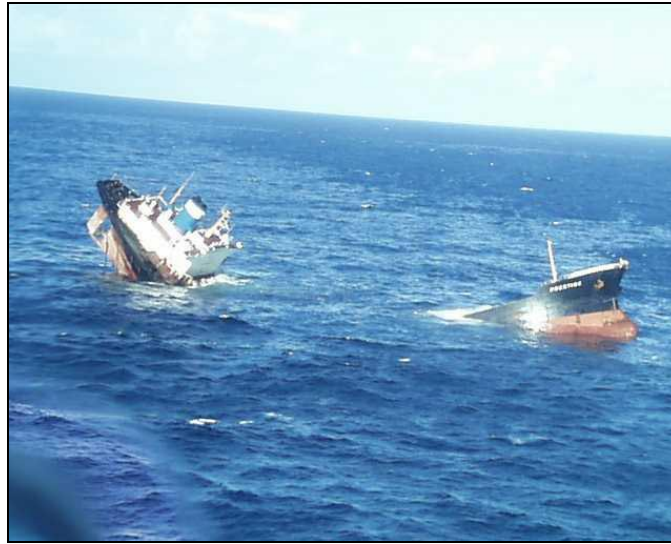
On the morning of November 19, 133 nautical miles off the coast of Spain in international waters, the PRESTIGE broke in two and sank. [Back to Table of Contents](#)

**Figure 5.** PRESTIGE after hull separation.

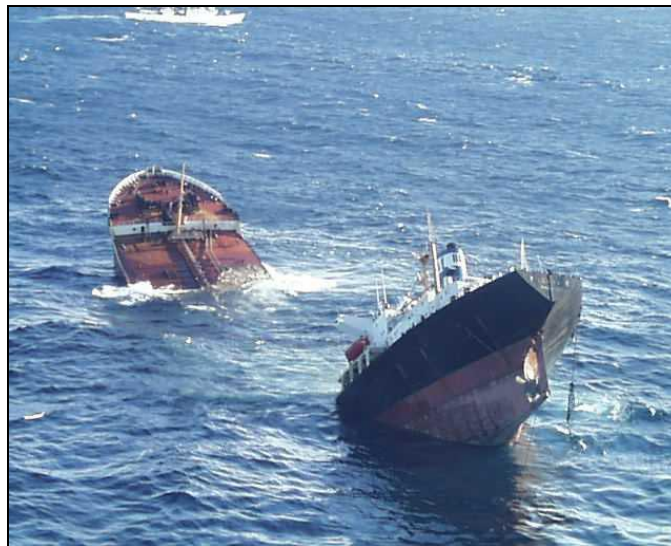
The break-up of the hull can be attributed to the continuous wave impact and internal sloshing the vessel incurred as it was towed out to sea. According to the calculations made by ABS, after the vessel was counter-flooded, the still-water bending moment was 154 percent of the allowable value and the shear force was 93 percent of the allowable value. The hull structure, even in its counter-flooded condition, was capable of remaining intact, and did so for six days as it was under tow. The additional dynamic wave loads, however, augmented the bending stress, and once the deck plate reached its buckling strength, the structure broke in two.

**Figure 6.** PRESTIGE just before sinking.

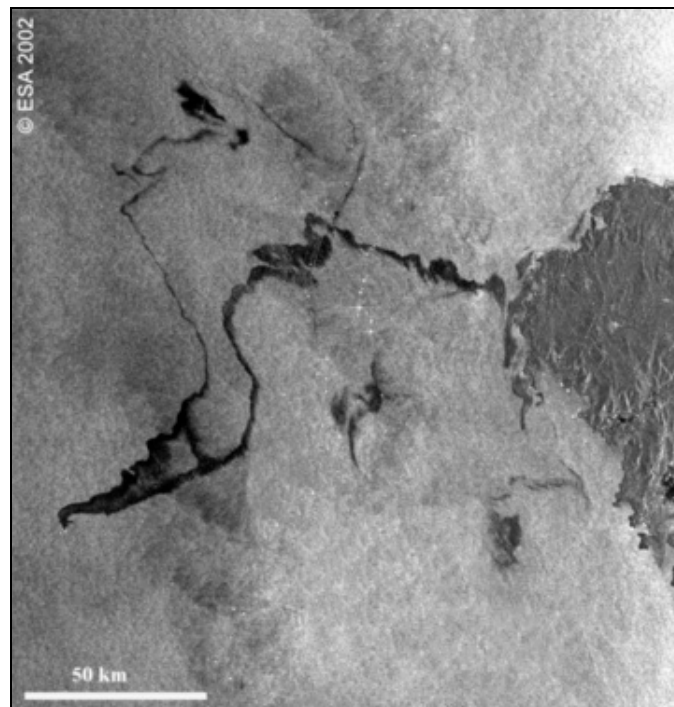
**Figure 7.** Satellite image of PRESTIGE oil spill from November 17, 2002.

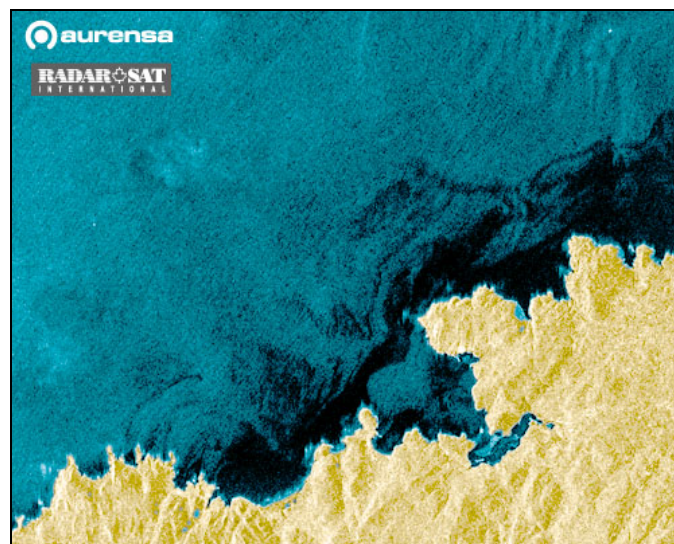
**Figure 8.** Satellite image of PRESTIGE oil slick on coast, November 18, 2002.
