REVIEW  
of  
**WELDED SHIP FAILURES**

by  
HAROLD G. ACKER  
Bethlehem Steel Company  
Shipbuilding Division

Prepared for  
**NATIONAL RESEARCH COUNCIL'S  
COMMITTEE ON SHIP STRUCTURAL DESIGN**

**December 15, 1953**

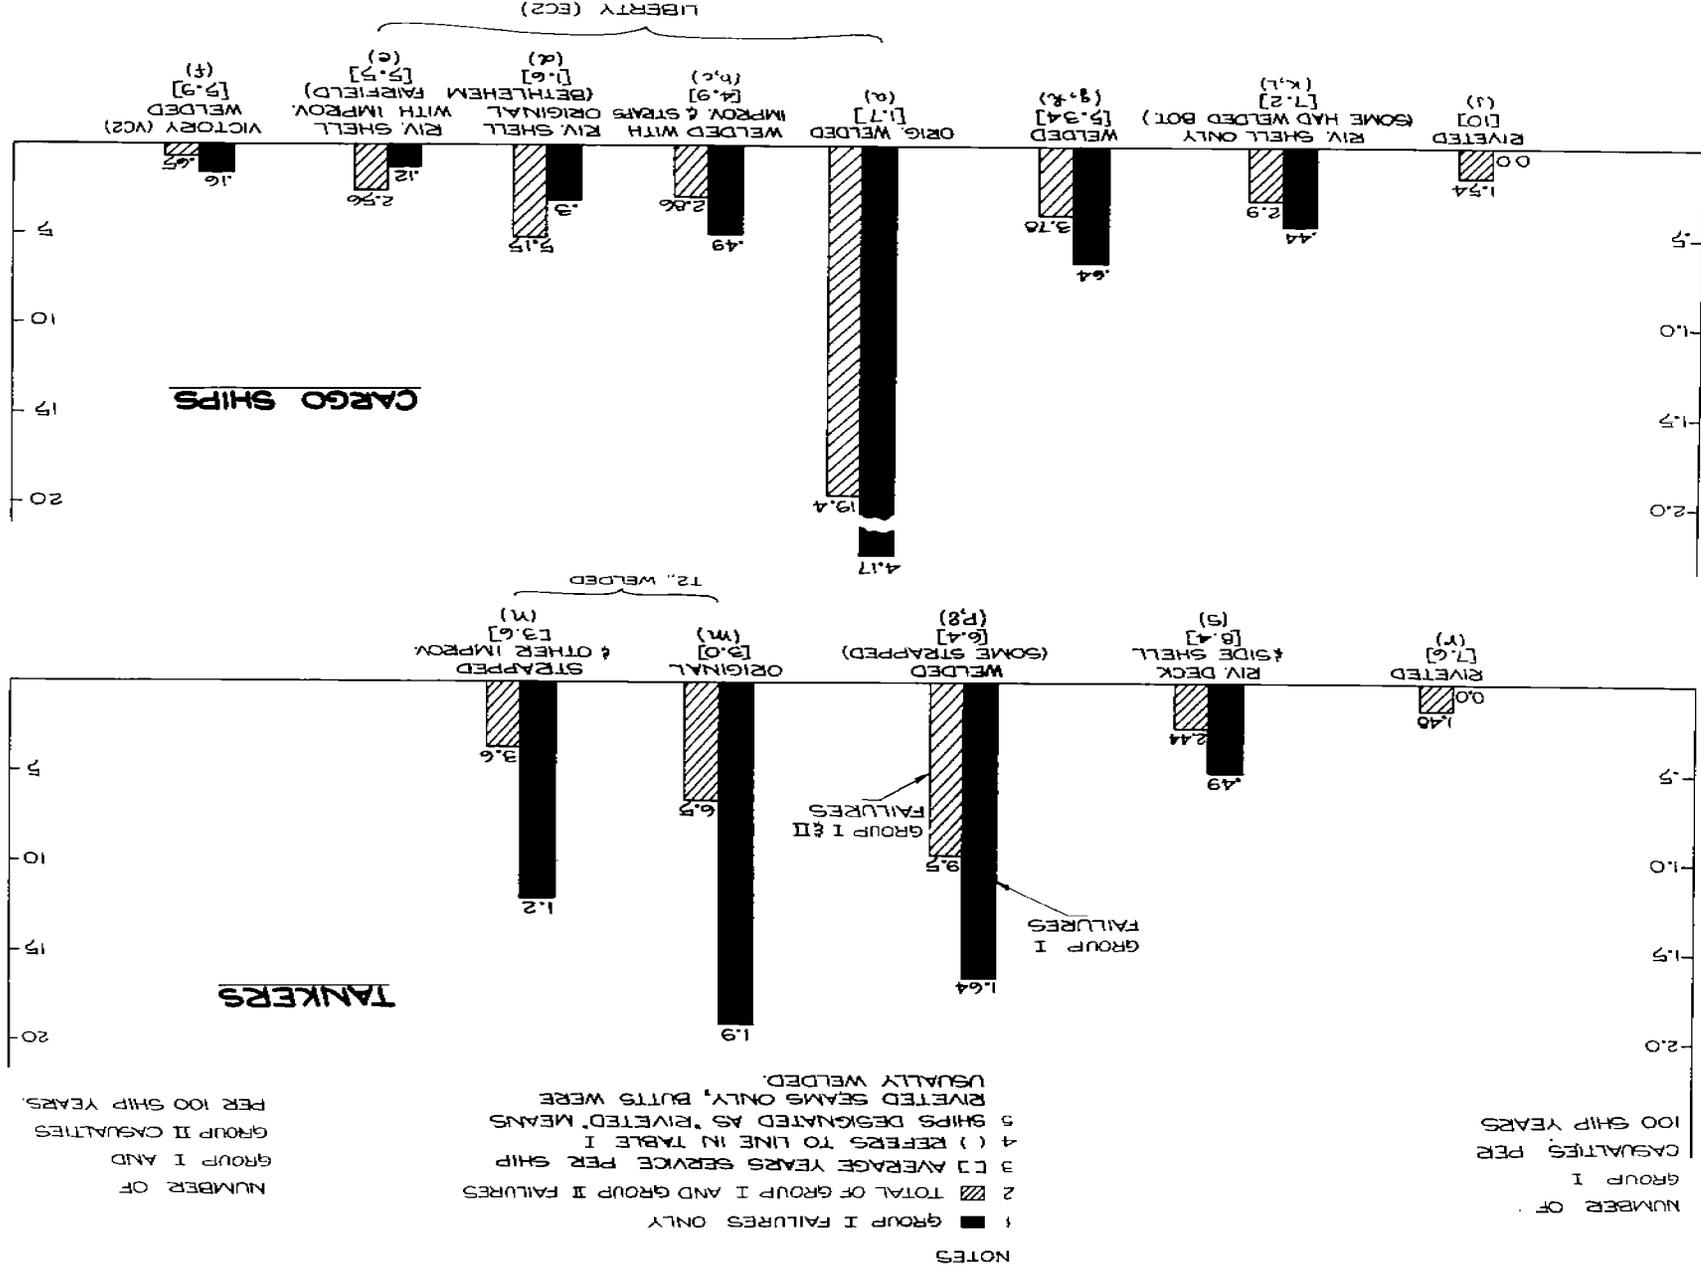
FIG. I - FREQUENCY OF CASUALTIES FOR SHIPS BUILT SINCE 1938

was substantially reduced after a few structural details, particularly the hatch corner and sheer strake cutout, were improved. This is illustrated in Figure 1. In addition, riveted crack arrestor straps were installed in the deck and at the gunwale of the welded Liberties, Figure 2.

Figure 1 shows that fractures in the original Bethlehem-Fairfield (B-F) Liberties (which differed from all other Liberties only in that they had riveted shell seams) were less extensive and less frequent than in the original welded Liberties. Incidentally the more serious failures in the B-F Liberties were in the shell, and not in the deck as in the case of the welded Liberties. The less serious fractures in the B-F Liberties, however, generally occurred in the all-welded deck, primarily at hatch corners. After corrective alterations were made to all Liberties, the frequency of failure in both riveted and welded types was about the same although the cracks in the B-F ships were still less extensive.

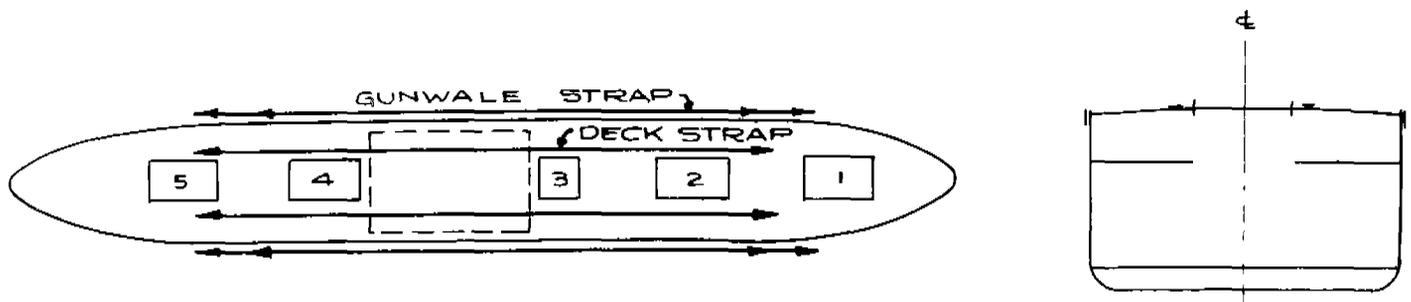
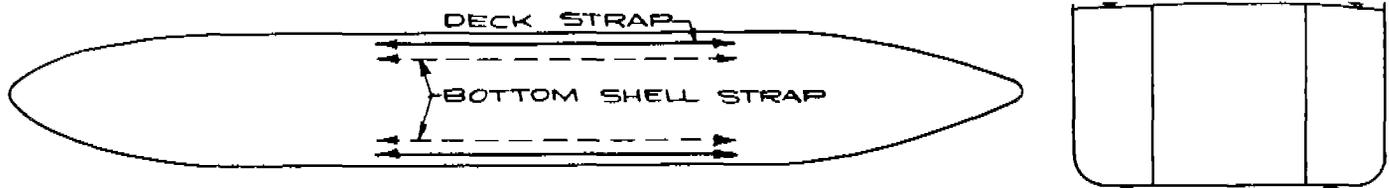
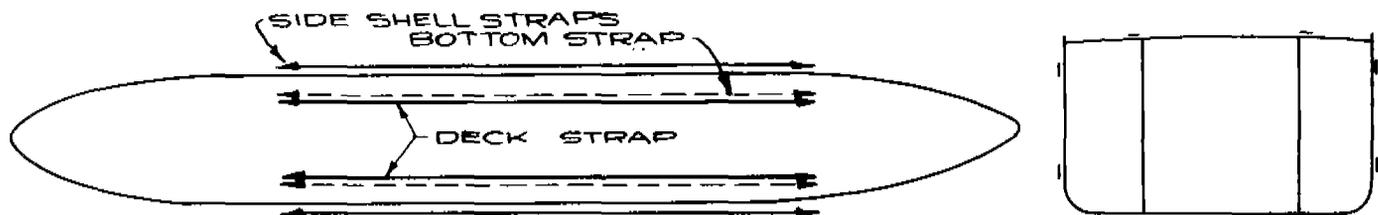
**FIG. 2 - LOCATION OF CRACK ARRESTOR STRAPS**

**WELDED LIBERTIES**

(NO STRAPS WERE REQUIRED ON THE BETHLEHEM FAIRFIELD LIBERTIES, WHICH HAD RIVETED SHELL SEAMS.)

**ORIGINAL MINIMUM REQ'D FOR T-2 TANKERS**

(NEW REQUIREMENT OF 1952 CALLS FOR A MIN. OF 8 STRAPS.)

ARRANGEMENT INSTALLED ON T-2'S BY SOME PRIVATE OWNERS

For the T2 tankers, most of the trouble stemmed from defects in bottom shell butt welds, and no simple remedial measures could be applied. Eventually at least 4 crack arrestor straps were installed in the T2 tankers--two on the deck and two on the bottom, see Figure 2. The straps covered the midship length of the ship where serious cracking had been experienced. While crack arrestors have been effective in limiting the extent of cracks, they have not decreased the incidence of cracks or prevented the breaking in two of ships. The frequency of Group I fractures in the T2's did not diminish significantly. Fractures in T2 tankers have therefore remained the major ship failure problem.

A new directive for structural modifications of T2 tankers was issued by the American Bureau of Shipping in April 1952. This included installing additional crack arrestor straps to bring the minimum number to eight and increasing the section modulus of the hull girder by 15%.

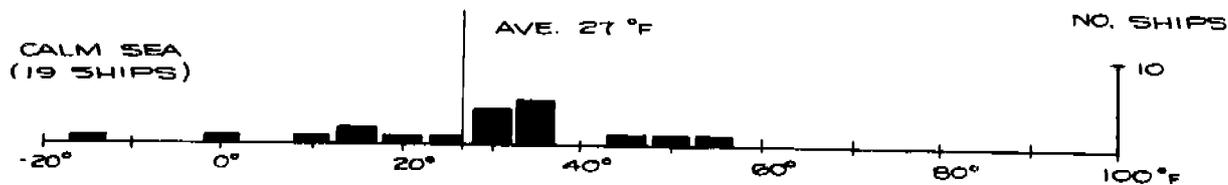
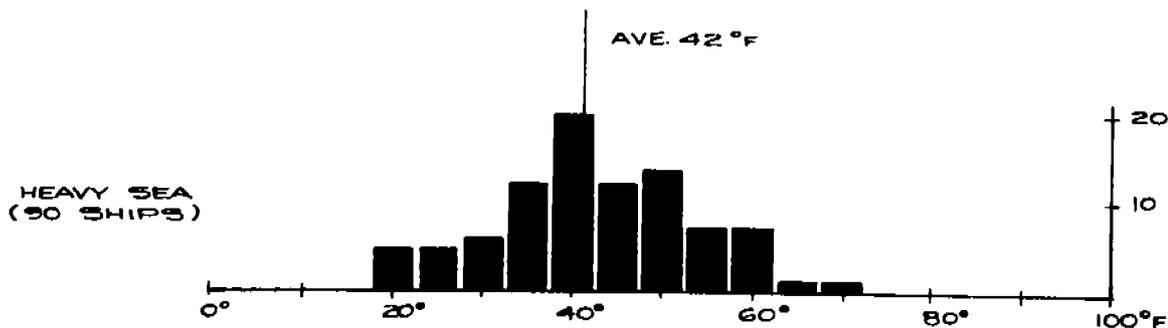
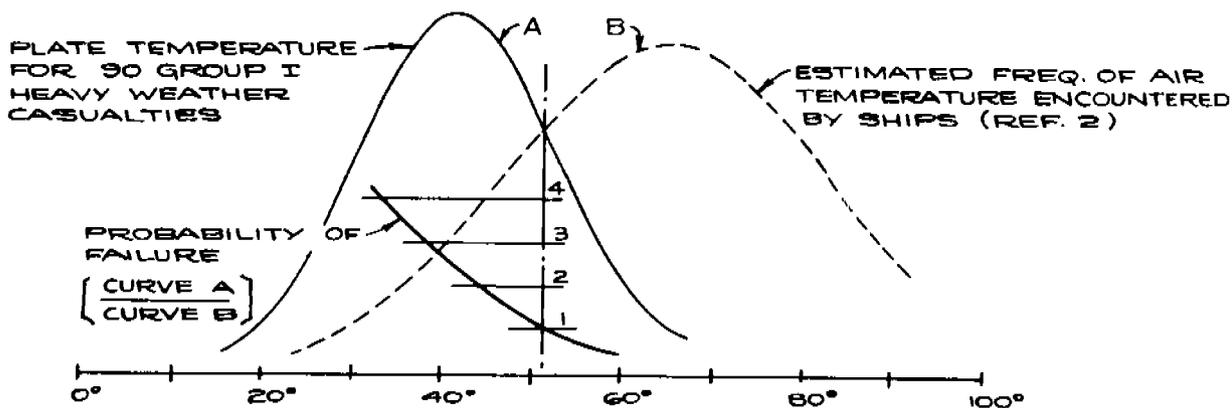
FIG. 3 TEMPERATURE AT FAILURE GROUP I CASUALTIES

The majority of failures occurred during heavy weather and near freezing temperatures, Figures 3 and 4.

Figure 3b shows that the probability of failure increases rapidly as the temperature is lowered. Although the failure temperatures include some sea water temperatures, there were very few cases where the water temperature was markedly different from the air temperature, and therefore the sense of the probability curve is valid. These curves, of course, are for ships built of wartime steel, and they indicate that the chance of failure increased about four times when the temperature was lowered from 50°F to 30°F.

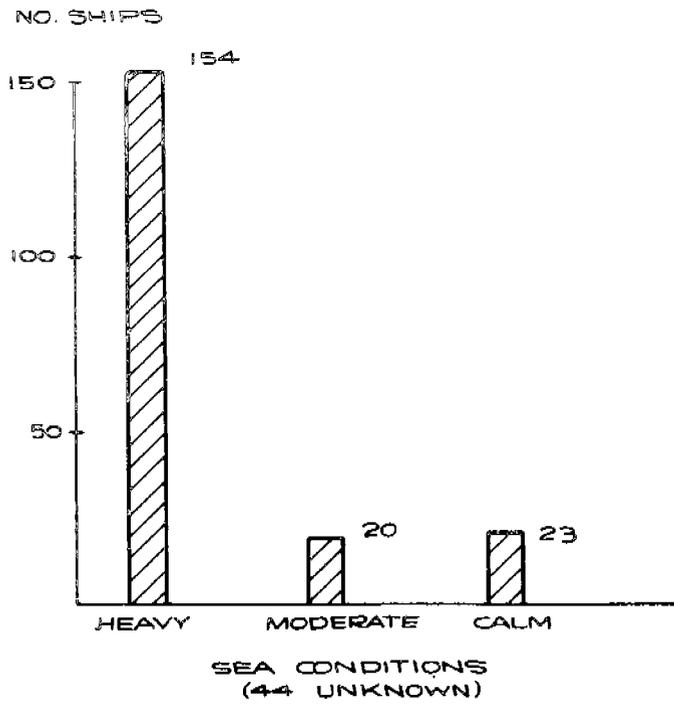
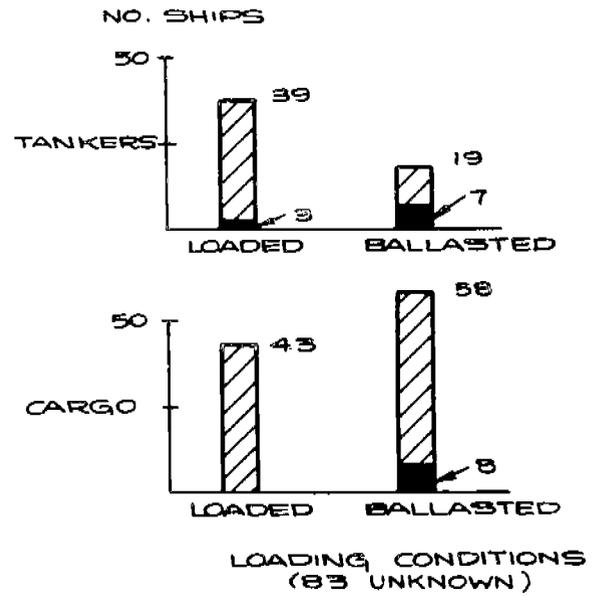
FIG. 4 - SEA AND LOADING CONDITIONS AT TIME OF FAILURE  
GROUP I CASUALTIES

Figure 4 shows that failures occurred more frequently

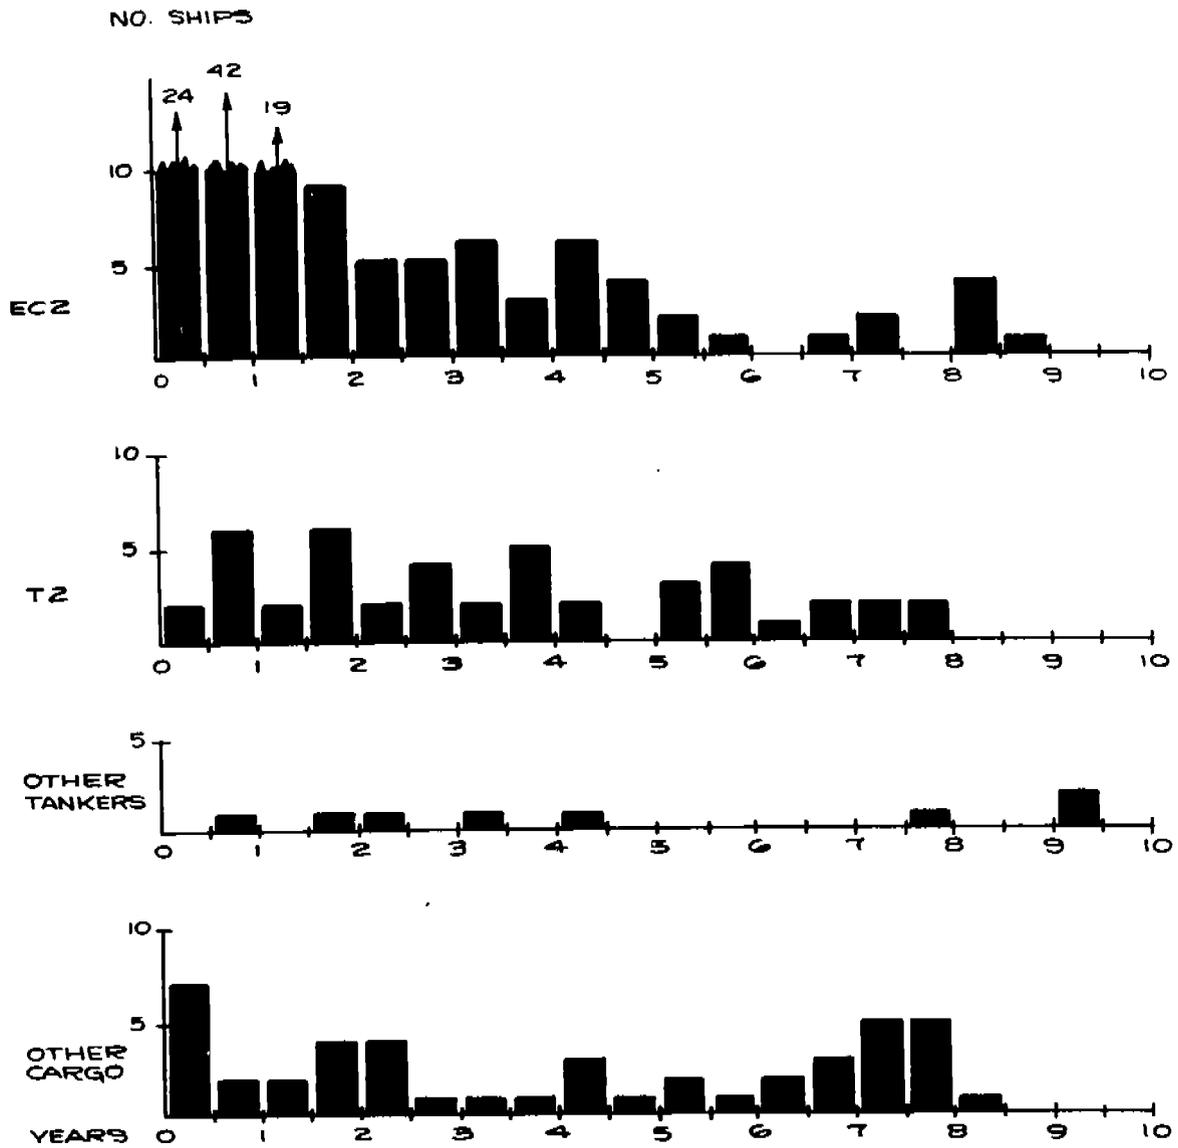
FIG. 5 - YEARS IN SERVICE AT TIME OF FAILURE  
GROUP I CASUALTIES

Except for the early Liberty failures in 1943-45, the frequency of failures in both cargo ships and tankers has not shown any particular trend either to increase or to decrease with length of service, Figure 5. For the Victories, however, all four Group I failures and 80% of the Group II failures occurred during the last two years, i.e., failures began to develop after the ships had given about 4 years of nearly trouble-free service.

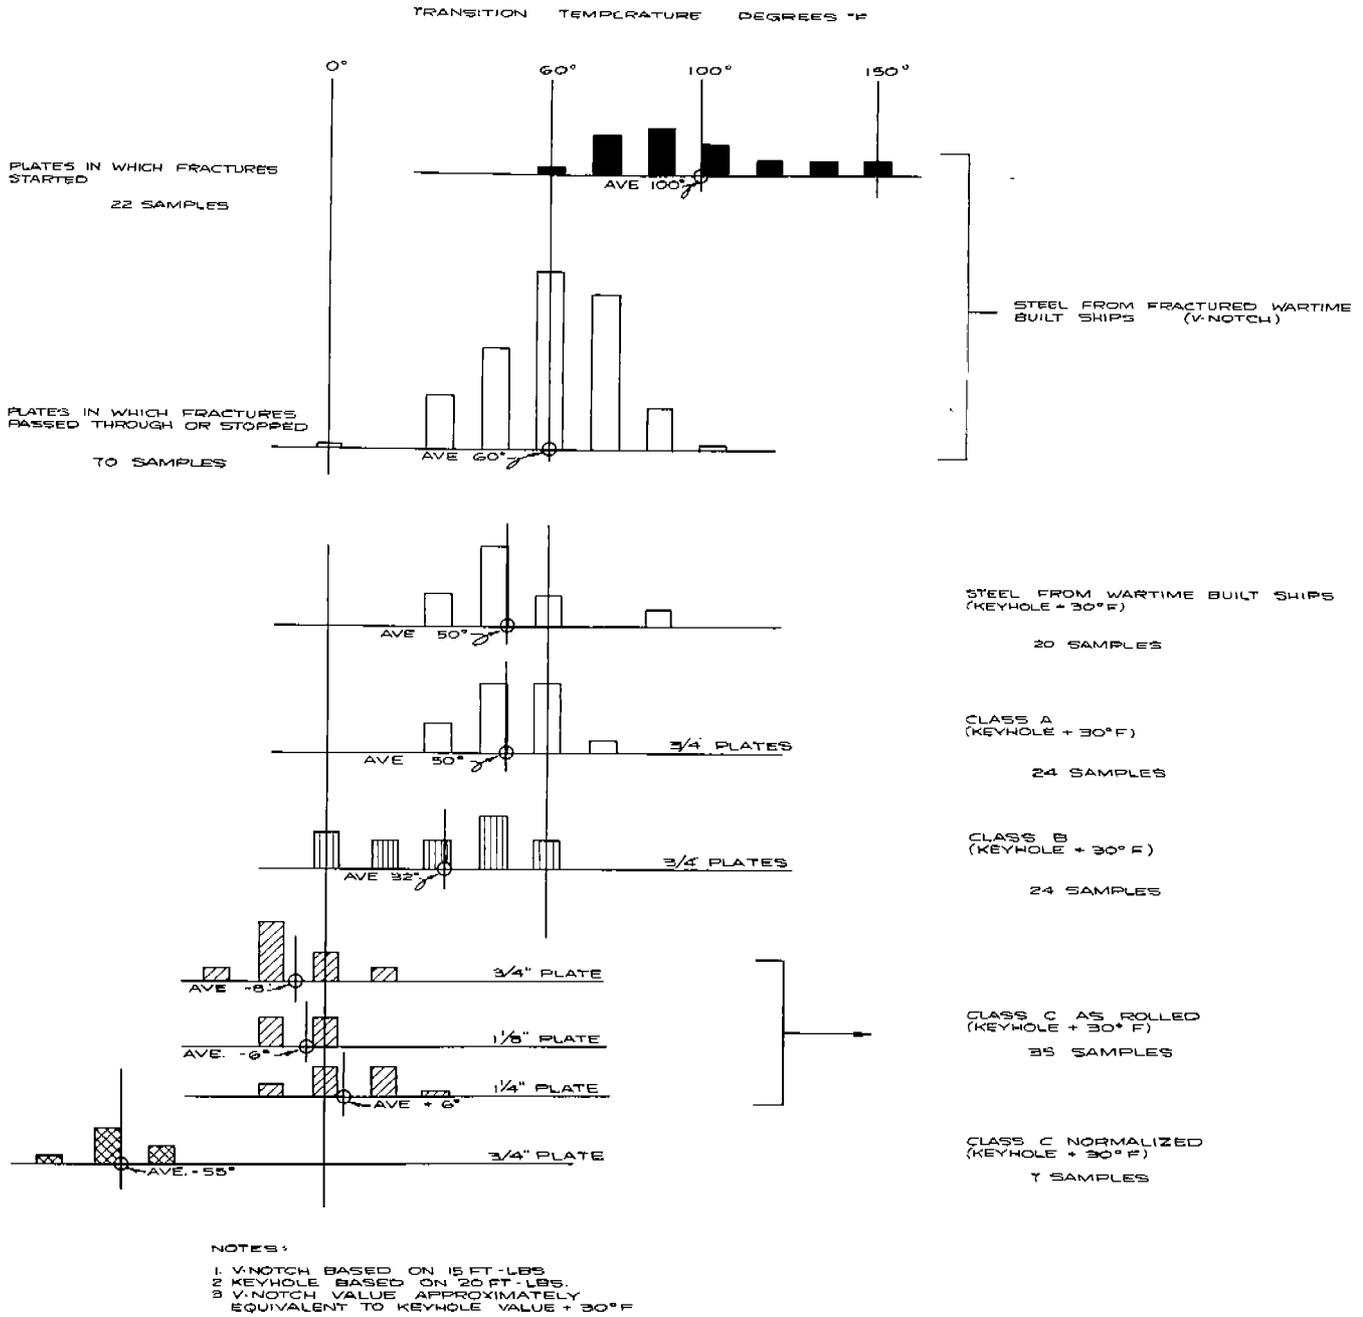
FIG. 6 - COMPARISON OF CHARPY TRANSITION TEMPERATURES OF WARTIME AND PRESENT ABS STEELS

Figure 6 compares the transition temperature of the old and new ABS steels assuming that the steel taken from the fractured ships is representative of the old steel<sup>(8)</sup>. The Charpy V-notch values were obtained by the National Bureau of Standards<sup>(9)</sup>. The keyhole values were obtained by the American Bureau of Shipping and several steel companies<sup>(10,11,12)</sup>.

Statistically, the source plates are specially selected plates in that they have significantly higher Charpy V-notch transition temperatures than the other plates. Another important finding is that the source plates have a considerably higher carbon content. There is essentially no difference in transition temperature between the thru and end plates; this means that whether or not the crack stopped cannot be

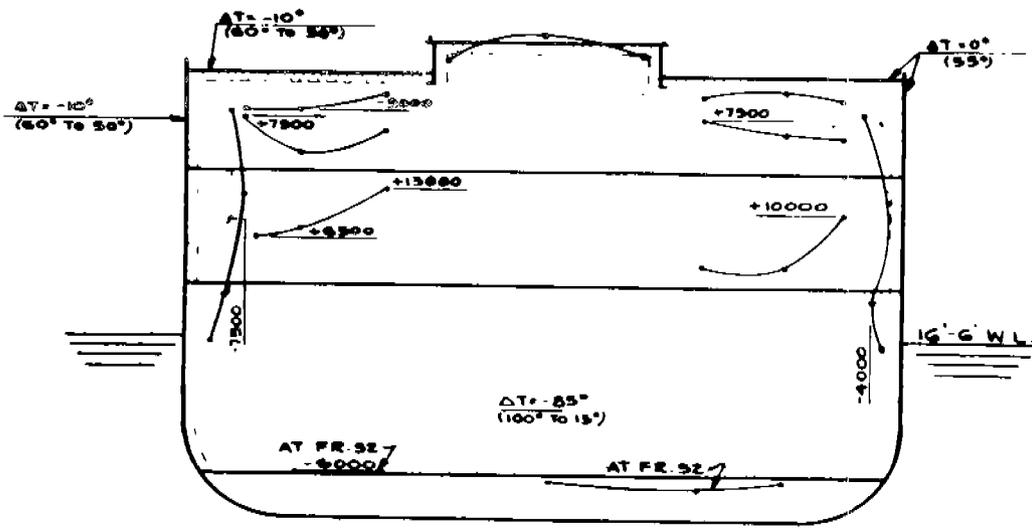
FIG. 9 - Measured Thermal Stresses in C2 Reefer Due to Cooling Down 85°F.

Cooling the hold 85°F in the actual test created tensile stresses in the 'tween decks of from 5000 to 10,000 psi. The outside shell and weather deck were put into compression, by about 3000 psi. See Figure 9.

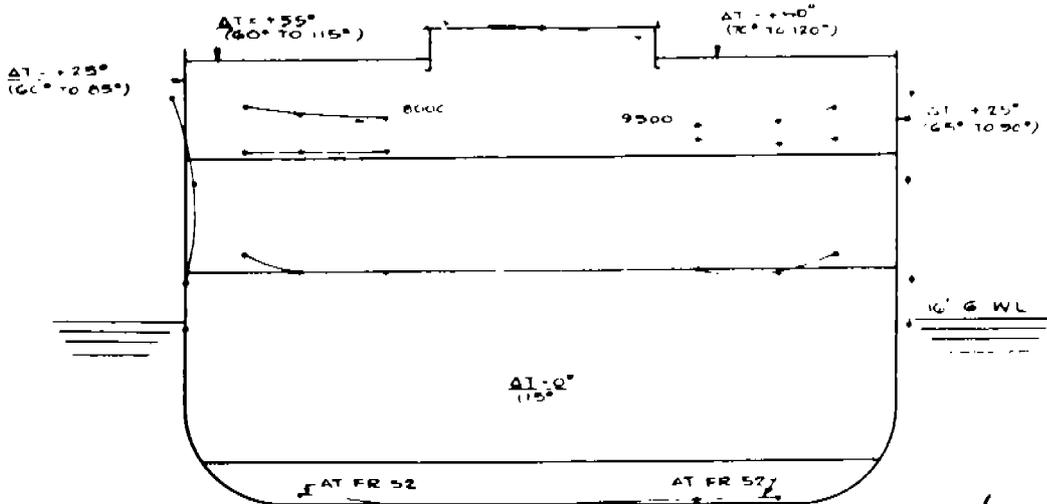
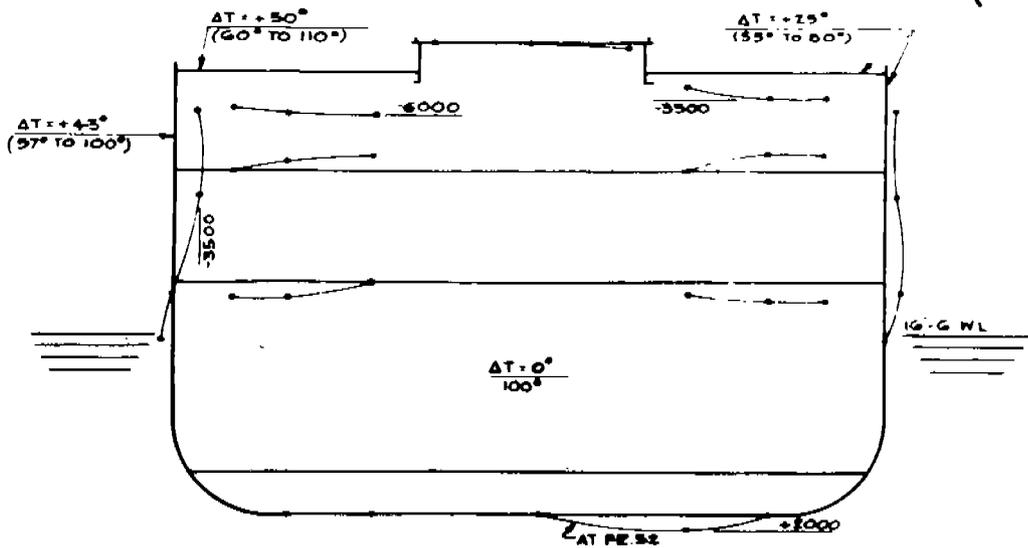
FIG. 10 - Measured Diurnal Thermal Stresses in C2 Reefer

The low temperature creates biaxial tensile stresses and at the same time lowers the notch sensitivity of the steel. Figure 10 shows diurnal thermal stresses on the same ship when the upper deck was exposed to the sun.
