Presented at the Marine Structural Inspection, Maintenance, and Monitoring Symposium
Sheraton National Hotel, Arlington, Virginia, March 18-19, 1991

The Structural Renovation of a Liquefied Gas Carrier

G.L. Stiehl, West Coast Shipping Company, Los Angeles, California

M.C. Cheung, MCA Engineers, Newport Beach, California

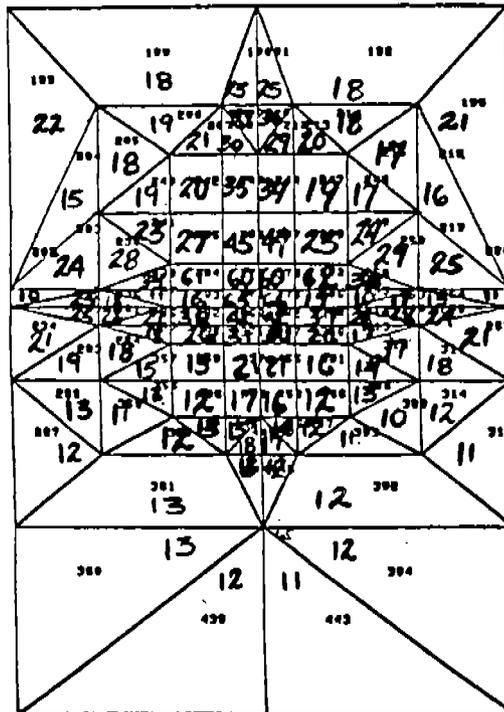
PLAN VIEW LOWER TANK
TOP KNUCKLE
VALUES ARE STRESS KSI
BEFOR REPAIR
FIG. 23

The stress results obtained from the analysis indicated that the maximum stresses in the area of the lower tank top knuckle and saddle tank bottom as expected by the known locations of fractures. The lower tank top knuckle had the higher stress, stress was also higher at web frames than ordinary frames, and stresses were higher in the middle of the tank than at the ends. All of these results correlated well with the fracture history. The fine mesh model also indicated that the area of excessive stress was extremely small and involved spaces not more than a few inches in diameter. Such a small flaw was unlikely to be uncovered by the kind of coarse analysis typically done in the design stage of ship construction projects. It was also observed that the model predicted stress above the yield of the material indicating that fractures could be expected immediately after the ship entered service, which also corresponded to actual experience.
