Corrosion and Safety of a Ship: Survey Report of a Long-Life Ship

M. Arita, H. Inoue, E. Fuji and T. Kobayashi, Ship Research Institute, Tokyo, Japan

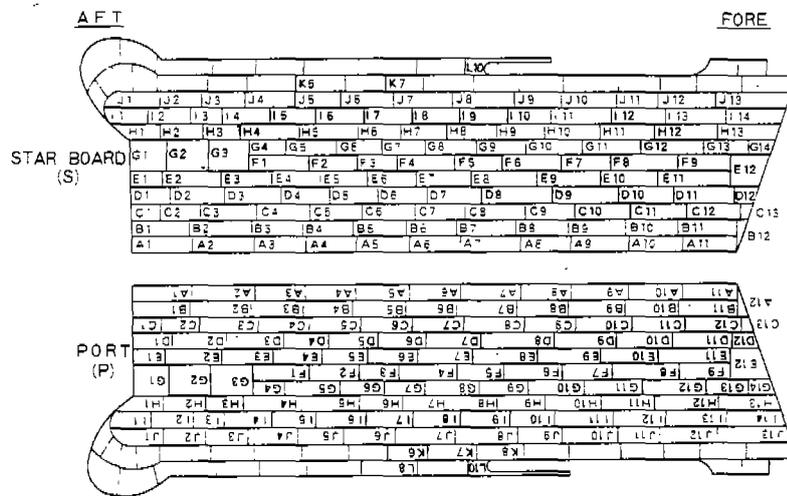
Fig. 2 Replacement of Side Shell Plate (Shaded Plates were replaced at 25 through 56 years old of ship age)

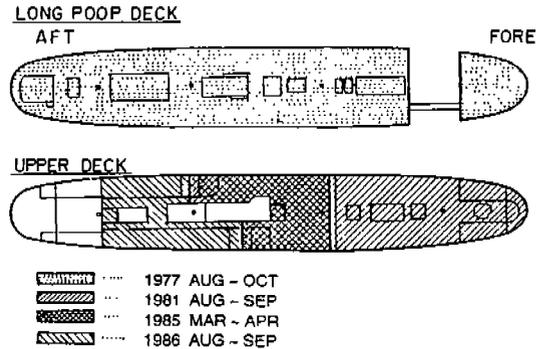
Fig. 3 Replacement of Deck Plate
(47 years old in 1977)

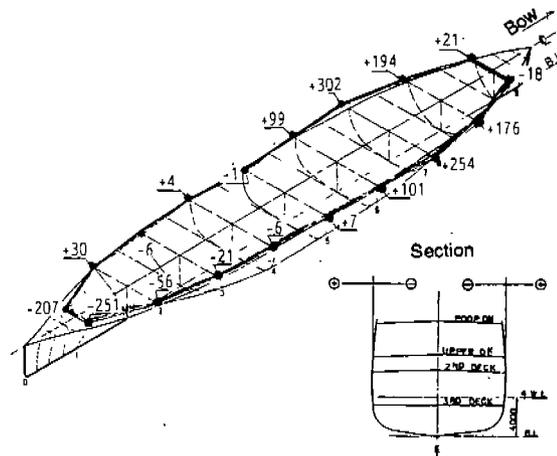
Figures 6 and 7 show horizontal deformations of side plates at the height from the keel line to be 4m (4WL) and 7m (7WL). In the figures, (+) indicates outward and (-) indicates inward deformations. At 4WL, there are little horizontal deformations around midship (at SS4 and SS5). And there are outward deformations at bow side and a little bit inward deformations at stern side. At 7WL, quite different from deformations at 4WL, whole deformations occur to port side direction. The maximum deformation at 4WL is 302 mm and this value corresponds to 2.3% of the breadth.

Fig. 6 Deformation of Side Shell at 4WL

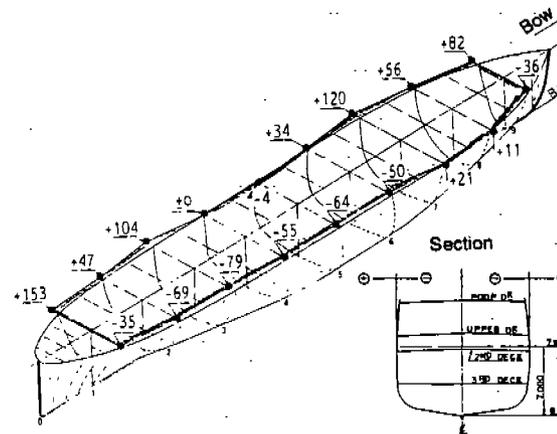
Fig. 7 Deformation of Side Shell at 7WL

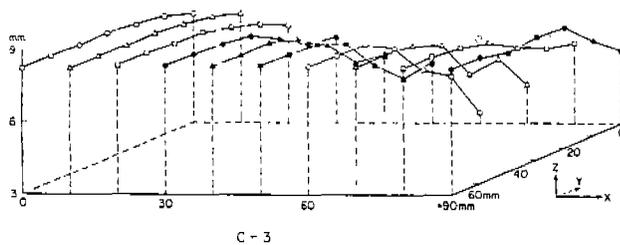
In specimen C-3 (Fig. 16), plate thickness decreases gradually to its longitudinal direction. In C-4 (Fig. 17), decrease in thickness is very large and there is even a corrosion hole. In C-6 (Fig. 18), plate thickness shows abrupt changes. In case of C-4, a crack initiated at the edge of the hole played as one of cracks initiated at many points on a corroded surface.

Fig. 16 Appearance of Corroded Surface (Test Specimen C-3)

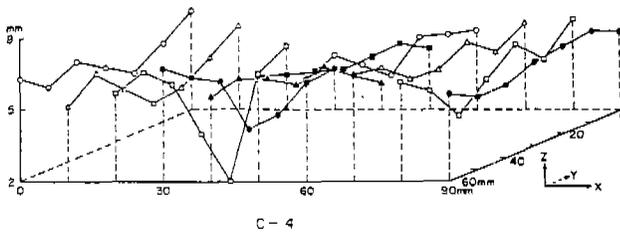
Fig. 17 Appearance of Corroded Surface (Test Specimen C-4)

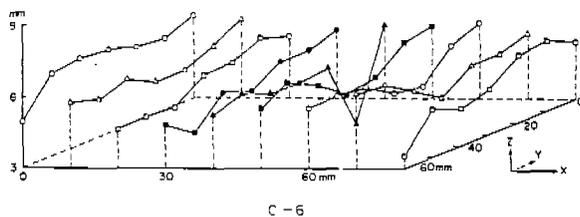
Fig. 18 Appearance of Corroded Surface (Test Specimen C-6)
