SSC-74

**ELECTRON MICROSCOPE TECHNIQUES
FOR STUDY OF FRACTURED SURFACES OF SHIP PLATE STEELS**

Final Report
of
Project SR-122

Stevens Institute of Technology
Hoboken, New Jersey

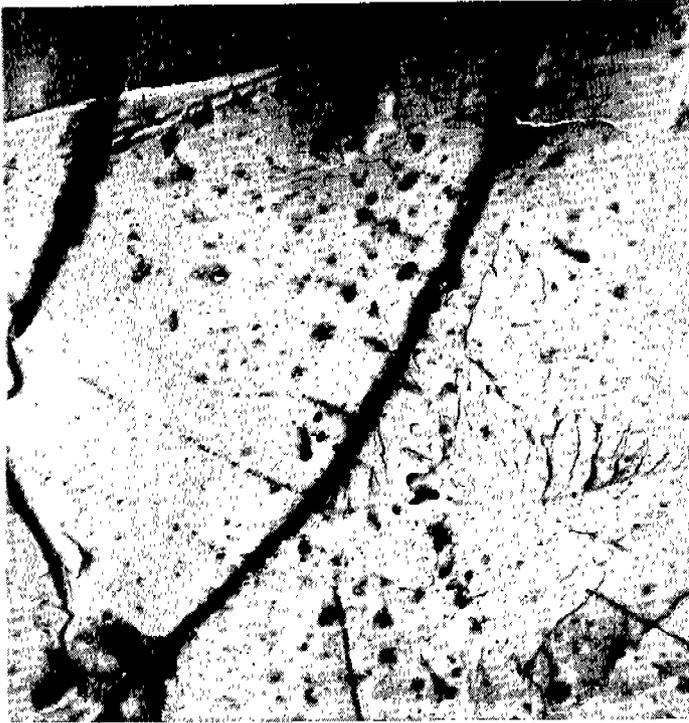
Figure 5. Fractured Surface of a Project C Steel Navy Tear Test Specimen Broken at 10 F (X5000)

Figures 3 through 11 are micrographs of C steel specimens that had been broken at each temperature noted in the preceding section. These micrographs

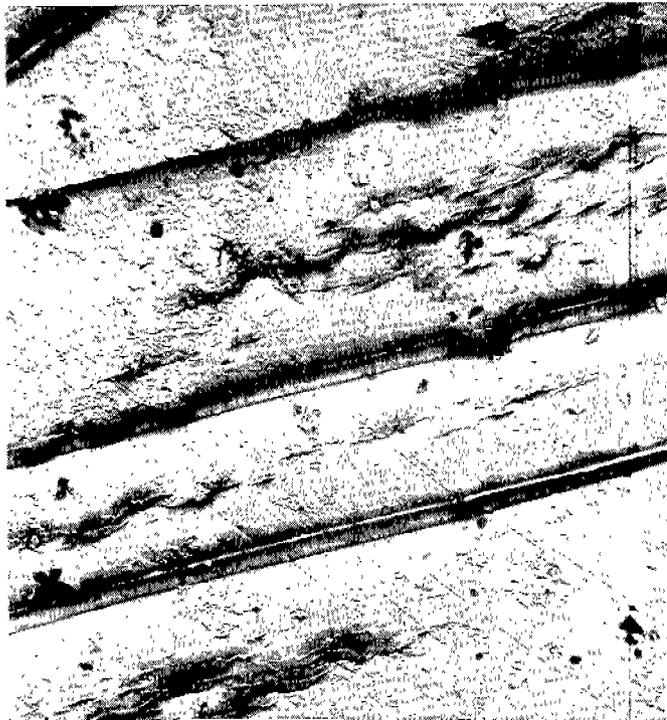
Figure 7. Fractured Surface of a Project C Steel Navy Tear Test Specimen Broken at 90 F (X5000)

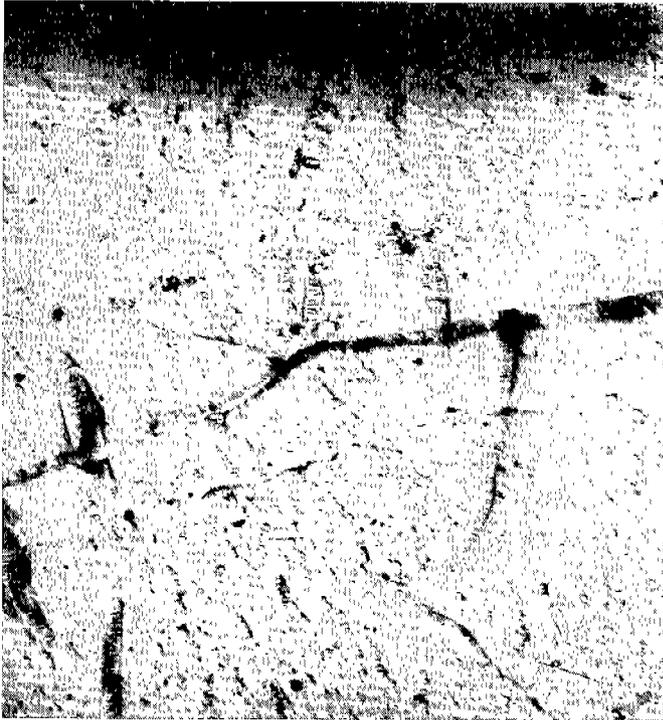
Figure 8. Fractured Surface of a Project C Steel Navy Tear Test Specimen Broken at 120 F (X5000)

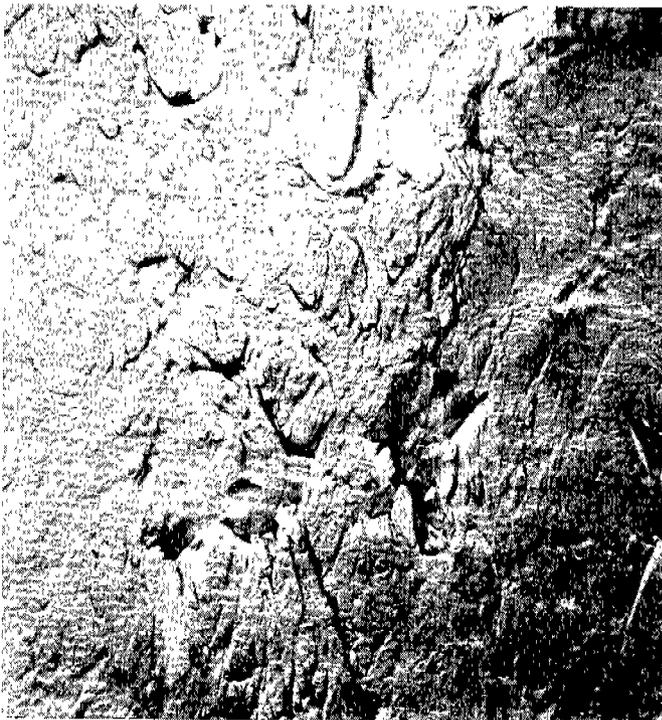
Figure 10. Fractured Surface of a Project C Steel Navy Tear Test Specimen Broken at 180 F (X5000)

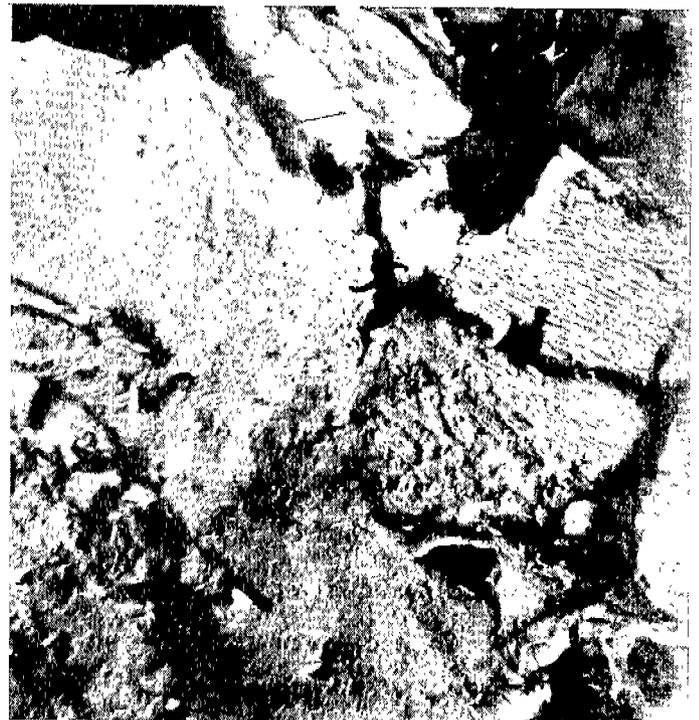
Figure 11. Fractured Surface of a Project C Steel Navy Tear Test Specimen Broken At 210 F (X5000)

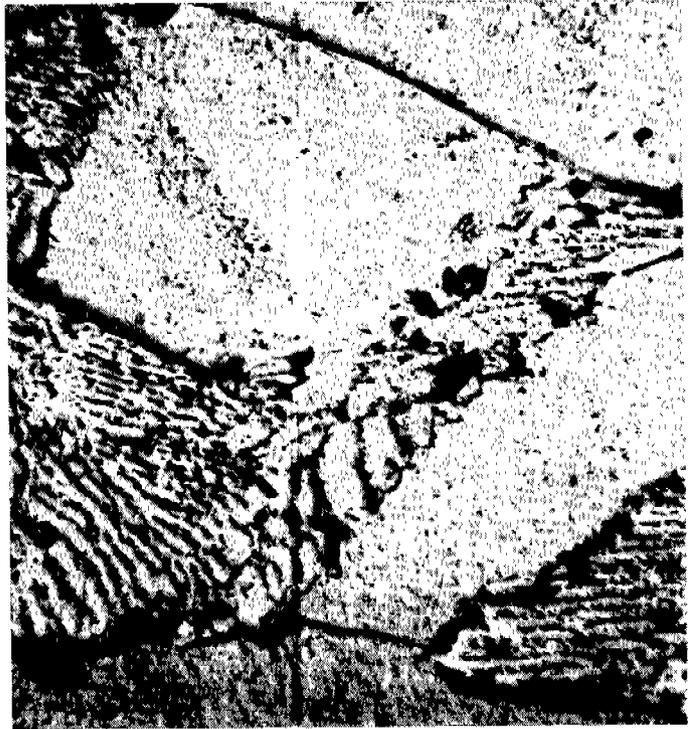
Figure 14. The Polished and Etched Surface of a Project A Steel Specimen Micrographed to Show Fine Detail. (X5000)

Figures 14 and 15 are micrographs of polished and etched A and C steel specimens. These serve to indicate that a rough fractured surface is not necessary for an examination of detail; fine detail can be observed from a polished and etched specimen.

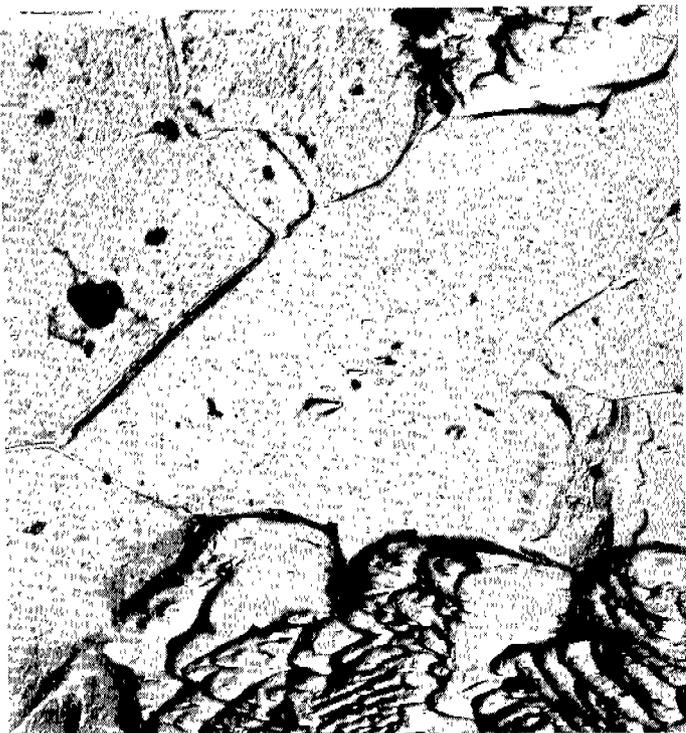
Figure 15. The Polished and Etched Surface of a Project C Steel Specimen Presents Fine Detail When Micrographed. (X5000)
