# Interaction and Compatibility Between Machinery and Hull from a Static and Vibratory Point of View

G. C. Volcy, Member, Bureau Veritas Maritimes Services  
Paris, France

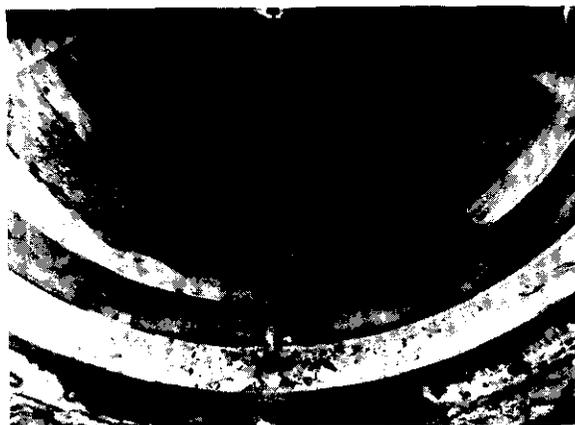
But as the size of ships and the power of machinery have increased, it has been stated that slope boring of stern tube was not sufficient to assure the correct behaviour of white metal, when anew severe damages to white metal in way of aft part of aft bushings have been encountered. On Figure 7 is presented a photo of such a damage.

Fig. 7 - Deteriorated aft part of aft bushing of a 260,000 DWT VLCC.
