REVIEW  
of  
**WELDED SHIP FAILURES**

by  
HAROLD G. ACKER  
Bethlehem Steel Company  
Shipbuilding Division

Prepared for  
**NATIONAL RESEARCH COUNCIL'S  
COMMITTEE ON SHIP STRUCTURAL DESIGN**

**December 15, 1953**

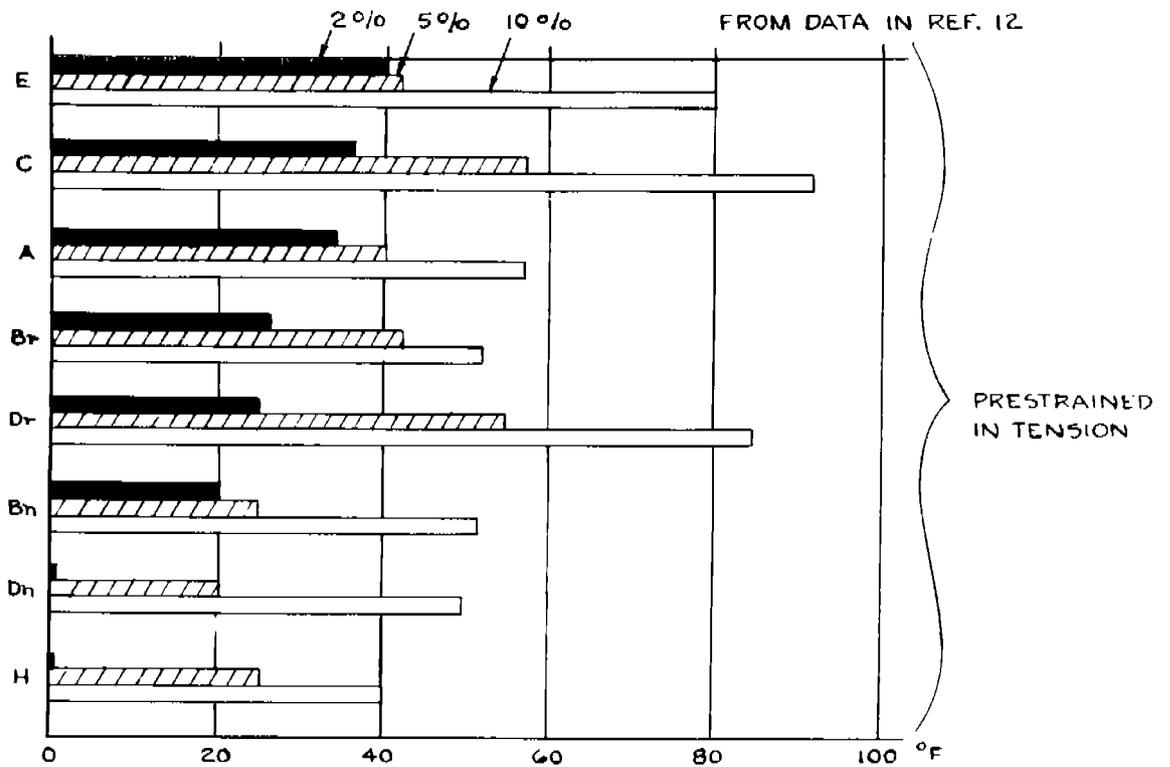
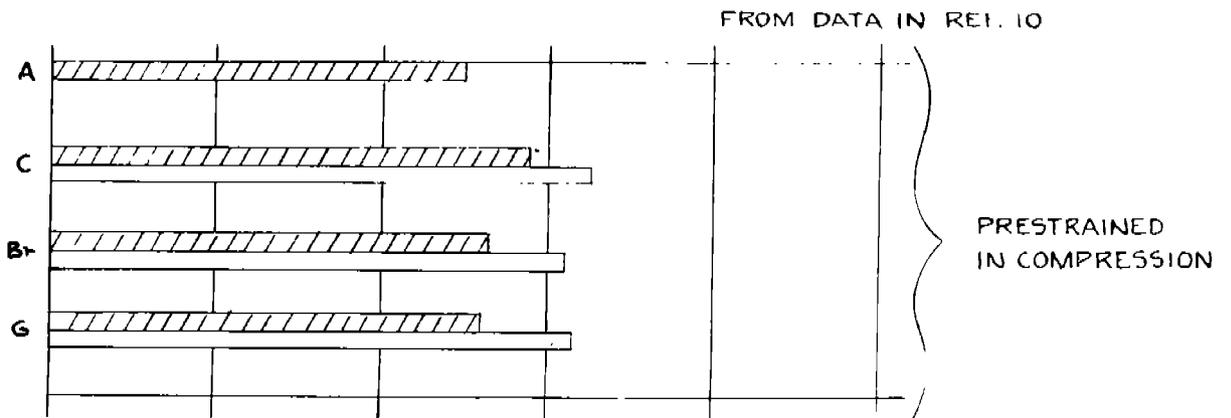
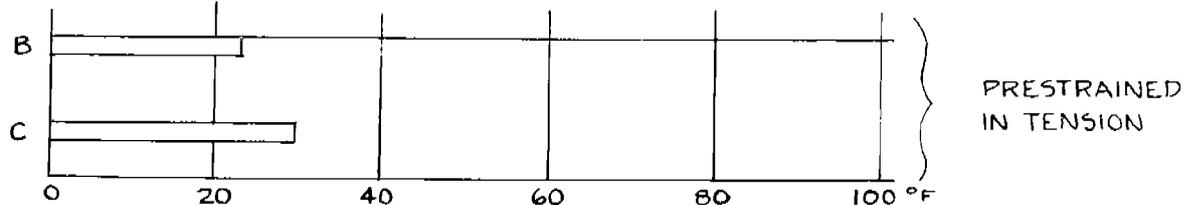
FIG. 7 - EFFECT OF PRESTRAINING  
CHARPY 20FT LBS. KEYHOLE

in Figure 7. Some steels are more susceptible to straining and strain aging than others. In general the rimmed steels are most susceptible and the fully killed steels are the least, especially at small strains.

INCREASE IN TRANSITION TEMPERATURE WITH VARIOUS AMOUNTS OF PRESTRAIN

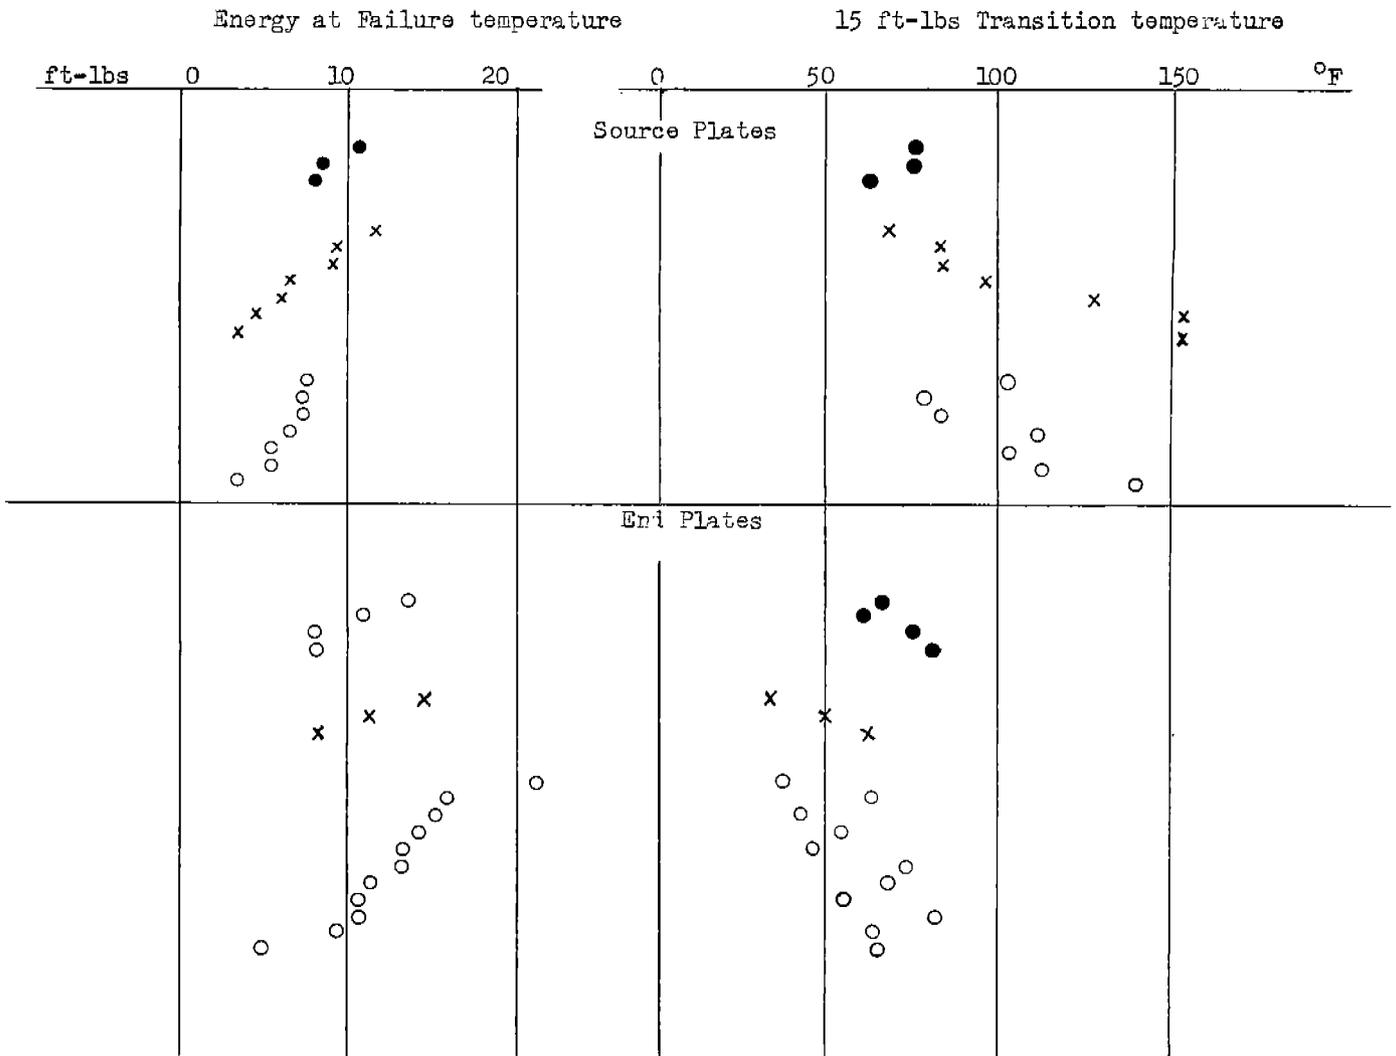
The interesting feature of the data is that most of the source plates at failure temperature absorbed less than 10 ft-lb, while most of the end plates absorbed more than 10 ft-lb. Also, the corresponding 15 ft-lb transition temperatures for the source plates averaged about 100°F and were all above 60°F, while those for the end plates averaged about 60°F with the highest at 82°F.

<u>Source</u>	<u>Thru</u>	<u>End*</u>
Average energy at fracture temperature, ft-lbs	7.1 (3.2 to 11.4)	9.5 (3.8 to 18.7)	12.3 (5.0 to 21.4)
Average 15 ft-lbs transition temperature, °F	101° (62 to 153)	65° (38 to 102)	59° (36 to 82)

Values for Source and End Plates are plotted below:

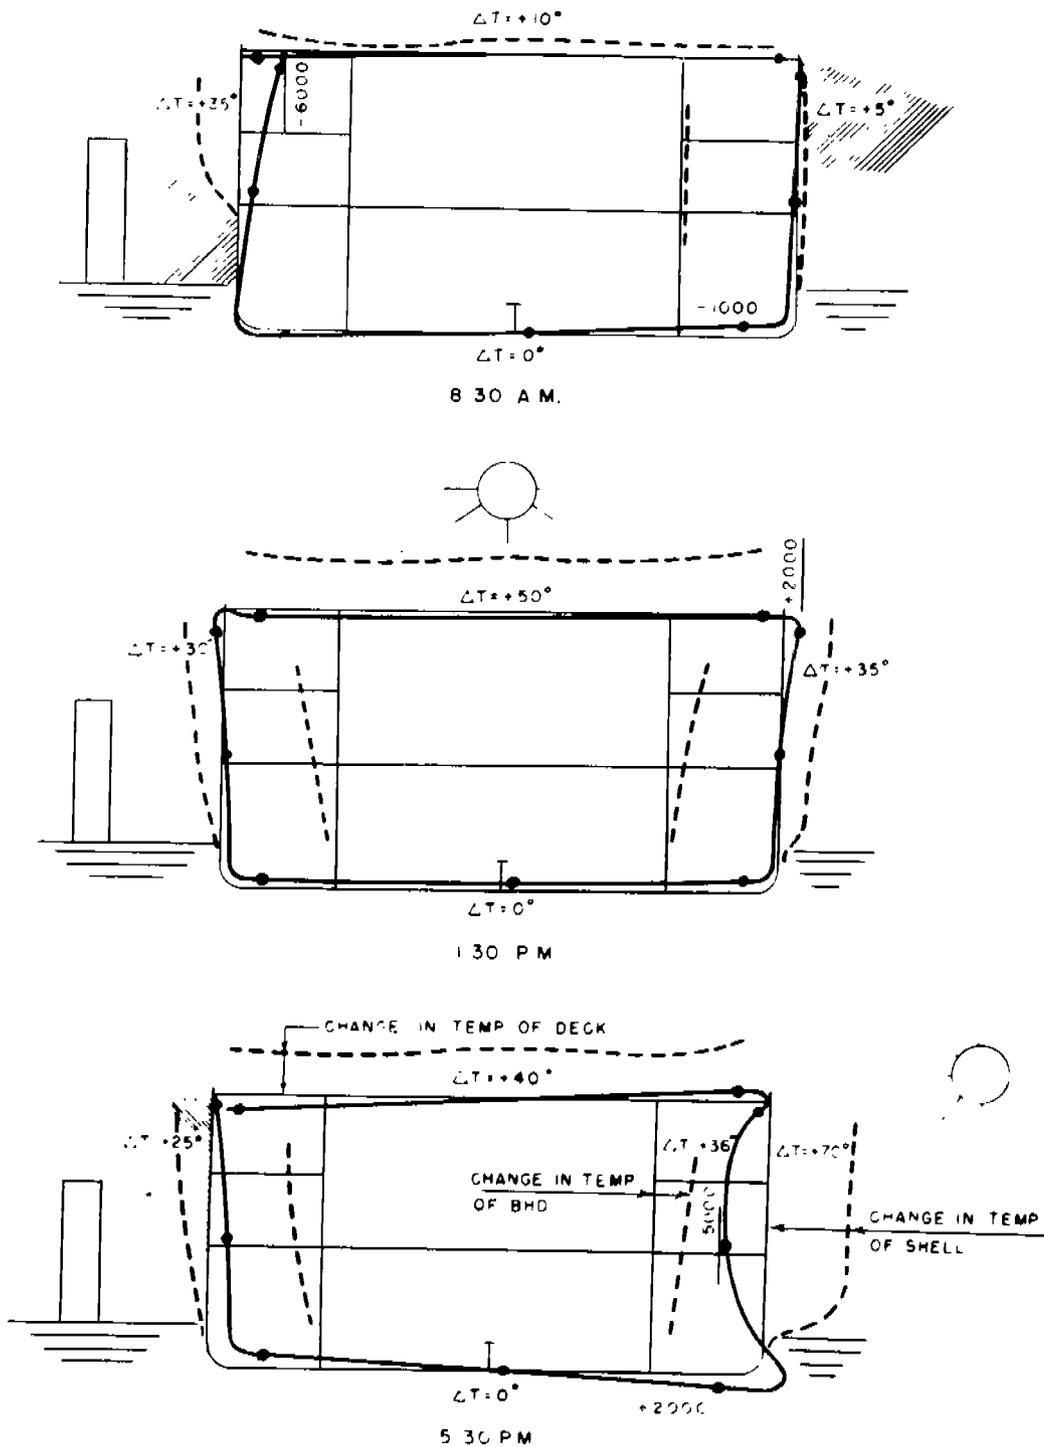
The two variables determining thermal stresses are the flexibility of the hull structure and the temperature distribution. Differences in temperature between top and bottom of the ship mean very little; if the temperature distribution is linear, no stress will result. To illustrate this, a comparison

1. All stress changes (psi) in fore and aft direction.
2. Tension (+) plotted outbd.  
Compression (-) plotted inbd.
3.  $\Delta T$  - Temperature change from "zero" condition taken at night.
