Presented at the Marine Structural Inspection, Maintenance, and Monitoring Symposium
Sheraton National Hotel, Arlington, Virginia, March 18-19, 1991

The Structural Renovation of a Liquefied Gas Carrier

G.L. Stiehl, West Coast Shipping Company, Los Angeles, California

M.C. Cheung, MCA Engineers, Newport Beach, California

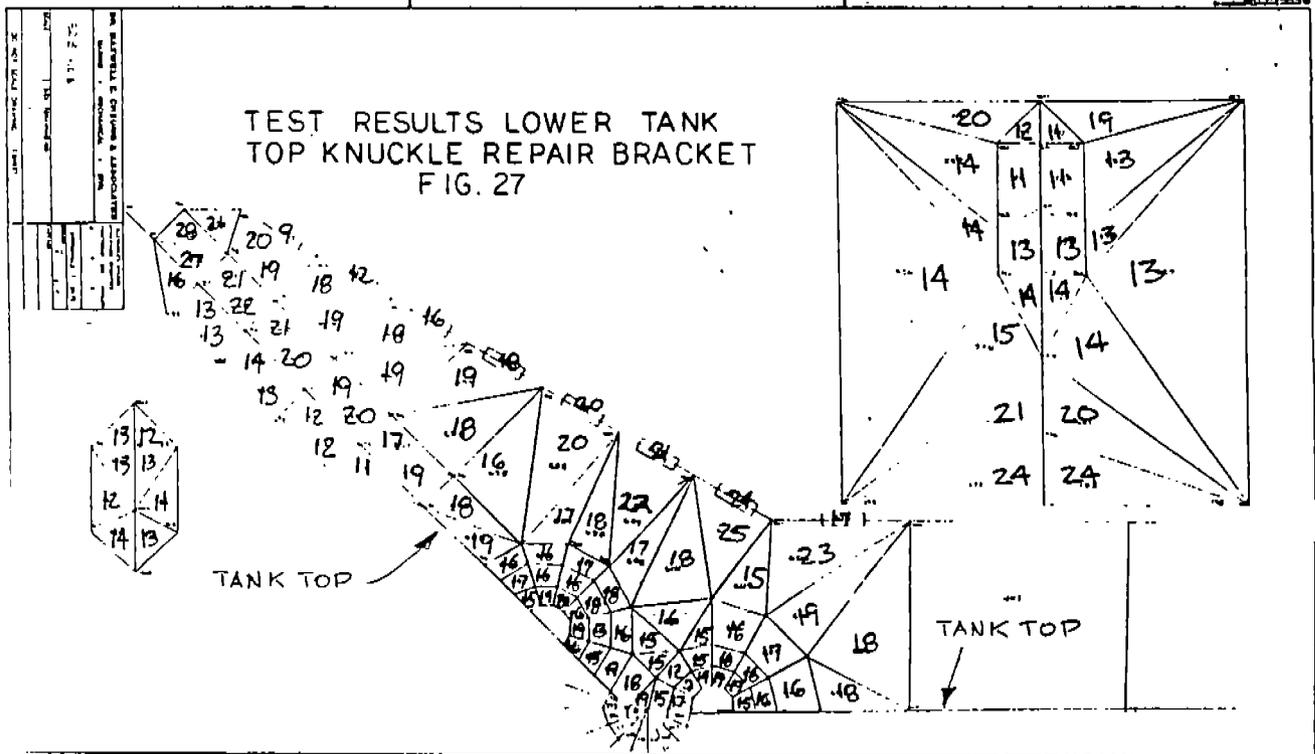
FIG. 28

TEST RESULTS LOWER TANK TOP KNUCKLE
REPAIR BRACKET

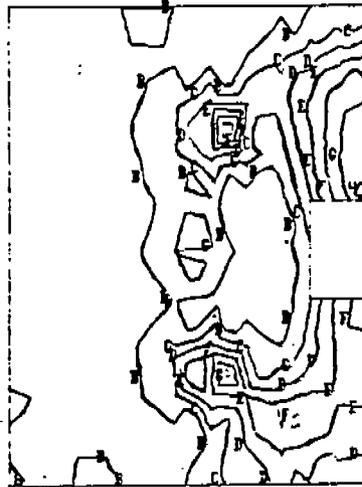
Fig. 42

Since the stage one model has a coarse element grid and consists primarily of orthotropic plates, it is not important, nor realistic, to interpret the actual stress level from the contours of this model. Rather, the results are used to detect high stress regions for reference and to generate internal forces for application to the second stage model. The maximum principal stress contours for the top port and starboard sides of the deck have indicated, for example, that the intersection of the longitudinal deck girder and frame 122, as well as the dome opening corners, are relatively high stress areas. (See Figure 42.)

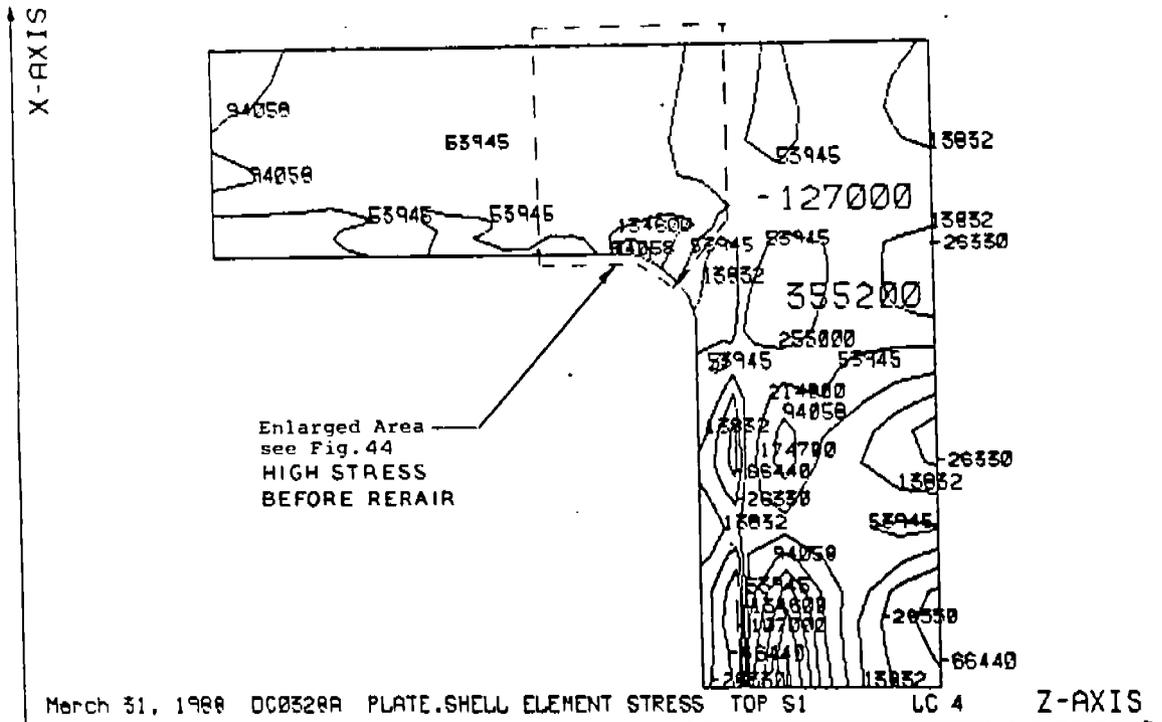
FIG. 43 PLAN UPPER DECK CORNER.

The second stage deck model is composed primarily of isotropic plates, but the density of the element mesh is not great enough to yield accurate stress results in the target areas. However, it is clear from this model that the forward starboard and aft port corners of the dome opening have high concentrations of tension stress (See Figure 43), the higher stress being 40 ksi at forward starboard corner. The highest stress appears at the forward part of the deck near the rigid boundary where the nodes are held fixed. Such local stress concentrations are common around points where the load is applied or where the model is fixed, but the critical area of the corner of the dome opening is sufficiently removed from the edge of the model to be unaffected by the rigid boundary.

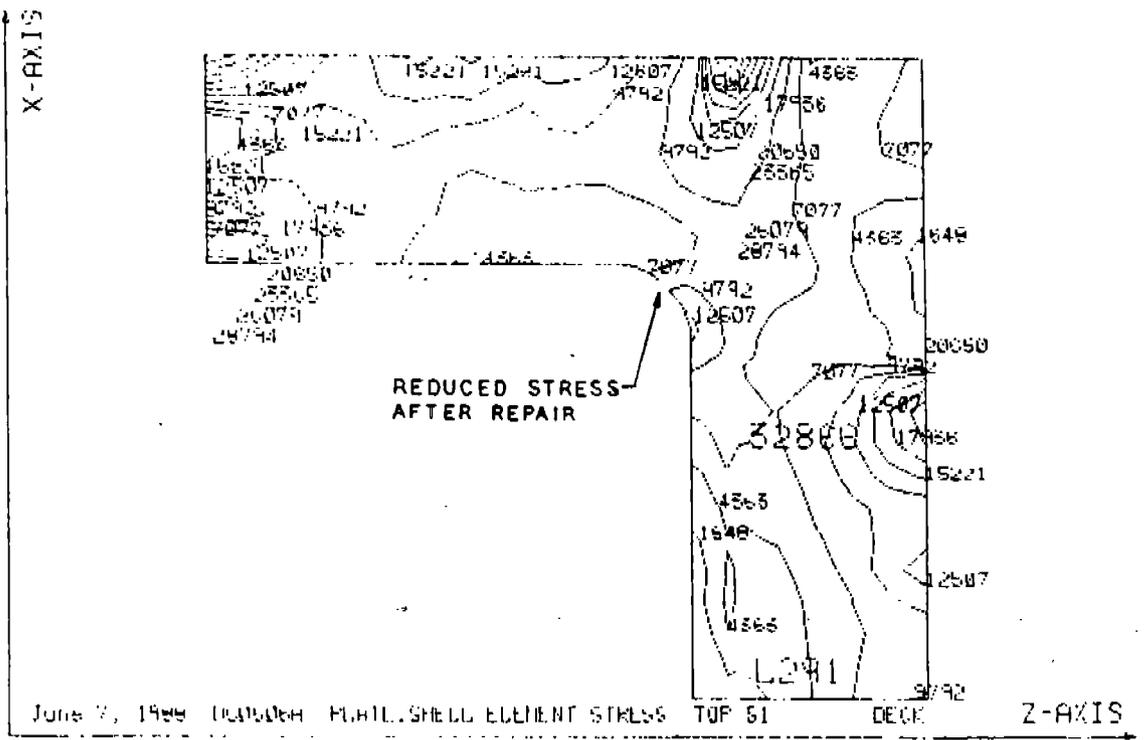
FIG. 46 PLAN UPPER DECK CORNER

analysis. The stress levels in the full hull model are, therefore, ignored and the internal forces are applied to the second stage model. The second stage model showed significant improvement over the unreinforced model. (See Figure 46.) The stress concentrations at corners of the dome opening, for example, were reduced to 10 to 15 ksi from a previous level of 40 ksi. The principal effects of the reinforcement were (a) an overall reduction in stress levels for the entire deck, (b) higher stress concentrations were moved away from the corners of the deck opening to less vulnerable areas, and (c) warping of the deck opening due to twisting of the deck structure was not as apparent as the original unrepaired model.

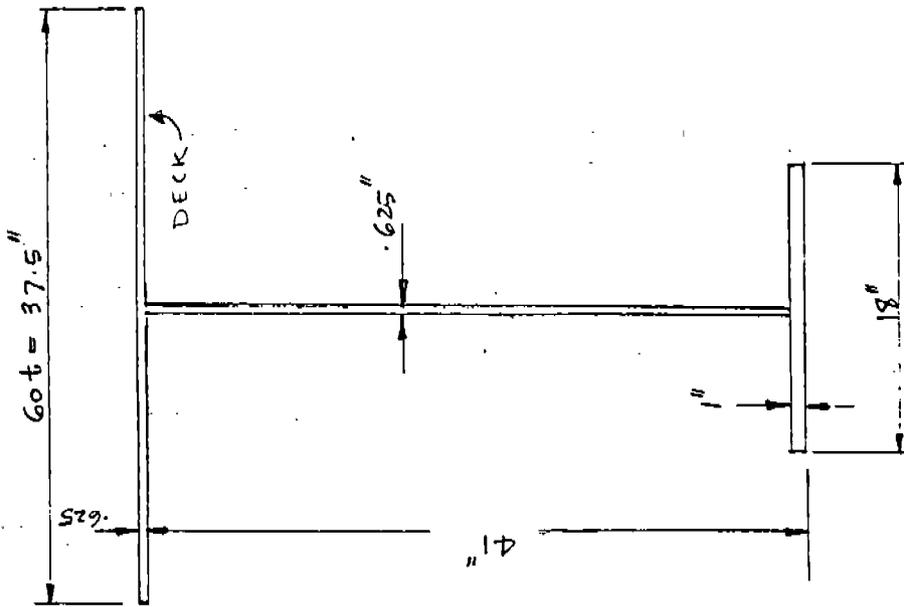
Fig. 47 Longitudinal Girder

UNDER DECK GIRDER AFTER REPAIR

The third stage model showed the most substantial reductions in stress when compared to the original structure. The maximum stress on the deck was reduced to 33 ksi. The stress concentrations near the round corner of the deck opening shifted to the forward side of the corner and fell dramatically from 166 ksi to 13 ksi. (See Figure 47.) The under deck girder intersections, reinforcing members and other under deck structure exhibited equally favorable results. Unfortunately, however, the additional diagonal girders needed to produce this result were very large, and resulted in a complex and elaborate modification to the under deck structure. (See Figures 41, 48 and 49.)

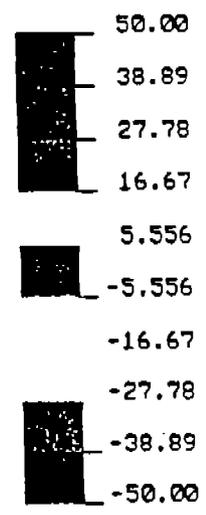
ORIGINAL (NO REPAIR)
 PRINCIPAL STRESS
 FIG. 60
 VIEW OF UNDER SIDE OF UPPER
 DECK PRIOR TO REINFORCEMENT

HIGH STRESS
 AT GIRDER
 INTERSECTION

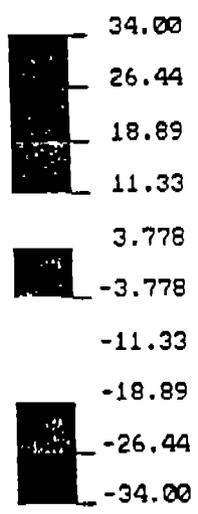
LOCAL (1992 REPAIR)
 PRINCIPAL STRESS
 FIG. 61
 VIEW OF UNDER SIDE OF UPPER DECK
 AFTER REINFORCEMENT

REDUCED
 STRESS AT
 INTERSECTION

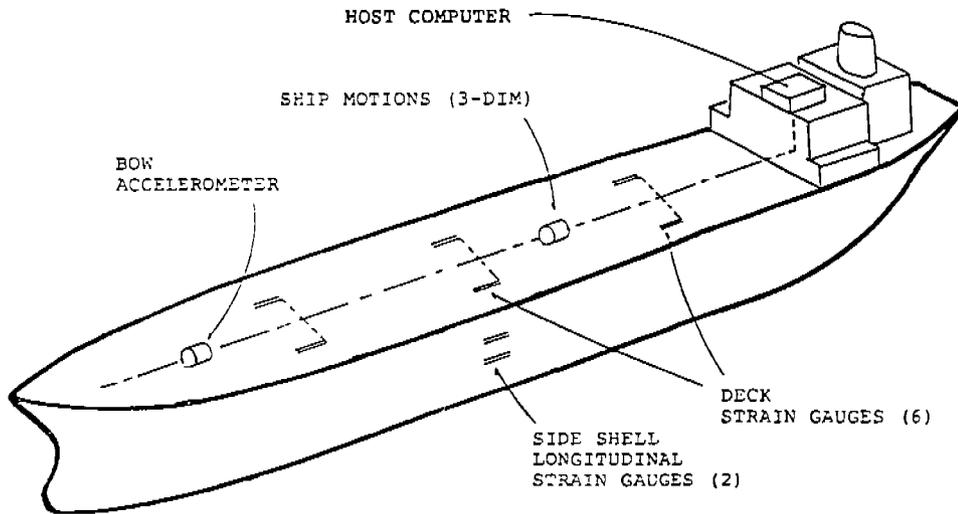
FIG. 65 SENSOR CONFIGURATION

The SMS is expected to consist of the following major components: (See Figure 65.)

can provide the means to read or write data at precise times without significantly restricting the microcomputer's task. DMA is also the only way to make the goal of high-speed foreground/background operation possible. (See Figure 65.)

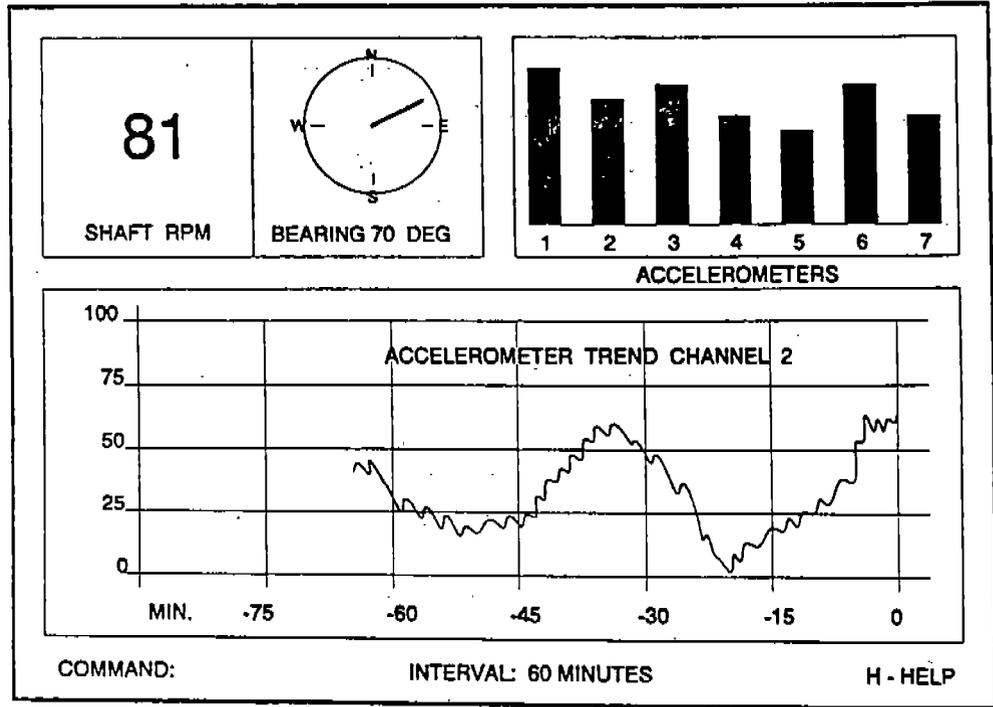
FIG. 66 DISPLAY ON THE VGA MONITOR

Responses of the structure to the waves motions are picked up at the sensors in the form of electrical signals. These raw signals then go through the signal conditioning circuits where amplification and filtering will be applied. The operation of conversion from voltage to current is needed to prepare for the long distance transmission. At the other end of the transmission line where the host computer is located, the current value in the current loop is again converted back to voltage by the means of a 250 ohm load. The resulting signals will then be routed to the A/D converter which is installed in the host computer. The A/D converter will digitize the signal according to the predetermined sampling rates. Data will then be real-time displayed on the screen of the computer and, at the same time, written onto the hard drive for future use in the trend display operation. (See Figure 66.)

The responses at the sensors are displayed in groups of bar charts representing the same type of sensors. At any moment, one particular group can be selected to display on the screen (See Figure 66). The history of the responses of any single sensor can be viewed by trend display at the lower portion of the screen (See Figure 66). Different intervals of time for the trend display can also be selected manually.
