Corrosion and Safety of a Ship: Survey Report of a Long-Life Ship

M. Arita, H. Inoue, E. Fuji and T. Kobayashi, Ship Research Institute, Tokyo, Japan

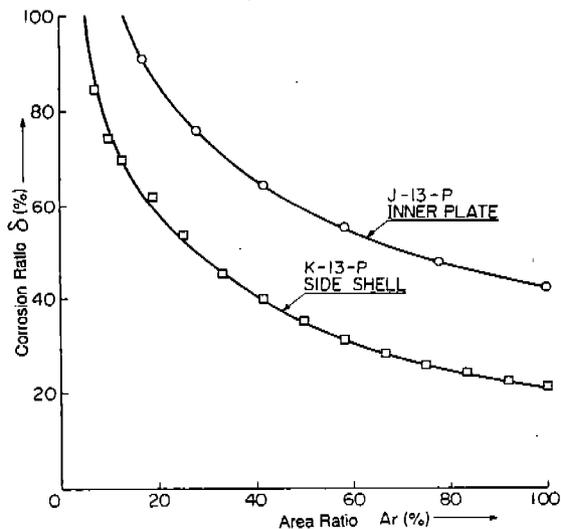
Fig. 4 Relation between Area Ratio A_r and Corrosion Rate δ

Figure 4 shows the relation between the corrosion ratio δ and the area ratio A_c for plates K-13-P (Table 2) and inner plate of J-13-P (Table 3). Where A_c is the Ratio of A (an area of a portion of concern around corrosion hole or holes imaginarily taken concentrically of it or them), to the area of the whole plate A_p . That is to say $A_c = A/A_p$. The corrosion ratio δ is the mean corrosion volume ratio calculated in the area of concern A stated above. As shown by both curves in Fig. 4, A_c is going to saturate as δ is approaching to 100%. Let us assume that the whole area corrosion rate Δ is the value of δ at $A_c = 100\%$, and that V is the ratio of corrosion hole or holes area to the whole area of the plate. In Fig. 5, two points (vacant circles) show the calculated relation between Δ and δ using Tables 2 and 3. It is natural that $\Delta = 0$ at $V = 0$. Then we get the quadratic curve which passes three points mentioned above as following.

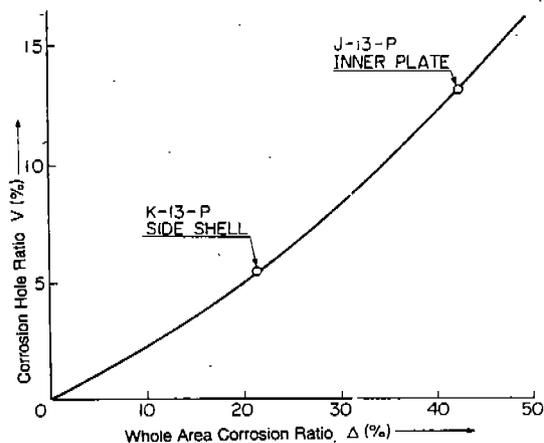
Fig. 5 Relation between Whole Area Corrosion Rate Δ and Corrosion Hole Ratio V

$$V = 7.76 \times 10^{-3} \Delta^2 + 9.97 \times 10^{-2} \Delta \quad (1)$$

We assume that the relation of equation (1) can be applied to the relation of Δ and V for whole ship. Putting $\Delta = 5.00$ in equation (1), we get $V = 0.693$. The corrosion hole rate of 0.693% is very big value. It is because that if there are corrosion holes in the bottom plating it is very dangerous for the ship (*K-maru* had such experience in her life). It can be understood from this analysis that mean thickness reduction rate of 5% at midship (shown in Table 1) is not a trivial but a serious matter.

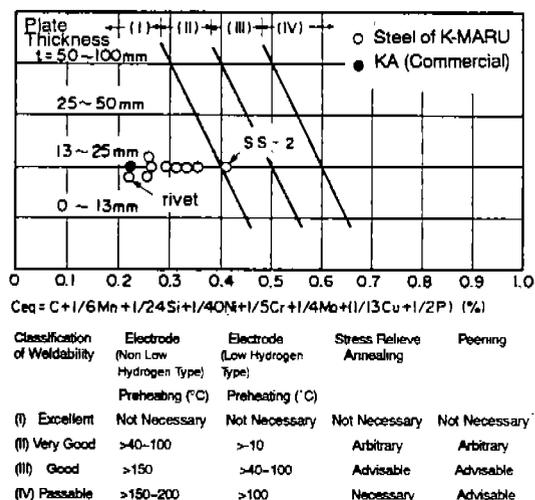
Fig. 8 Welding Conditions of Steel Plate Used Based on Carbon Equivalent [1]

Figure 8 indicates that the welding of SS-2 should be done by limited conditions.

Material	Carbon Equivalent C_{eq} (%)
KA (Commercial)	0.222
SS-1	0.262
SS-2	0.407
SS-3	0.255
SS-4	0.259

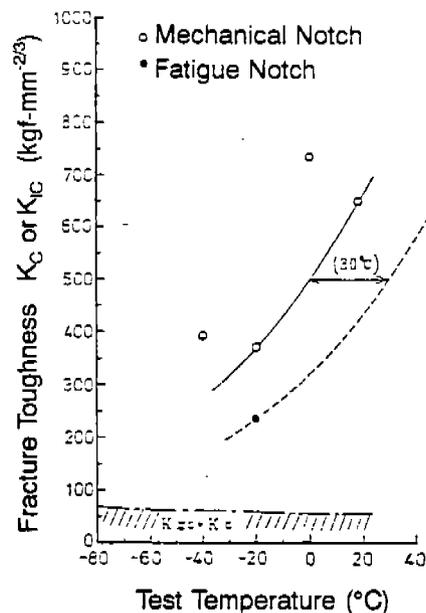
Fig. 10 Temperature Dependency of Fracture Toughness K_{Ic} of SS-2

Figure 10 shows the results. The solid line in the figure shows the transition curve connecting lower bound of experimental data values of specimens with mechanical notches. The broken line in the figure corresponds to the transition curve for specimens with fatigue crack, being obtained by shifting the solid line to higher temperature side by 30°C [2]. In the case that an experimental value of K_{Ic} is equal to K_{Ic} , the thickness t of the specimen satisfies the following equation.

The region of $K_c = K_{Ic}$ for wide range of temperature can be calculated as shown by the shaded area in Fig. 10, assuming temperature dependency of σ_y as equation (5)[3] and conducting the same calculation as equation (4).

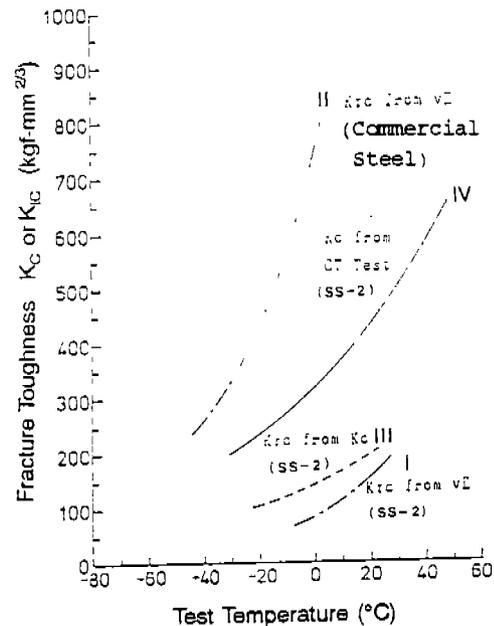
Fig. 11 Comparison of Fracture Toughness of SS-2 and Commercial Steel of NK-A Grade

In Fig. 11, K_{Ic} value calculated by the equation (6) (curve I), K_{Ic} value by the equation (7) (curve III), K_{Ic} for commercial steel plate (curve II) and also K_{Ic} value obtained from CT test as shown by the broken line in Fig. 10 (curve IV), are shown.

For SS-2, the crack length, at which K_I in the equation (8) becomes K_{Ic} (brittle fracture may occur at this value) can be obtained by using curve I and III in Fig. 11. Results are shown in Table 9, assuming working stress σ to be 10 and 20 kgf/m². Under condition of 10°C and $\sigma = 10$ kgf/m², $2c$ is 92 mm or 44 mm. These values are less than 100 mm (considered to be the critical crack length to be found by naked eye inspection), and there are possibilities that such cracks exist in plates equivalent to SS-2 not found by inspection. Such a case is very dangerous for *K-maru*.

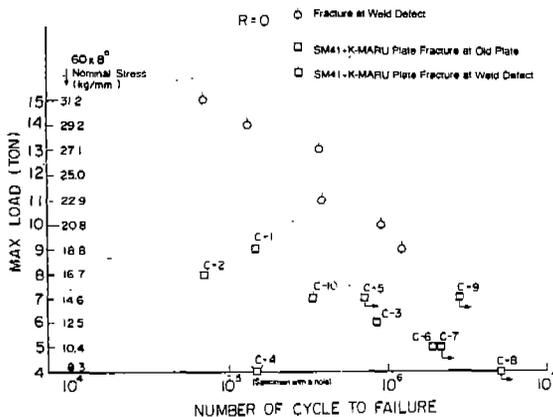
Fig. 14 Fatigue Life Diagram Expressed by Load Applied

Figure 14 shows the fatigue life diagram expressed by a load and a nominal stress. Figure 15 shows the fatigue life diagram expressed by a stress at the section with a minimum sectional area. Number C-1, C-2 etc. in Figures 14 and 15 are test specimen numbers. If a welding is sound enough, fatigue cracks in a butt weld joint specimen of SM41A initiate at weld toe and propagate to the thickness direction. But in the "B" type specimens tested, because of relatively large insufficient penetration of weld metal, fatigue cracks initiated at weld defects and propagated in weld metal to final failure. In spite of the fact that the same welding was used for "A" type specimen, fatigue cracks initiated at several points simultaneously on a corroded surface of a old plate and propagated to a thickness direction of a plate to final failure, with one exception (specimen C-4). It could be observed from macro fracture surfaces that many fatigue cracks initiated at many parts in a rough corroded surface and they merged gradually into one and proceeded to a final failure.
