**SSC-463**

**INSPECTION TECHNIQUES FOR  
MARINE COMPOSITE  
CONSTRUCTION AND NDE**

**SHIP STRUCTURE COMMITTEE**  
**2012**

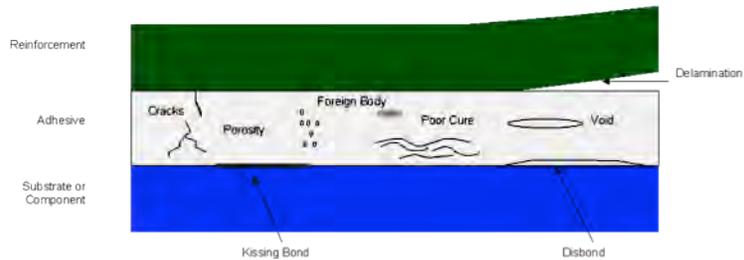
Figure 1. Bonded joint failure modes  
[NetComposites 2004]

### 2.1 Bonded Joint Failure

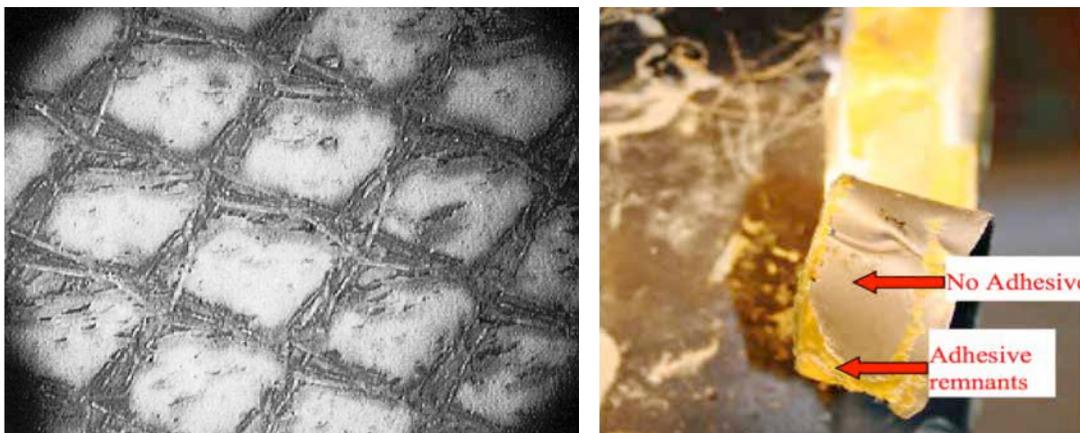
Figure 2. Cohesive (left) and Adhesive (right) bond failure examples  
[Davis 2010]

During cohesive failure, the adhesive sticks to both surfaces, but cannot hold them together. With film adhesives used for honeycomb sandwich construction, Cohesive failure usually occurs through the plane of the carrier cloth, which is the weakest plane in an effective bond because of the reduced surface area caused by the presence of the carrier cloth. The surface is rough and often slightly milky in appearance due to matrix cracking formed by the failure (see Figure 2). The causes of cohesive failure include inadequate overlap length and factors causing high peel stress or high thermal stresses. [Davis 2010] Cohesive failure can also occur from the presence of voids or improper bond-line thickness.

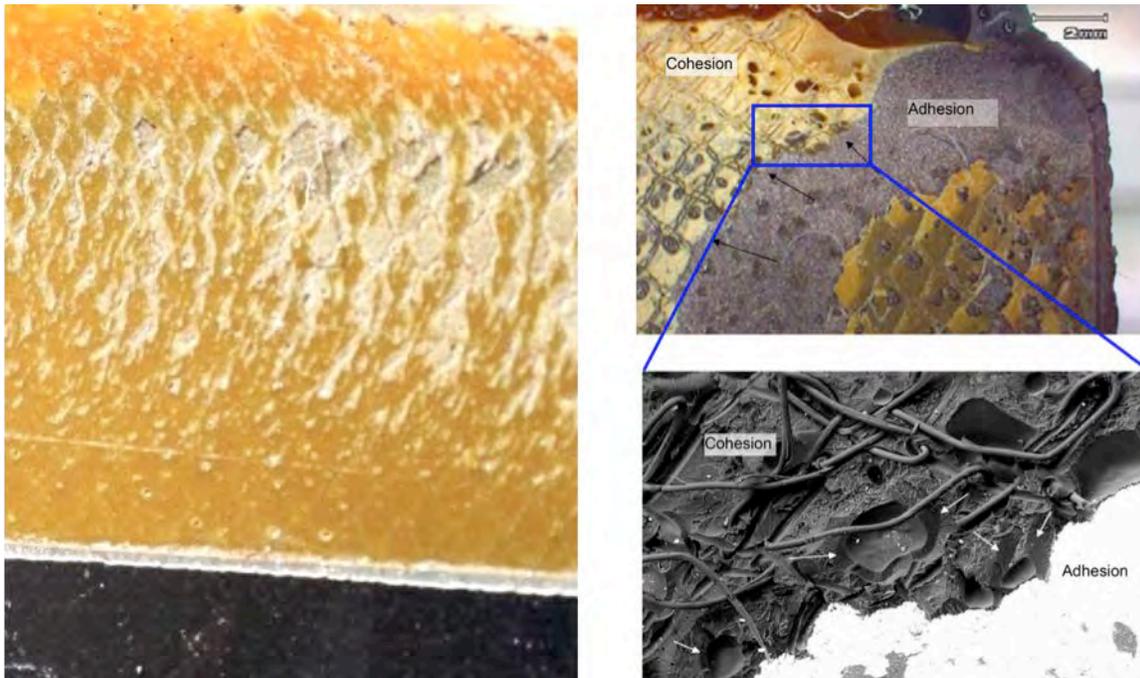
**Figure 3. Mixed-mode bond failure (light areas) and adhesion failure (darker areas) (left) and adhesive bond failure ahead of the disbond front, where the white portion in the lower right of is bare substrate (right). [Davis 2010]**

Adhesive bond failures occur at the interface between the adhesive and the adherent, with residual adhesive remaining at any location on one surface only (see Figure 3). The chemical bonds at the interface are weaker than within the adhesive. The surface of the adhesive is smooth and often replicates surface features from the adherent. Adhesion failures exhibit lower strength than cohesive failures. Causes of adhesive failure include contamination during manufacture, the use of out-of-life adhesive, insufficient surface preparation and inadequate temperature control during production. [Davis 2010]

Mixed-mode failures exhibit both cohesive and adhesive failure, resulting from a partially degraded interface. Mixed-mode failures are essentially a transitional phase between cohesive and adhesive failure. The failure exhibits areas of smooth surface as well as areas, which are rough. The strength of adhesive bonds exhibiting mixed-mode failure is lower than the cohesive failure strength. Figure 3 shows examples of mixed-mode adhesion failures. [Davis 2010]

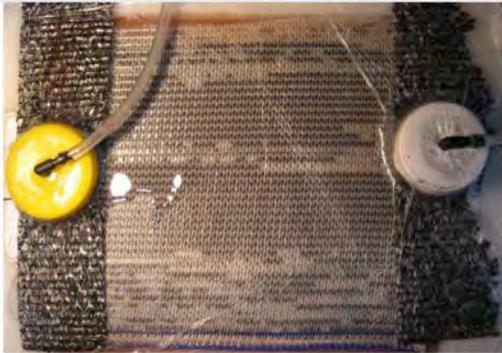
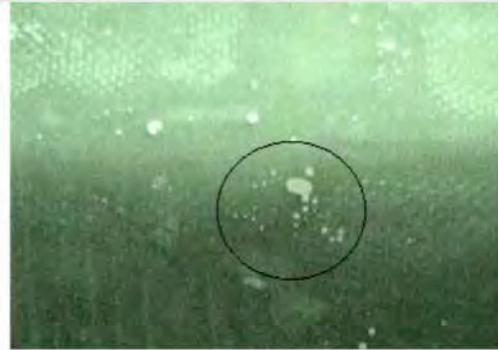
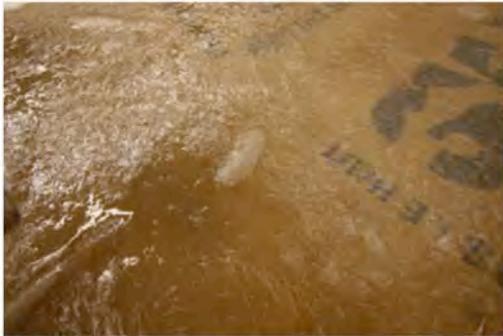
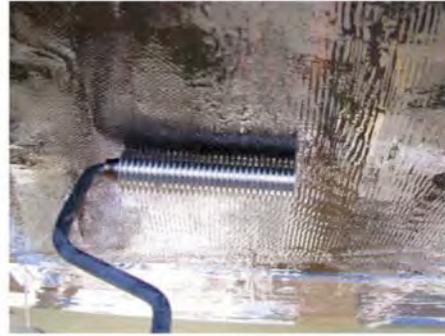
Air bubbles introduced during infusion manufacturing process due to resin "boiling" [Eddie Matejowsky, Brisbane, Australia, 2006]

Air bubbles trapped during hand layup that were removed by sanding [Boat-Project.com, 2001]

Air bubbles trapped during hand layup before being "rolled out" [Jeff Lilly Restorations, San Antonio, TX]

Using a "bubble buster" to roll out trapped bubbles in hand layup laminate [Greg Murphy, Grand Rapids, MI, 2009]

Figure 4. Examples of air bubbles in composite laminates

Air bubbles in a laminate are defined as air entrapped within and between the plies of reinforcement and are usually spherical in shape. Air bubbles in laminates are always an artifact of the manufacturing process, as illustrated in Figure 4. Ribbed rollers called “bubble busters” are used during hand lay-up to eliminate air bubbles in laminates. Vacuum bag leaks can cause air bubbles in infused laminates.

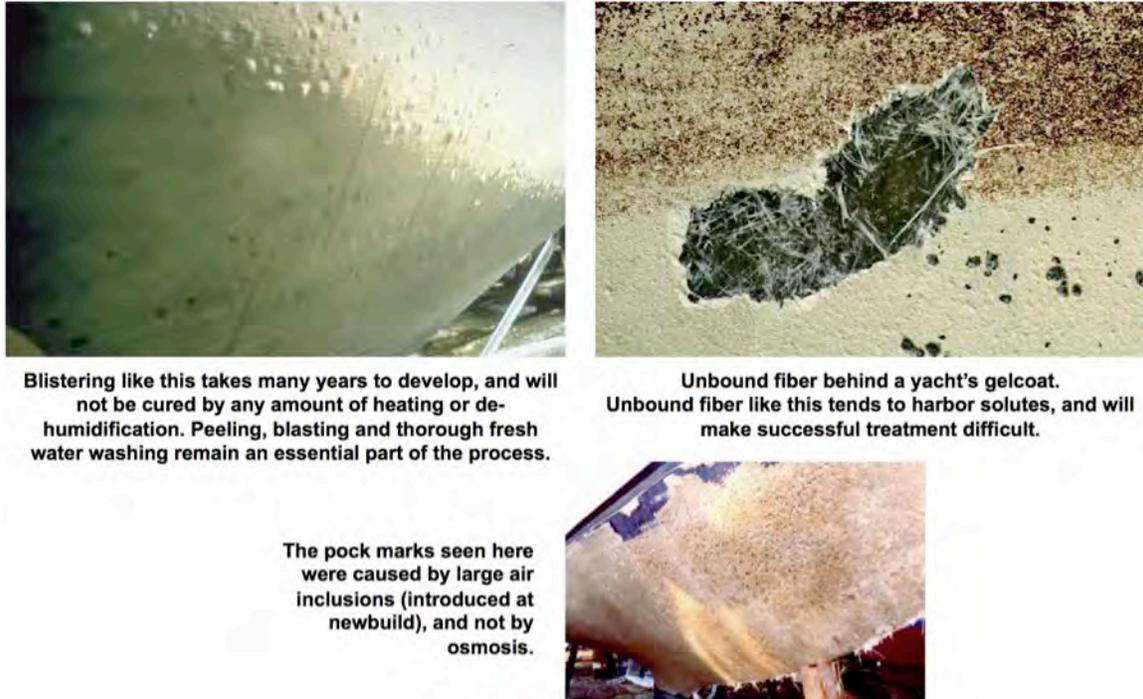
Blistering like this takes many years to develop, and will not be cured by any amount of heating or de-humidification. Peeling, blasting and thorough fresh water washing remain an essential part of the process.

Unbound fiber behind a yacht's gelcoat. Unbound fiber like this tends to harbor solutes, and will make successful treatment difficult.

The blistering of gel-coated, FRP structures has received much attention in recent years. The defect manifests itself as a localized raised swelling of the laminate in an apparently random fashion after a hull has been immersed in water for some period of time. When blisters are ruptured, a viscous acidic liquid is expelled. Studies have indicated that one to three percent of boats surveyed in the Great Lakes and England, respectively, have appreciable blisters. There are two primary causes of blister development. The first involves various defects introduced during fabrication, including defective raw materials. Additionally, blisters can form in service when a part that contains internal voids is heated under environmental conditions. Entrapped liquids are also a source of blister formation. [Greene 1999] Figure 5 shows some examples of blisters in recreational boat hulls.

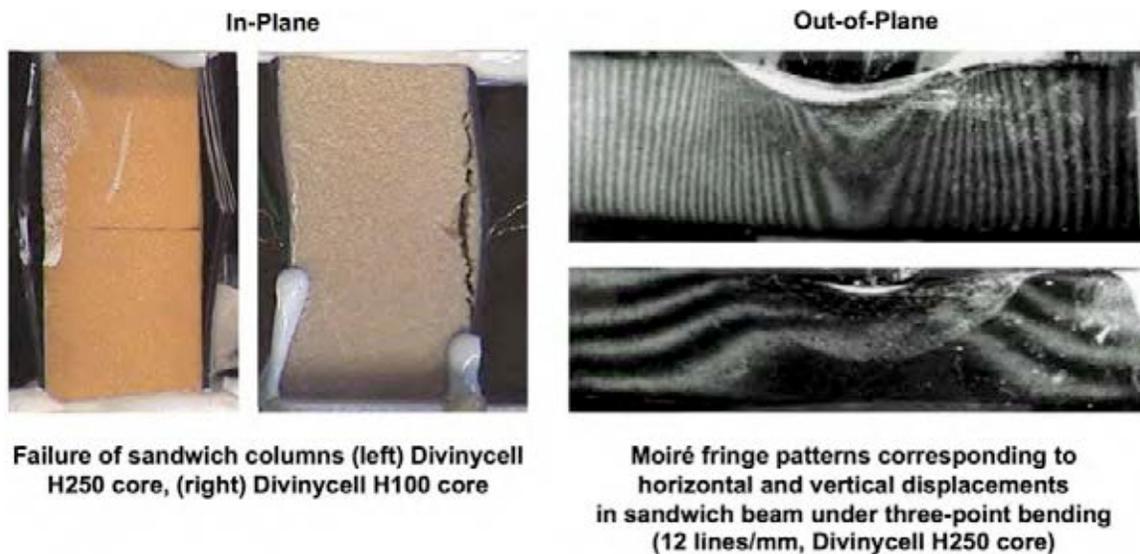
Failure of sandwich columns (left) Divinycell H250 core, (right) Divinycell H100 core

Moiré fringe patterns corresponding to horizontal and vertical displacements in sandwich beam under three-point bending (12 lines/mm, Divinycell H250 core)

Figure 6. Illustrations of core crushing [Gdoutos 2004]

Examples of core crushing are shown in Figure 6.

Figure 6 shows examples of in-plane and out-of-plane core crushing. Figure 7 shows examples of honeycomb core crushing. Figure 8 shows a detail of out-of-plane foam core crushing.

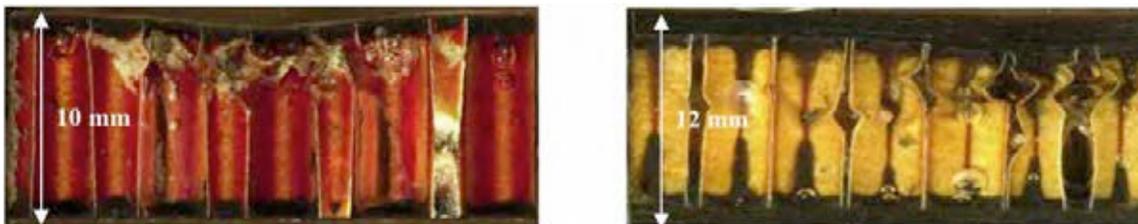
**Figure 7. Photographs showing core crushing in (left) GRP-high density Nomex and (right) CFRP-medium density Nomex sandwich constructions. [Gower 2005]**

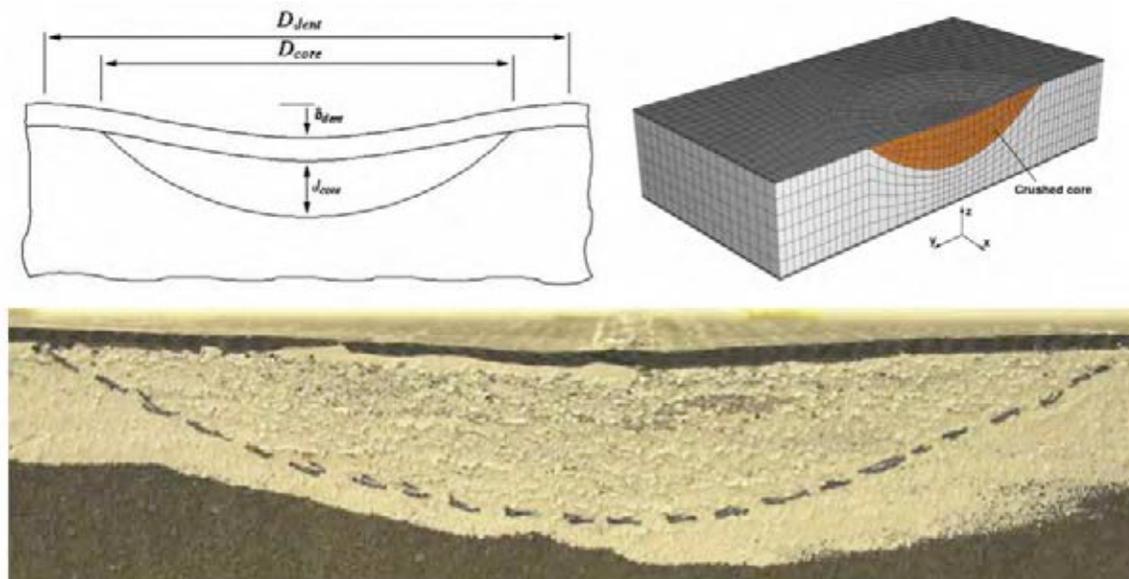
**Figure 8. Schematic of indentation damage (top left), FE-model of a sandwich panel with indentation damage (top right), and a photograph of a cross-section with indentation damage (bottom) [Zenkert 2005]**

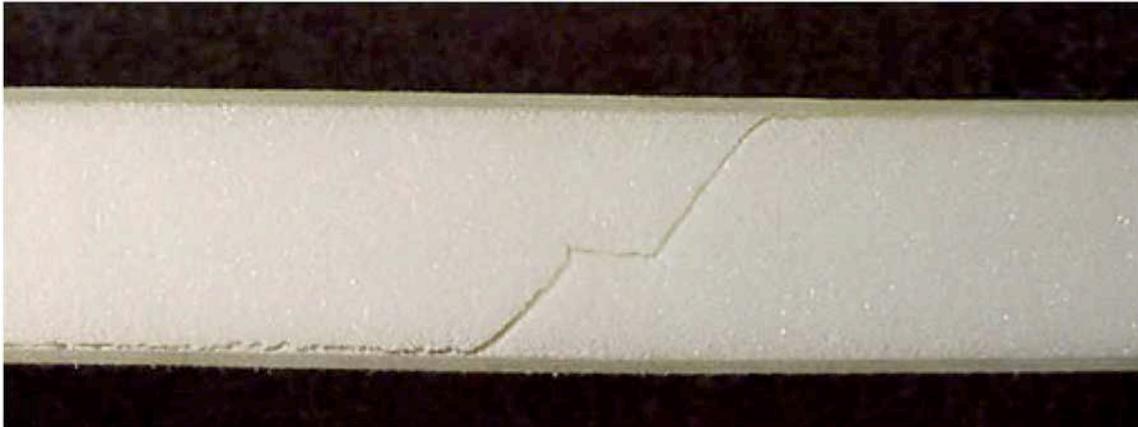
**Figure 9. Fatigue fracture of PMI 51 S foam core,  $P/P_{crit} = 65\%$ ,  $n = 1.1 \times 10^6$  cycles [Roosen 2002]**

In a sandwich laminate, the core resists bending forces via shear loading, which is maximum at the neutral axis. Figure 9 illustrates a classic core shear failure where the crack extends between both face-skins. Note also that the core shear failure is also accompanied by skin-to-core separation.

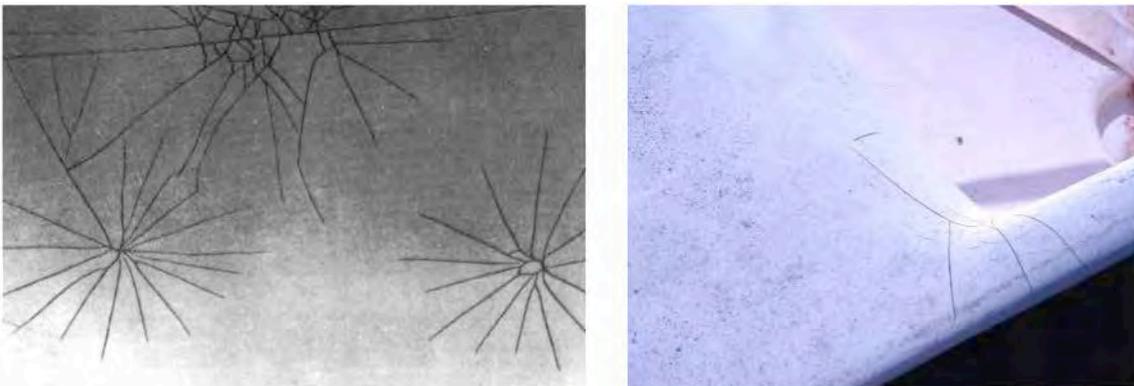
**Figure 10. Examples of fiberglass crazing in gel coat finishes. Note that photo on right shows crazing in area of stress concentration. [Coackley 1991]**

Cracks, crazing, and abrasions, are common types of composite laminate damage, which are characterized by a depth typically less than 1/16" (2 mm), where the damage does not extend into the primary reinforcement. This damage has no structural implications by itself. However, if unattended, it can cause further damage by water intrusion and migration. Crazeing may indicate the presence of high stress or laminate damage below the surface. [Greene 1999] Figure 10 shows examples of crazing to fiberglass laminates.

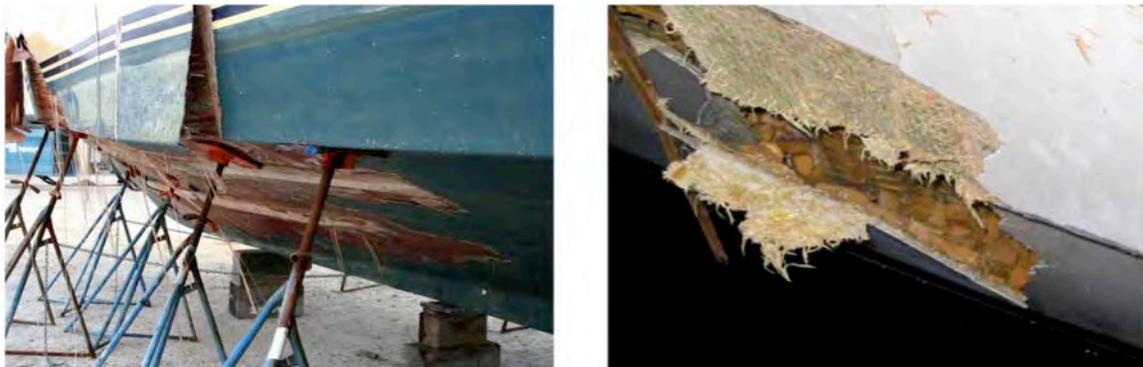
**Figure 11. Examples of severe delamination resulting from manufacturing defects [www.yachtforums.com]**

Delaminations are one of the principal defects that can occur in manufacture, machining and in-service. They are caused by contamination at ply interfaces, insufficient cure or expired raw material, inclusions (such as peel ply), and impact loading. This type of defect has a severe detrimental affect on mechanical strength, particularly under compressive loads, and on the life expectancy of composite components. The occurrence of production/handling induced delaminations can be avoided by using best manufacturing processes. [Gower 2005] Figure 11 shows pictures of severe boat hull delamination.

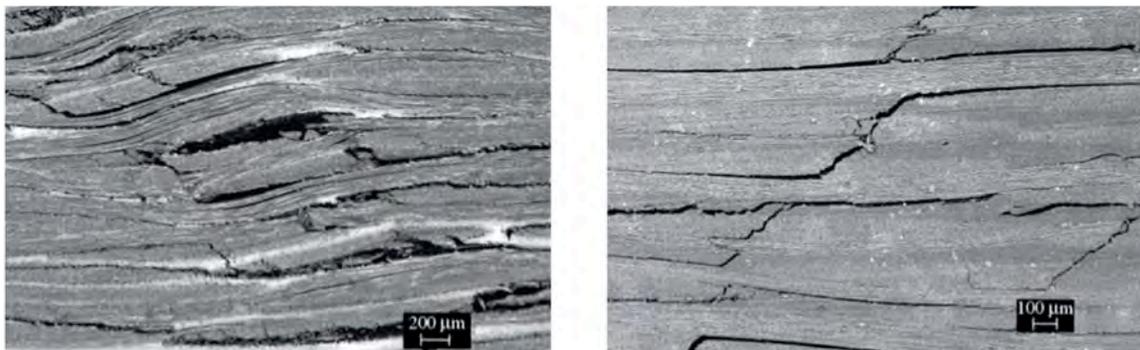
**Figure 12. SEM micrographs of delaminated specimens after interlaminar shear tests of carbon/epoxy laminates [Paiva 2005]**

Environmental ingress can be the basis for formation of sub-surface delaminations. Edge delaminations are quite common due to environmental ingress. [NetComposites 2004] Figure 12 shows scanning electron microscope (SEM) images of delamination in composite laminates. Figure 13 shows edge delamination common to machined composite laminates.

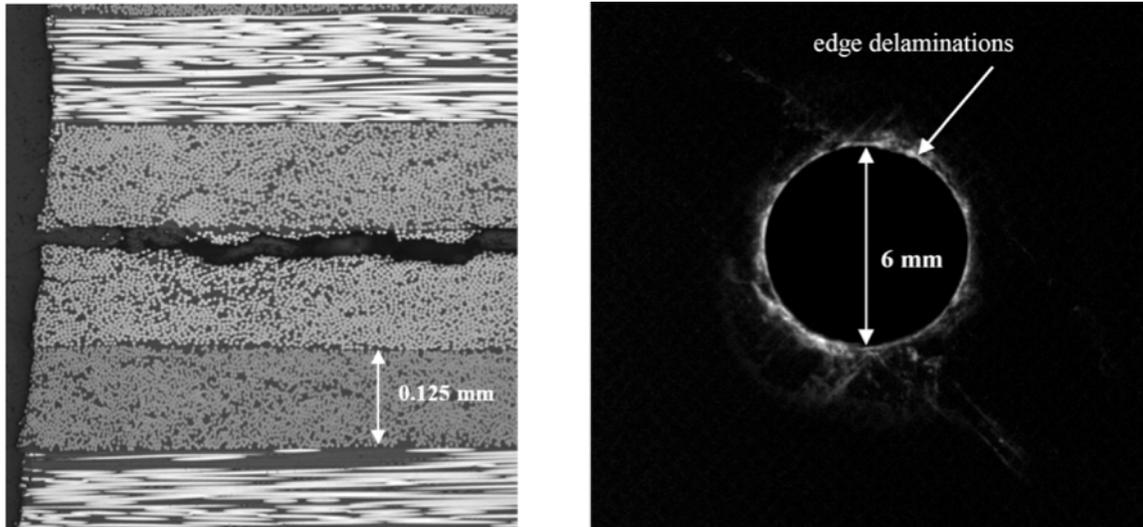
**Figure 13. Micrograph of an edge delamination within a CFRP panel (left) and X-ray image of edge delaminations around a drilled hole in a CFRP panel (right) [Gower 2005]**

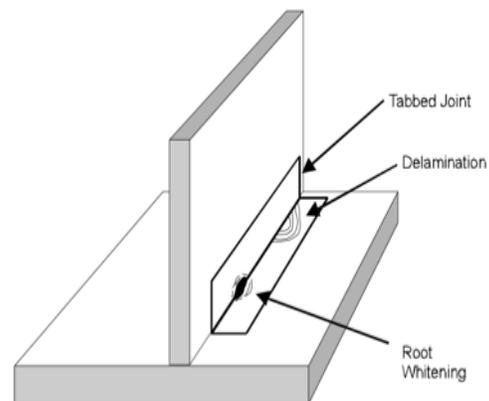
**Figure 14. Delamination of tabbed joint [Greene 1999]**

Connections such as at bulkheads or hull to deck are accomplished with laminated tabbed joints consisting of successive plies of overlapping glass reinforcement. The tabbed joint forms a secondary bond with the structural components being joined, since the components are usually fully cured when connected. Because the geometry of tabbed joints tends to create stress concentrations, they are susceptible to delaminating and peel, as shown in Figure 14. [Greene 1999]

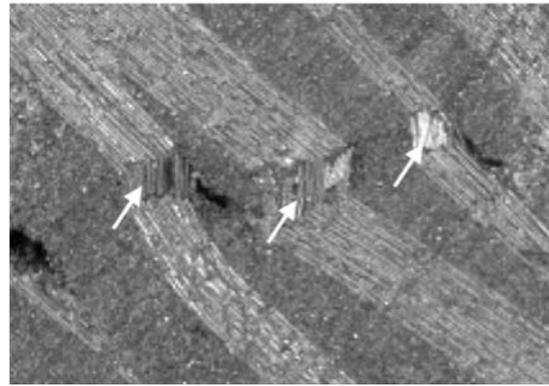
**Figure 15. Formation of kink bands when composite laminates are under compression (marked with arrows) [Rakow 2006]**

Broken fibers can be critical because loads in composite structures are typically designed to be carried by the fibers. Unlike cracking in metallic structures, fiber failure is usually limited to the zone of impact contact. The resulting loss in residual strength is controlled by a relatively small damage size. One exception can be a high-energy, blunt impact over a large area, which breaks internal structural elements such as stiffeners, ribs, or spars, but leaves the exterior composite laminate skin relatively intact. [Ilcewicz 2009] Figure 15 shows an SEM image of compressive fiber failure and Figure 16 shows an instance of fiber fracture and pullout.

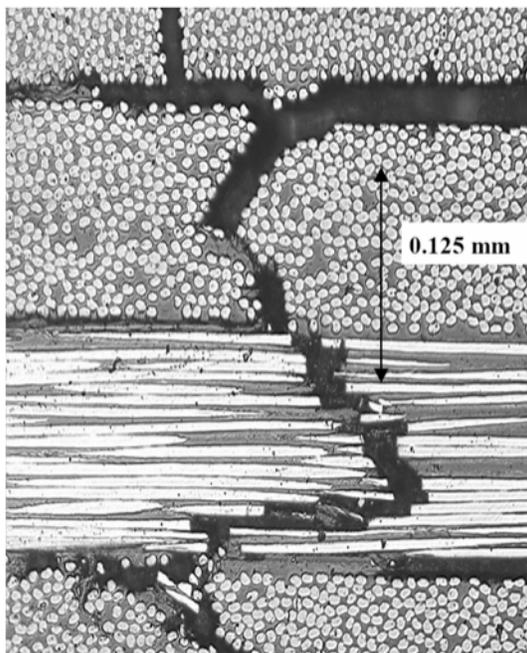
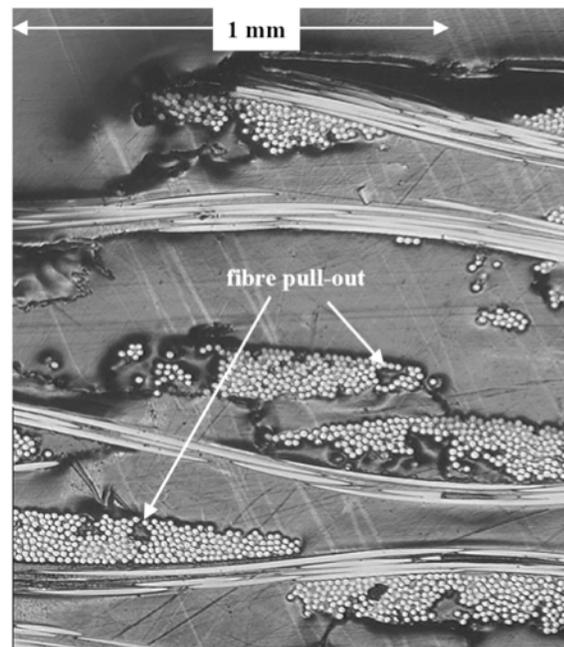
**Figure 16. Micrograph of fiber fracture in a multidirectional CFRP laminate (left) and Micrograph showing fiber pullout in a woven GRP material (right) [Gower 2005]**

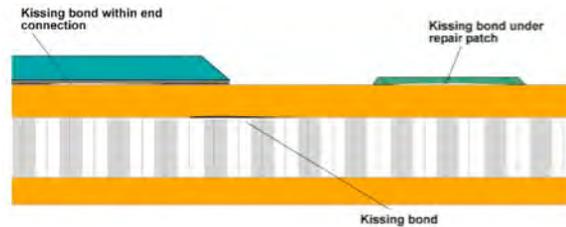
Figure 17. Various types of “kissing” bonds [NetComposites 2004]

Kissing bonds can potentially occur anywhere in a composite component where there is adhesive bonding, including end-fittings, core bonding and with repair patches, as shown in Figure 17. Detectability by NDE will depend on the size, location and tightness of the kissing bond.

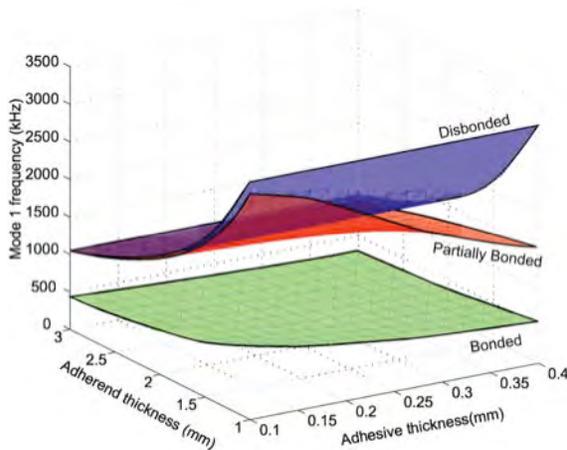
Figure 18. Mode 1 frequency variation with adhesive thickness for bonded, partially bonded and disbonded conditions [Allin 2002]

Figure 18 shows the change in natural frequency of bonded, partially-bonded and disbonded laminates. Figure 19 shows how the use of “peel ply” material can create a kissing bond condition.

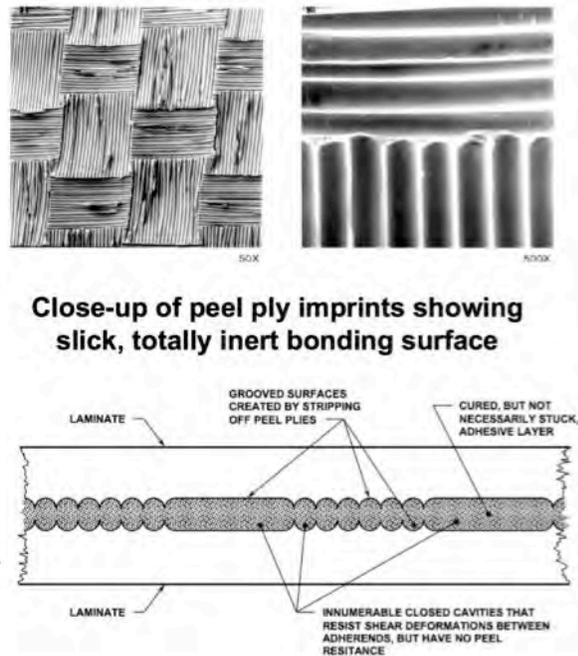
Figure 19. The influence of “peel ply” on “kissing” bond formation [Hart-Smith 2004]

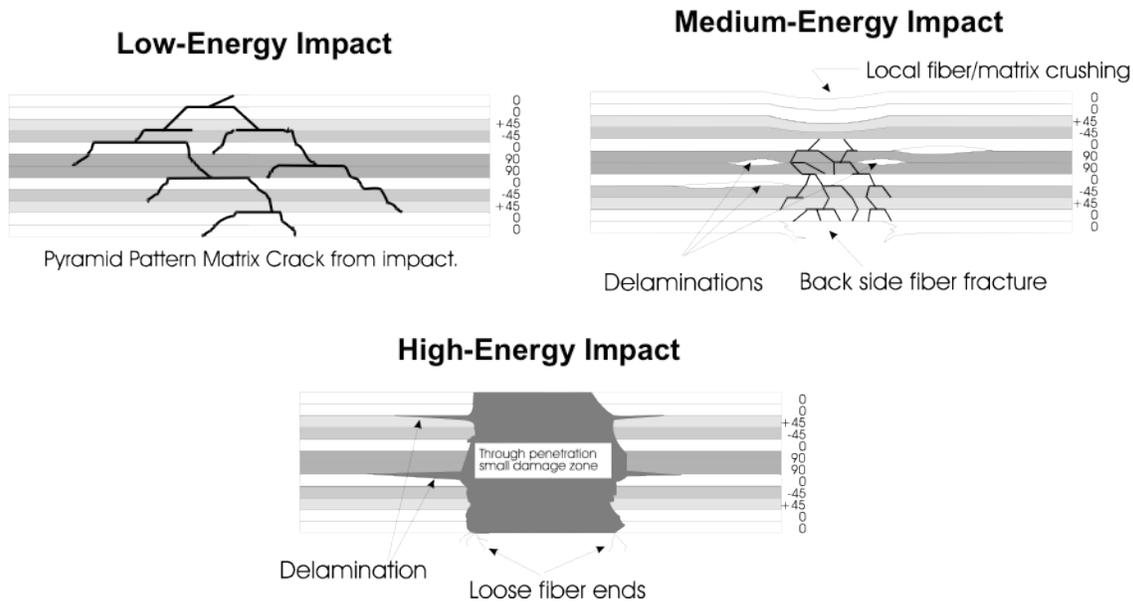
**Figure 20. Impact damage types [Abaris Training Resources Incorporated]**

The diagrams shown in Figure 20 illustrate potential types of damage from various types of impact events. What is not shown in the diagrams is the additional effect of velocity associated with impacts. For example, low-speed, high-energy impacts can leave large-area delaminations and substructure damage without much exterior damage. On the other hand, high-speed impacts (such as bullets) penetrate without leaving wide-area delaminations and potential substructure damage. [Ilcewicz 2009] It is also possible for sandwich laminates to exhibit damage on the inside skin without any noticeable damage on the impacted side. [Miller 2011]

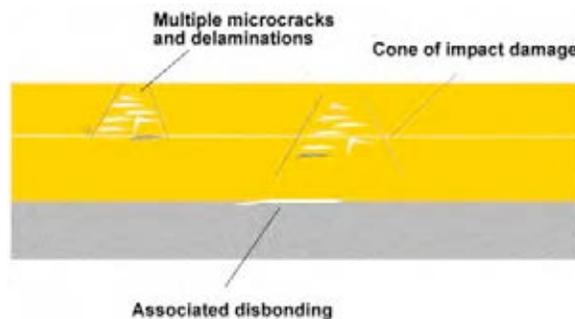
**Figure 21. Impact damage [NetComposites 2004]**

Typically, impact loads will create a conical area of damage below the surface that contain small microcracks and delaminations, as shown in Figure 21. Damage is usually most extensive sub-surface and may be difficult to ascertain on visual examination of the surface itself.

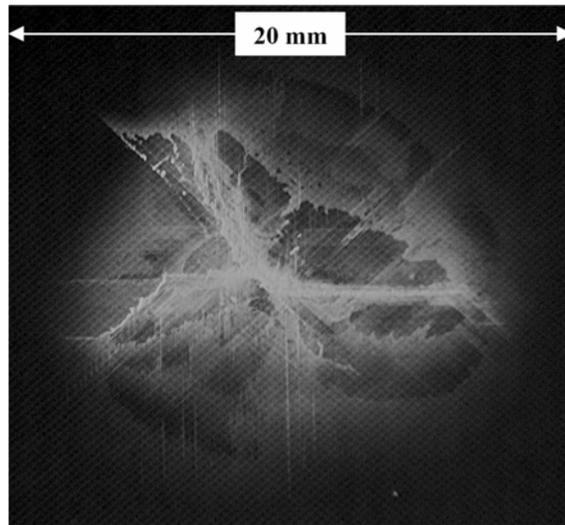
**Figure 22. X-ray image of impact delaminations within a CFRP panel [Gower 2005]**

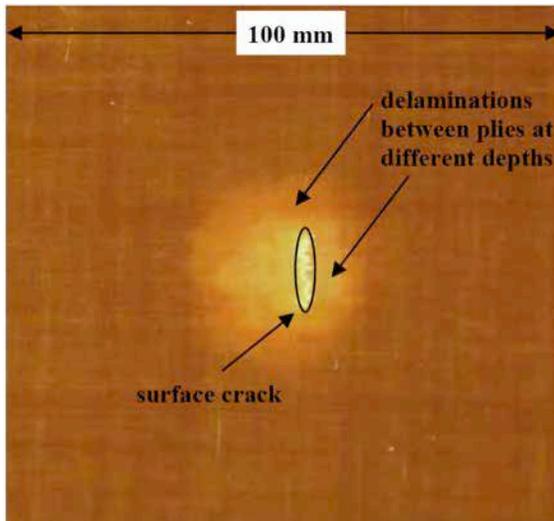
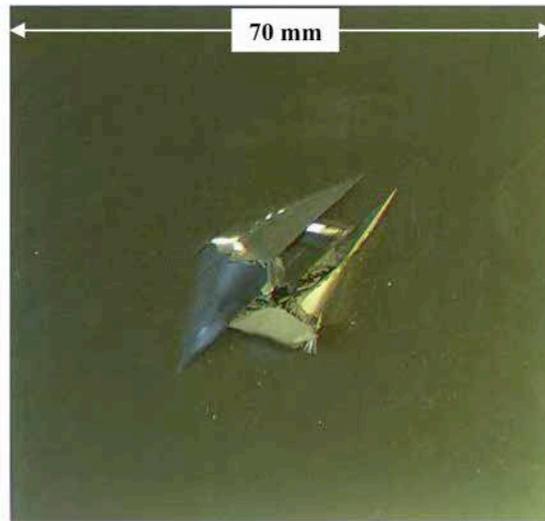
**Figure 23. Digital photograph of centrally located delaminations on the impact surface of a GRP skin on a Nomex sandwich construction (left) and digital photograph of back surface impact damage showing delamination and fiber fracture in a CFRP panel [Gower 2005]**

Figure 23 and Figure 24 show the surface of laminates subjected to impact damage. Figures 25 and 26 show sandwich panels with impact damage. It is instructive to note the wide variation in damage depending upon impact energy, impactor geometry and laminate construction.

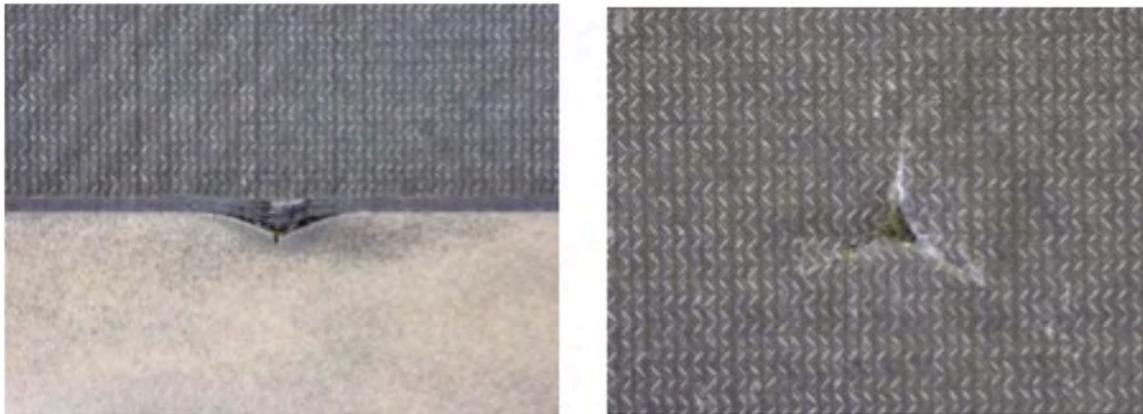
Figure 24. Damage types occurring from blunt object impact (left) and sharp object impact (right) [Zenkert 2005]

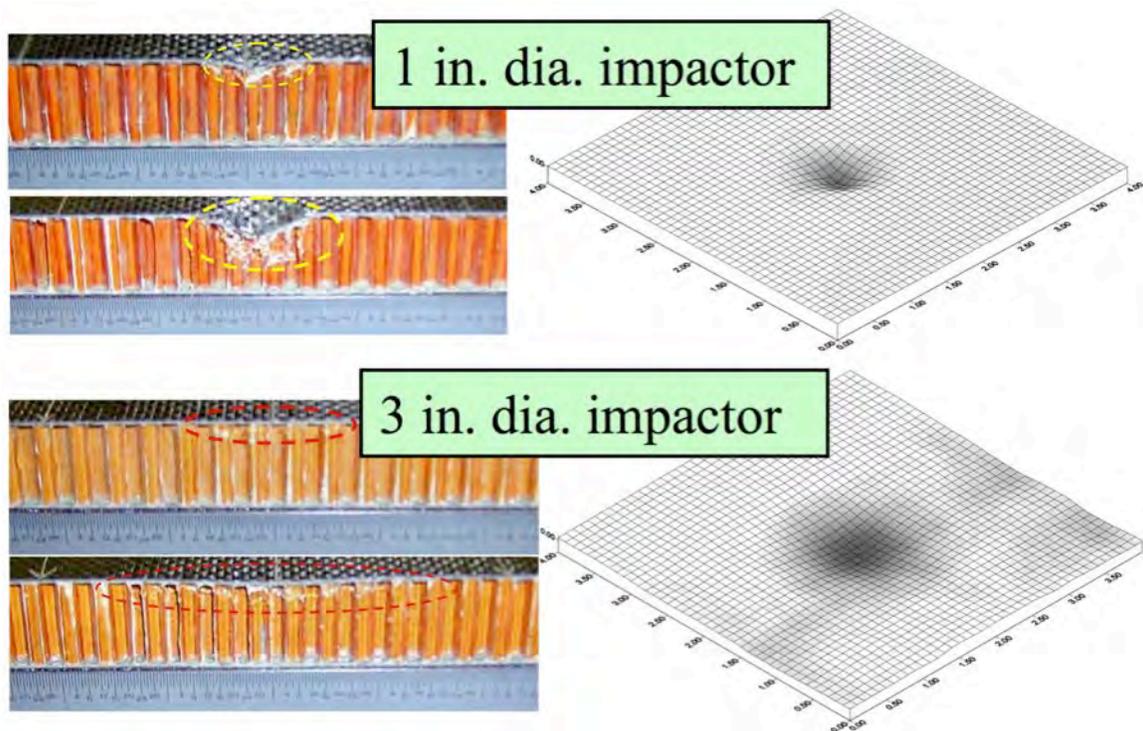
Figure 25. Foreign object impact damage in honeycomb-cored sandwich laminates [Ilcewicz 2006]

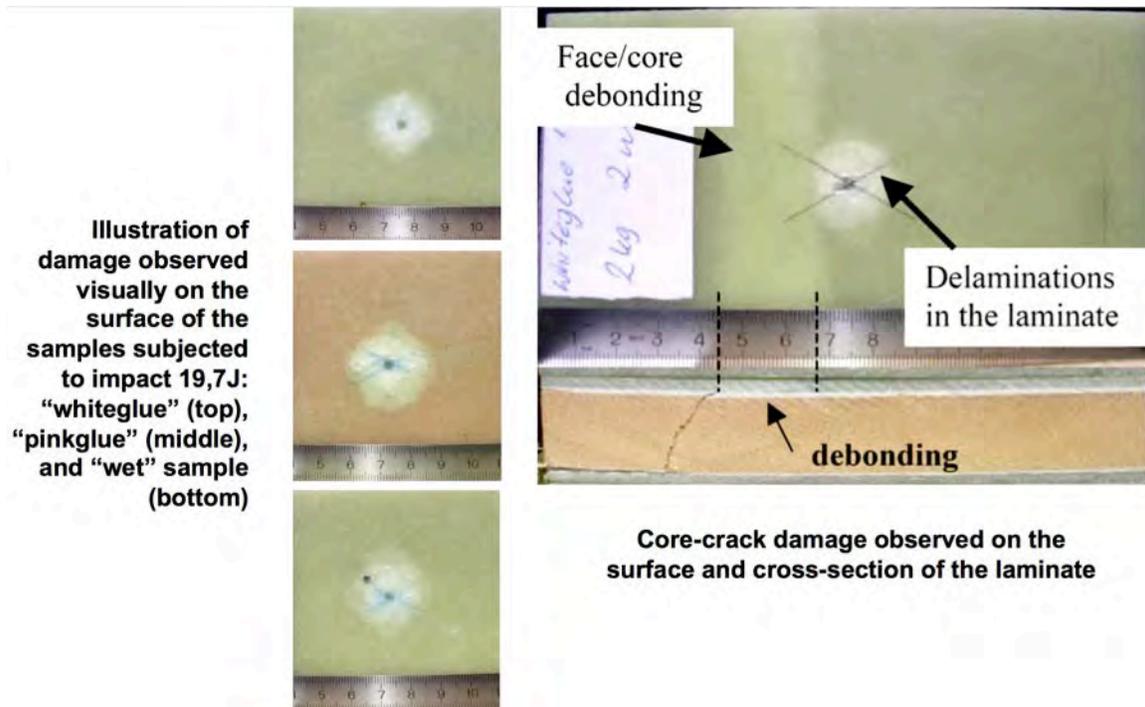
Figure 26. Sandwich laminate impact damage [Lendze 2006]

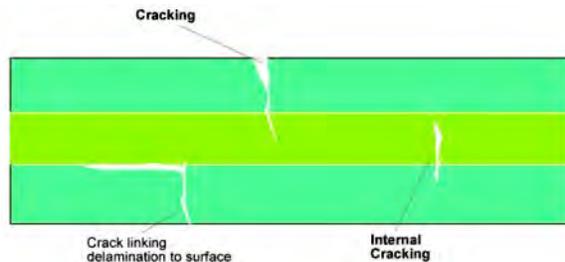
Figure 27. Schematic representation of cracks in laminates [NetComposites 2004]

Laminate cracking refers to discrete defects in the composites that are usually through thickness, as shown in Figure 27. A crack is distinct from a delaminations or disbond which refer to inter-laminar separation of material or decohesion of a bond. Matrix cracking or transverse cracking refers to the finer scale types of multiple cracking normally occurring in the central plies of a laminate. [NetComposites 2004]

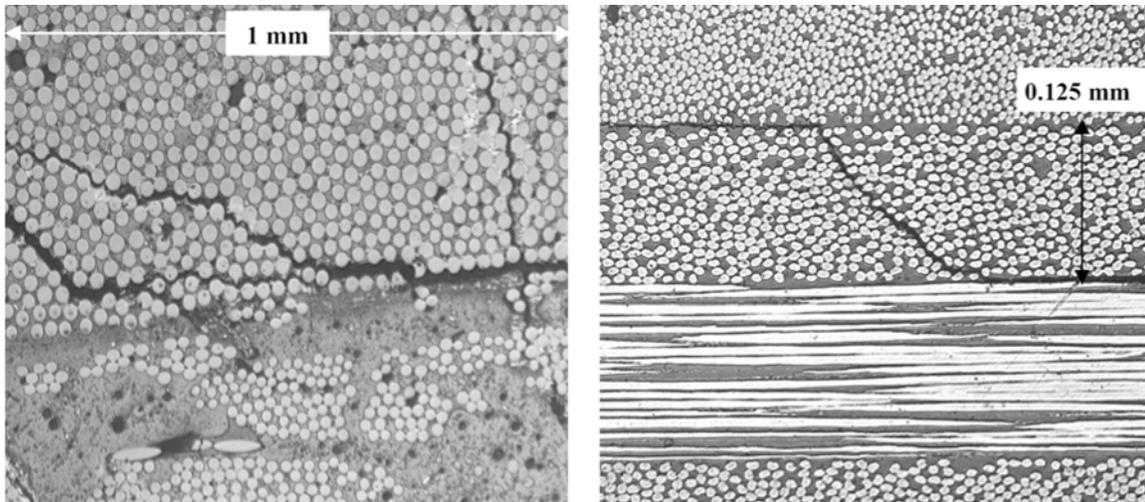
**Figure 28. Micrographs of matrix micro-cracking in (left) a woven GRP and (right) a multidirectional CFRP laminate [Gower 2005]**

Figure 28 shows micrographs of matrix cracking.

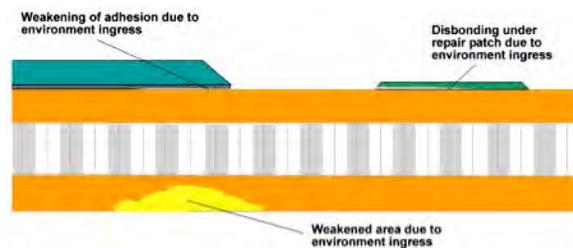
**Figure 29. Schematic representation of moisture ingress in sandwich laminates [NetComposites 2004]**

Figure 29 is a schematic of moisture ingress damage. Erosion or damage to gel coat or barrier layers can initiate damage to the laminate. The extent of damage will depend on service conditions and the particular resins used. Exposed edges and edges of adhesive bonds are particularly susceptible. [NetComposites 2004]

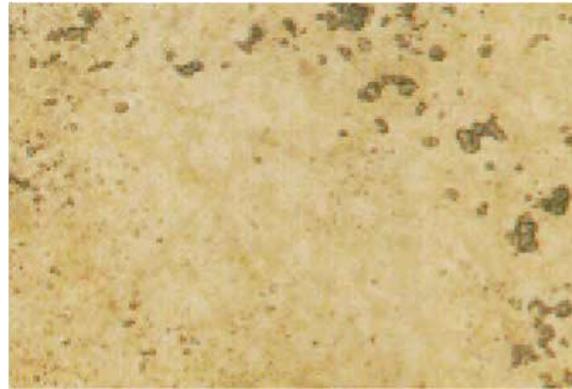
Figure 30. Image of pits or pinholes showing small regular or irregular craters on surface [Derakane 1997]

Pits or pinholes are defined as small regular or irregular craters on the laminate surface, usually with nearly equal width and depth. Typically pinholes go through the gel coat surface. Larger pits are referred to as craters, which can only be seen on the back side of the gel coat. Pinholes arise during fabrication as a result of catalyst or contamination on molds or improper equipment operation. This type of defect in itself is not a structural concern, although it can lead to further degradation of the laminate. Figure 30 is a picture of surface pitting.

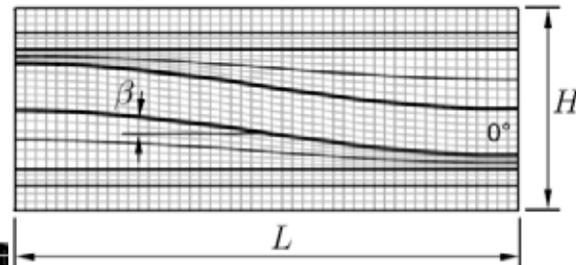
Figure 32. FE model geometry, representing one wavy  $0^\circ$  ply – the regarded geometrical features are in the order of  $10^{-1}$  mm ( $y_{ply}$  thickness) [Anastasi 2008]

Figure 31 shows images of various degrees of ply waviness. Figure 32 illustrates the angle  $\beta$  used to depict ply waviness in geometric models. Figure 33 is an extreme example of ply waviness.

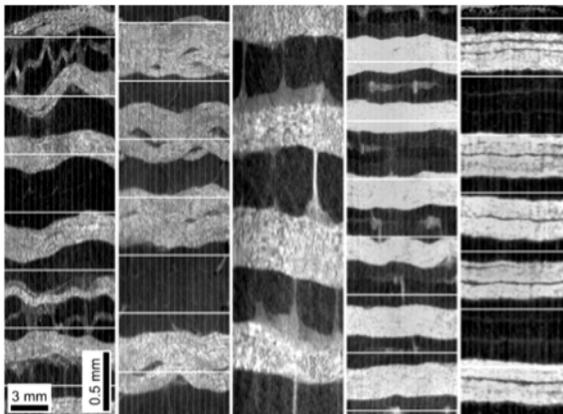
Figure 31. Different ply waviness morphologies made visible by laminate edge photographs (distorted at a ratio of 10:1); the waviness angle  $\beta$  ranges from  $5.5^\circ$  (left) to  $1.4^\circ$  (right); the wavelength  $L/H$  from 3.7 (left) to 1.5 (right) [Pansart 2009]

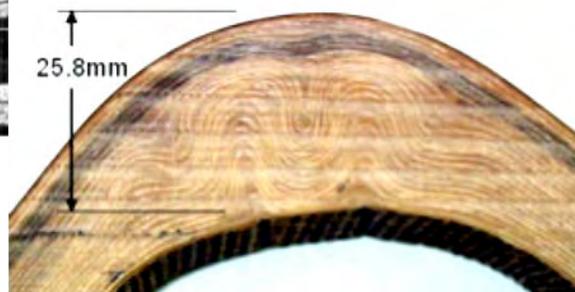
Figure 33. Composite sample close-up of apex showing extreme fiber-waviness [Anastasi 2008]

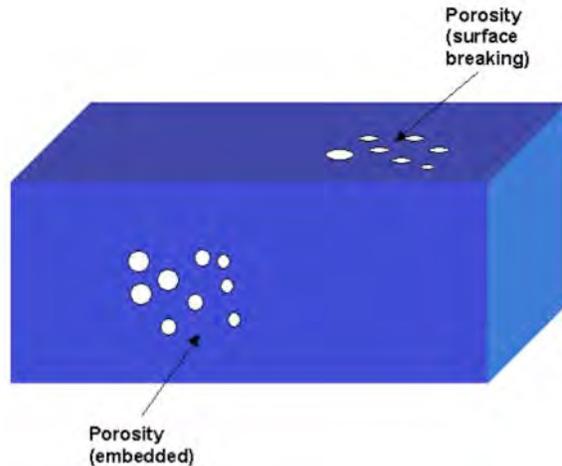
**Figure 34. Schematic of laminate porosity [NetComposites 2004]**

Porosity can be described as a large number of small voids, each of which is too small to be of structural significance but which collectively may reduce the mechanical properties of the laminate to an unacceptable degree. Figure 34 is a schematic of porosity in composite laminates. Porosity usually occurs during the curing cycle and is caused by entrapped air, moisture or volatile products. Porosity is most common in laminates manufactured by hand lay-up. Closed molding methods are less susceptible to air entrapment if mold integrity is maintained. Single or isolated large air bubbles are also referred to as

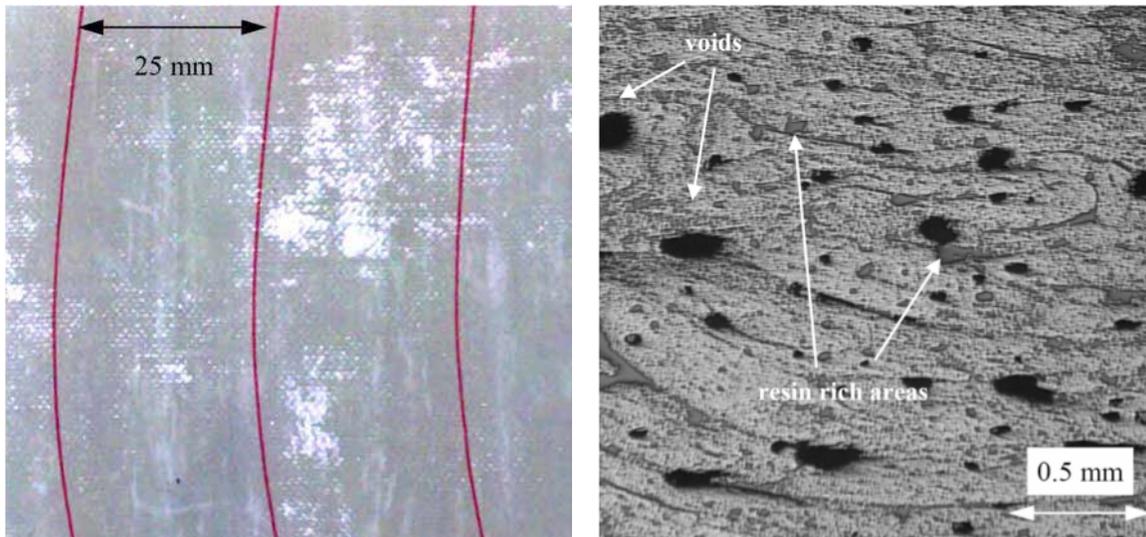
**Figure 35. Resin starved areas in a woven GRP laminate (left) and micrograph of resin rich areas in a filament wound CFRP material [Gower 2005]**

Figure 35 shows examples of resin rich and resin starved laminates. Figure 36 shows highly-magnified images of resin rich and resin starved areas in composite laminates.

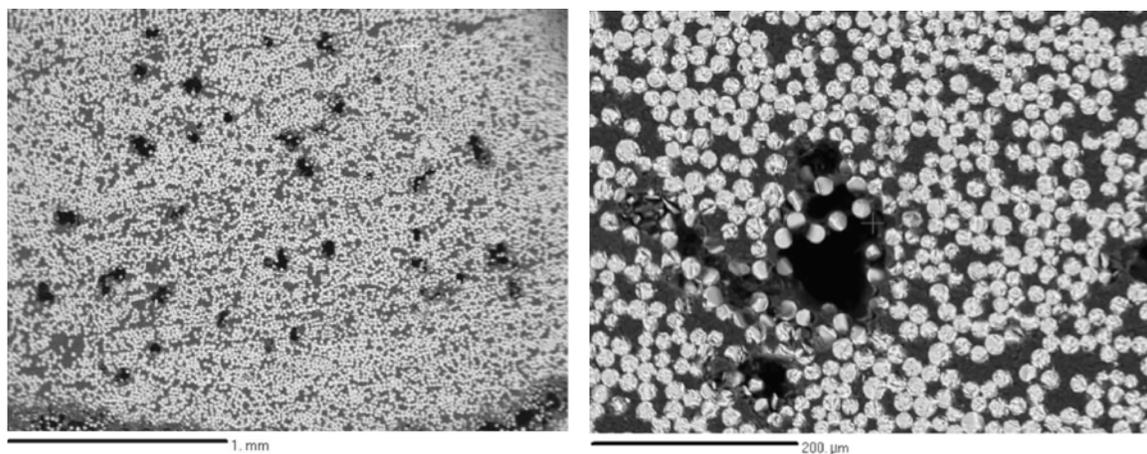
**Figure 36. Hand-polished material fabricated by the VARTM process and imaged with backscattered electron imaging. Both voids (black areas) and resin-rich areas (shown as light gray) are present. [Herzoga 2004]**

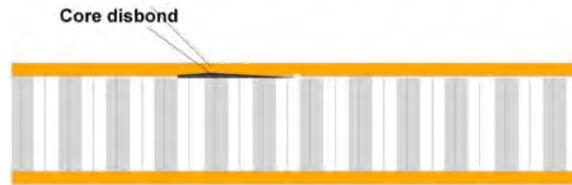
Figure 37. Schematic of skin-to-core disbond [NetComposites 2004]

It should be noted that core disbonds are defined as a separation of the composite outer or inner skins from the core. This is different from a delamination, which refers to a similar separation between any plies or layers of the composite. Figure 37 is a schematic of skin-to-core disbond. [NetComposites 2004]

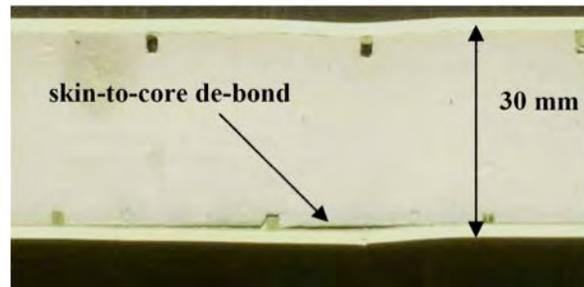
Figure 38. Photograph of skin to-core de-bond in a GRP skin, PU foam sandwich [Gower 2005]

Figure 38 shows a skin-to-core disbond in a foam-cored sandwich laminate. Figure 39 show disbonds from a fatigue test program.

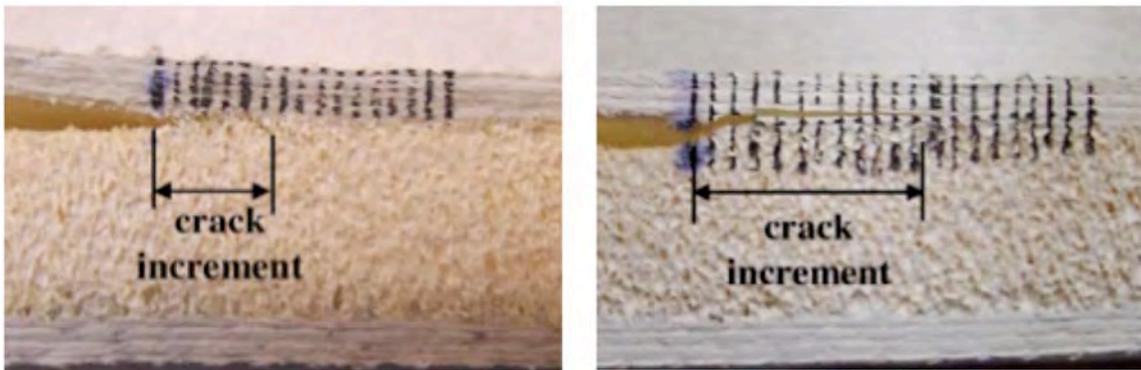
Figure 39. Compliance based crack length measurements showing crack path in PVC foam [Berggreen 2008]

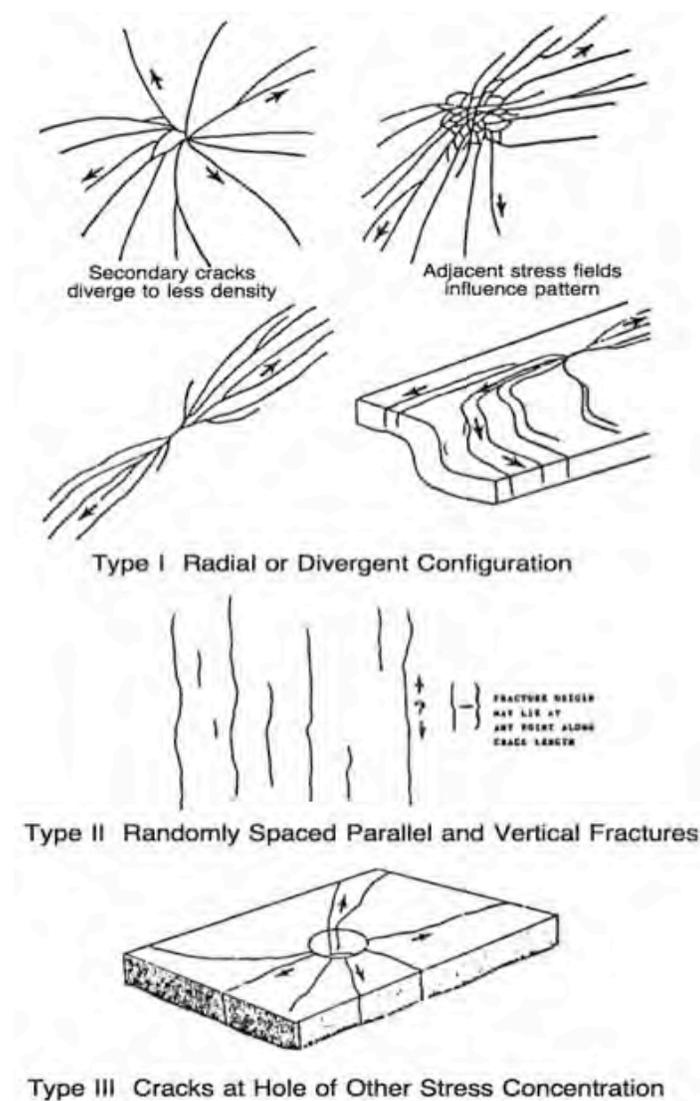
Figure 40. Schematic of surface cracks  
[Greene 1999]

Load sources that can exacerbate a poorly bonded sandwich panel include wave slamming, dynamic deck loading from gear or personnel, and global compressive loads that tend to seek out instable panels. Figure 40 is a schematic representation of surface cracks. [Greene 1999]

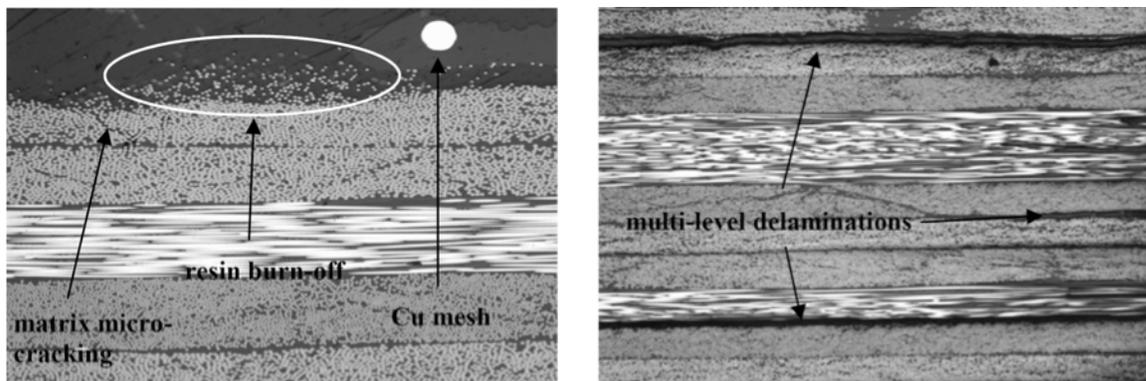
**Figure 41. Micrographs of (left) resin burn-off and matrix micro-cracking in CFRP panel containing lightning strike protection and (right) large scale delaminations in unprotected panel [Gower 2005]**

Figure 41 shows micrographs of thermal damage to a composite laminate.
