**SSC-463**

**INSPECTION TECHNIQUES FOR  
MARINE COMPOSITE  
CONSTRUCTION AND NDE**

**SHIP STRUCTURE COMMITTEE**  
**2012**

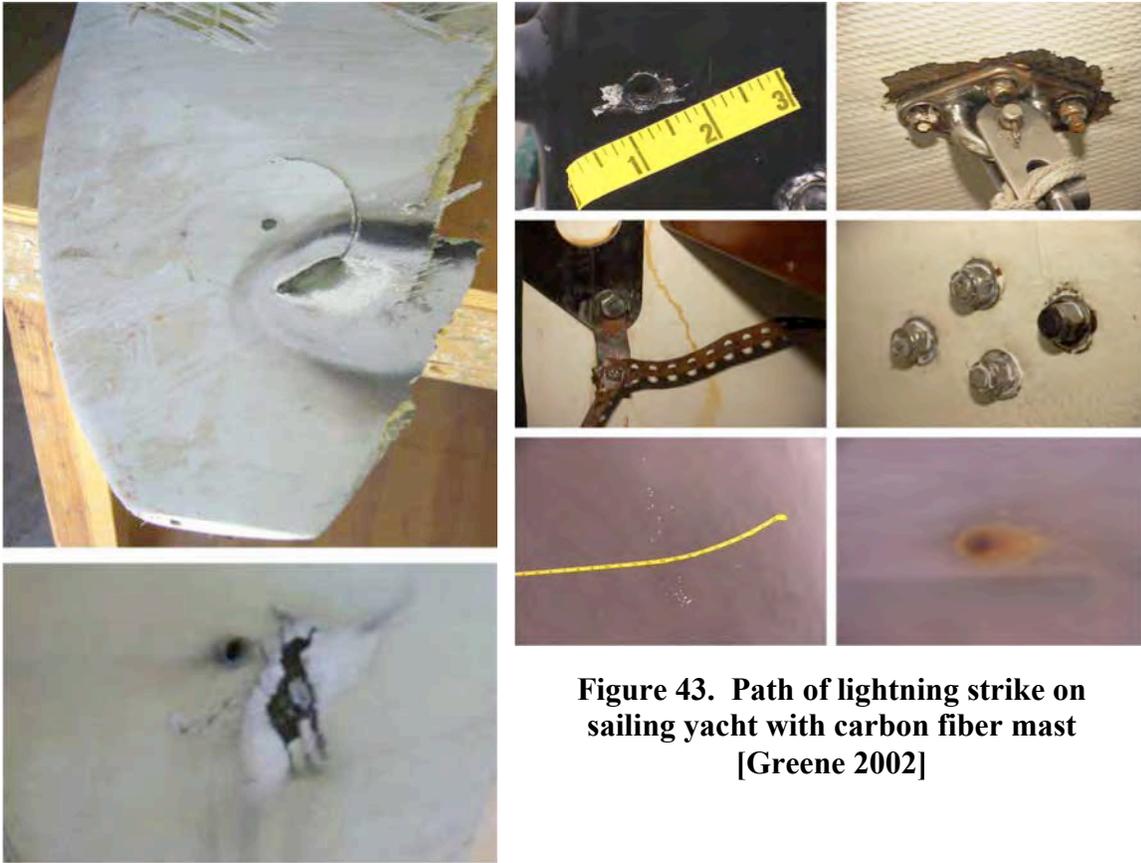
**Figure 43. Path of lightning strike on sailing yacht with carbon fiber mast [Greene 2002]**

**Figure 42. Lightning damage to wind turbine blades [Kithil 2008]**

Figure 42 shows lightning damage to a wind turbine blade. Figure 43 illustrates the discharge path of a lightning strike to a sailboat with a carbon fiber mast.

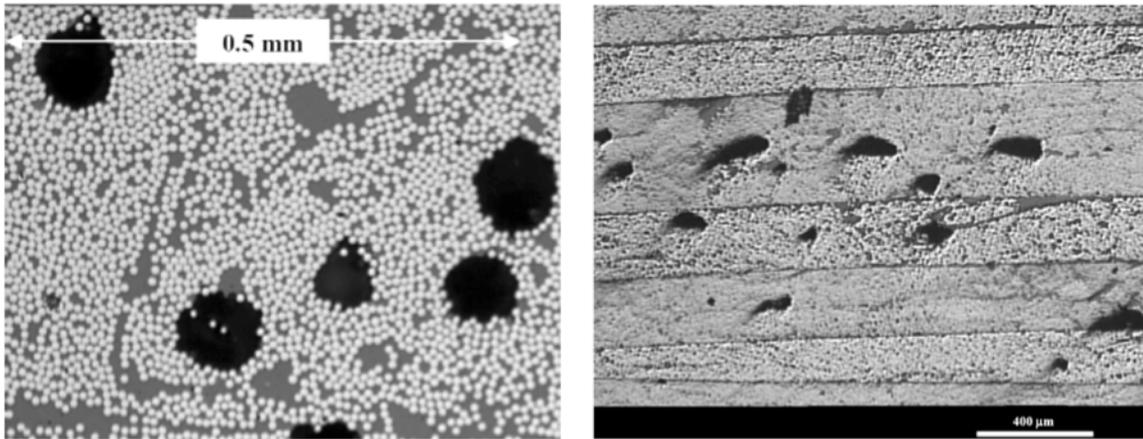
**Figure 44. Micrographs of voids in (left) unidirectional pre-preg and (right) filament wound CFRP materials [Gower 2005]**

Voids and/or porosity may result from trapped air between fibers, the presence of solvents/ moisture or other volatiles, or incorporation of air in the resin during mixing. These defects can occur in all composite materials and are of considerable concern as they can act as local stress concentrations. Voids can cause a reduction in structural performance (i.e. lower transverse and through-thickness tensile, flexural, shear and compression strengths, corrosion resistance and electrical properties), particularly when exposed to service environment (e.g. hot/wet) conditions for long periods. Large voids may be of sufficient size to act as delaminations, resulting in premature failure of the laminate. It is generally accepted that the void or porosity content of a component should not exceed 1-2% for high performance laminates. Figure 44 shows micrographs of voids in laminates. [Gower 2005]

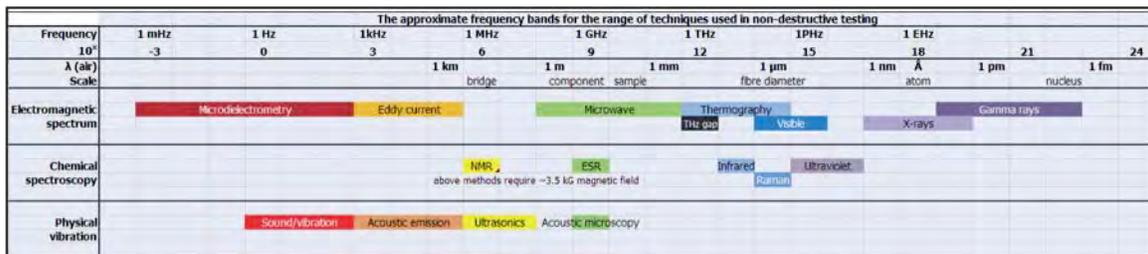
Figure 45. Approximate frequency spectrum for the range of techniques used in NDE. [www.tech.plym.ac.uk/sme/MATS324]

This chapter presents a wide variety of NDE techniques that are used to inspect composite laminates in various industries. Most of the techniques are “passive” but some methods excite the structure at frequencies shown in Figure 45. Typically, defects are found when anomalies in recorded responses are noted. In the case of laser shearography, the composite laminate is “actively” stressed.

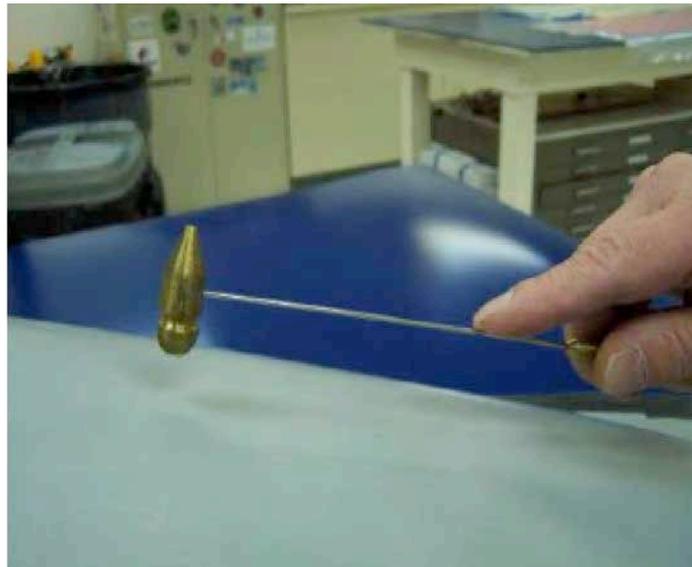
**Figure 46. Picture of a military specification tap hammer [Courtesy of Abaris Training Resources Incorporated]**

The tap test is often performed with a medium-sized coin, a steel washer approximately 25 mm (1 inch) in diameter, a small tap hammer (shown in Figure 46), or an electronic device, such as the Mitsui Woodpecker WP-632DS. The Woodpecker is connected to a computer that records the sound of a good section of panel and then compares it to subsequent readings in other areas that may be damaged. The aerospace industry has evaluated three similar tap test devices: the Boeing tap hammer; the Wichitech RD3, developed by Boeing and licensed to Wichitech; and the CATT, developed by Iowa State University and licensed to Advanced Structural Imaging, Inc. The CATT has an automatic tapping carriage that eliminates any effects due to a human operator. [Ilcewicz 2009] These devices are illustrated in Figures xx and xx in the Aerospace chapter.

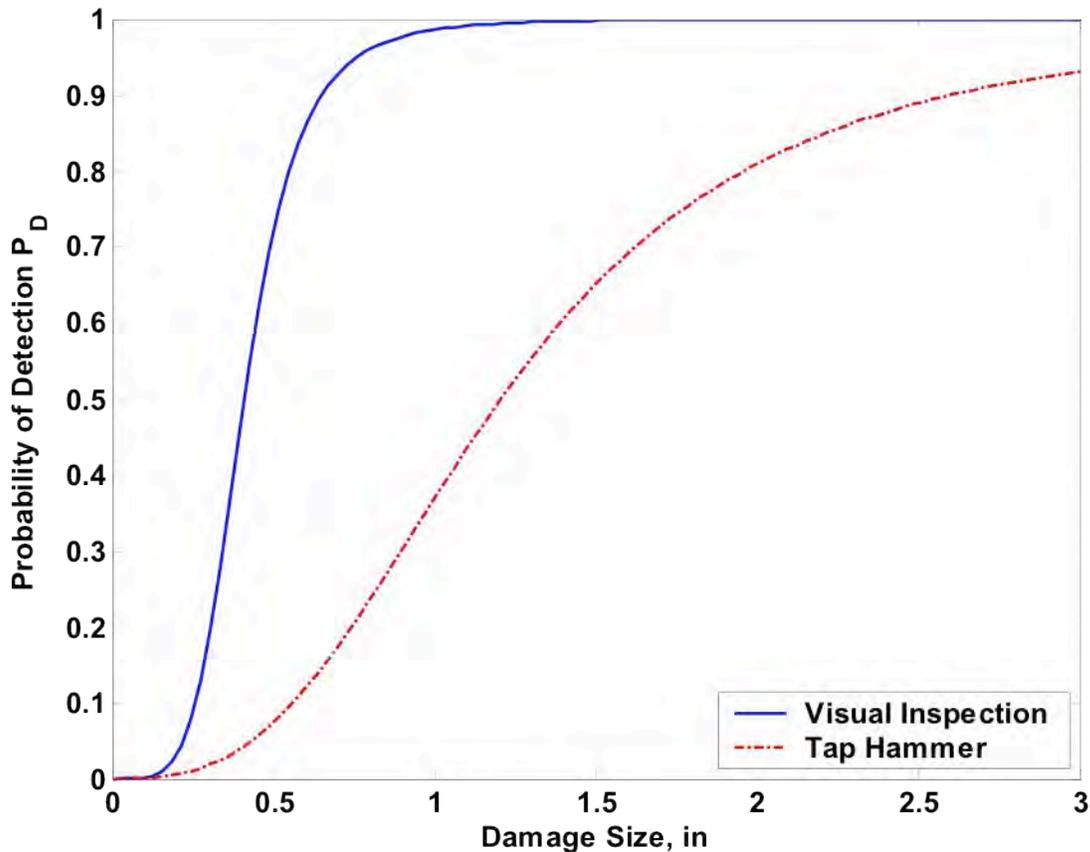
Figure 47. PoD for Visual and Tap Hammer Inspection Methods [Huang 2005]

Figure 47 represents data from a controlled laboratory environment where inspectors had a priori knowledge of defects. [Huang 2005]. This resulted in a PoD that was higher for visual inspection when compared to manual tap hammer techniques.

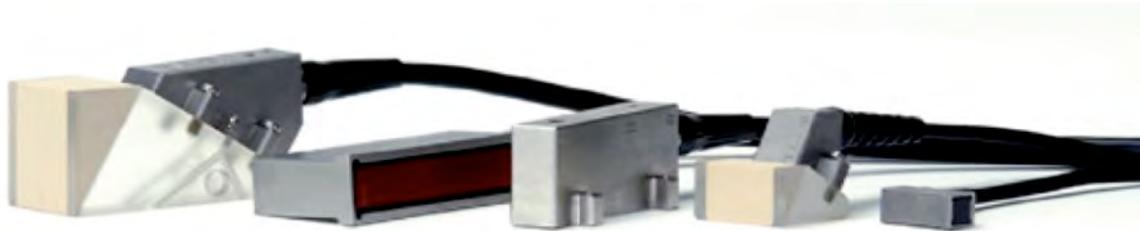
Figure 48. Typical ultrasonic phased array probe assemblies [Nelligan 2007]

Phased array systems utilize the wave physics principle of phasing, whereby the time between a series of outgoing ultrasonic pulses is varied so the individual wave fronts generated by each element in the array combine with each other to add or cancel energy in predictable ways that effectively steer and shape the sound beam. Figure 48 shows some examples of ultrasonic phased array probe assemblies. [Nelligan 2007]

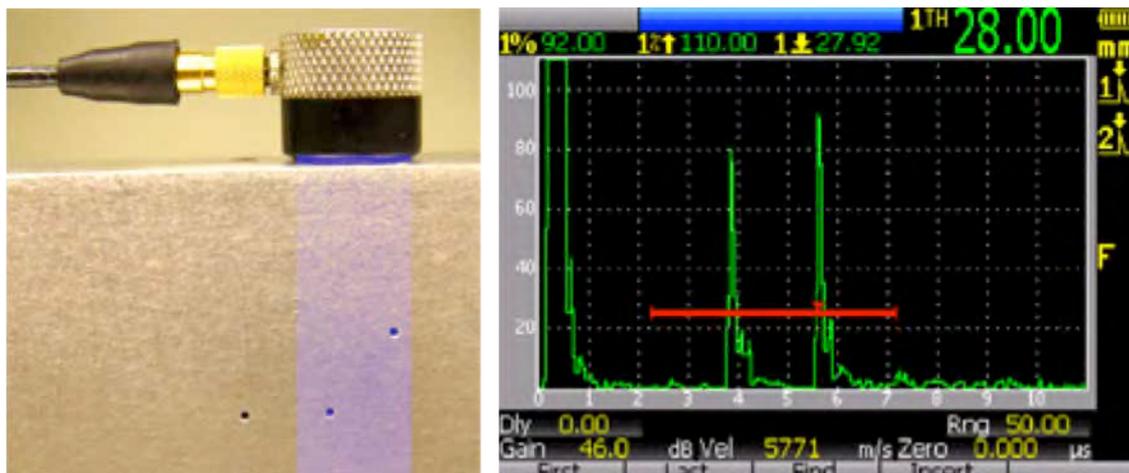
Figure 49. Single-element contact ultrasonic transducer (left) and A-scan image (right) [Nelligan 2007]

An A-scan is a simple waveform presentation showing the time and amplitude of an ultrasonic signal and is used for conventional ultrasonic flaw detectors and waveform display thickness gages. An A-scan waveform represents the reflections from a single sound wave location in the test piece. The flaw detector A-scan shown in Figure 49 depicts echoes from two holes drilled into the side of a steel reference block. The columnar sound beam from a common single-element contact transducer intercepts two out of the three of the holes and generates two distinct reflections at different times that are proportional to the depth of the holes. [Nelligan 2007]

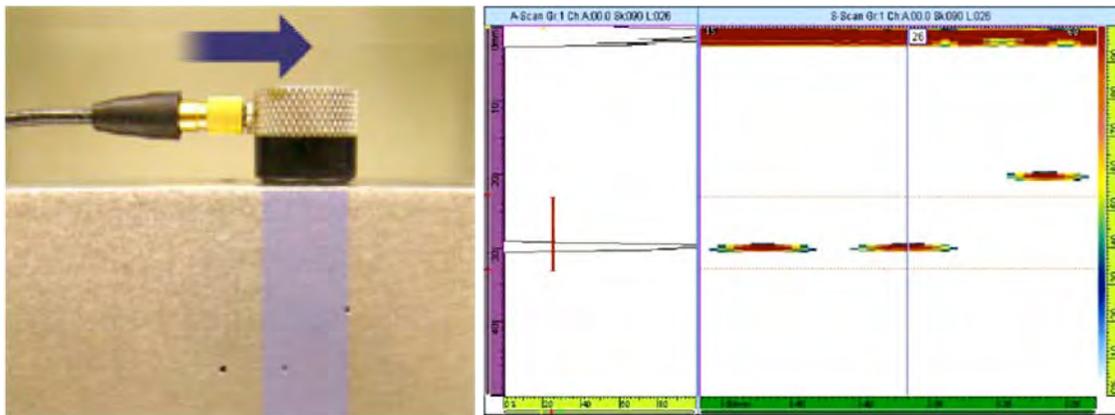
**Figure 50. Ultrasonic transducer scan movement (left) and linear scan B-scan image (right) [Nelligan 2007]**

A B-scan is an image showing a cross-sectional profile through one vertical slice of the test piece, showing the depth of anomalies with respect to their linear position. B-scan imaging requires that the sound beam be scanned along the selected axis of the test piece, either mechanically or electronically, while storing relevant data. In Figure xx, the B-scan shows two deep anomalies and one shallower one, corresponding to the positions of the holes in the test block. With a conventional flaw detector, the transducer must be moved laterally across the test piece. Figure 50 shows the transducer movement necessary for a B-scan and the resulting data image. [Nelligan 2007]

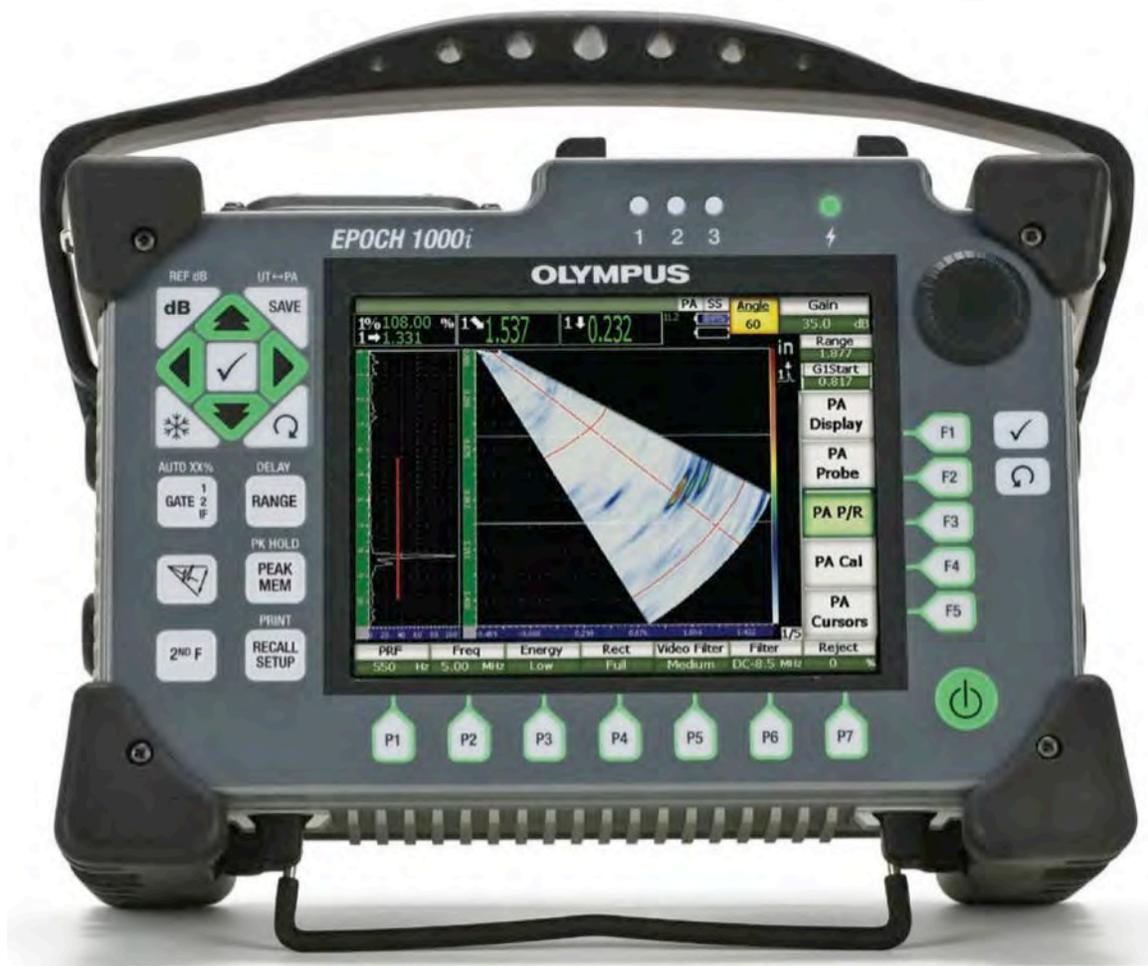
**Figure 51. EPOCH 1000i ultrasonic and phased array flaw detector with simultaneous A-scan and S-scan display [Olympus 2008]**

An S-scan or sectorial scan image shows a two-dimensional cross-sectional view based on a series of A-scans that have been plotted with respect to time delay and refracted angle. The horizontal axis corresponds to test piece width, and the vertical axis to depth. This is the most common display used for medical sonograms and industrial phased array images but is not as common for NDE applications. The sound beam sweeps through a series of angles to generate an approximately cone-shaped cross-sectional image. Figure 51 shows a portable UT device with combined A-scan and S-scan displays. [Nelligan 2007]

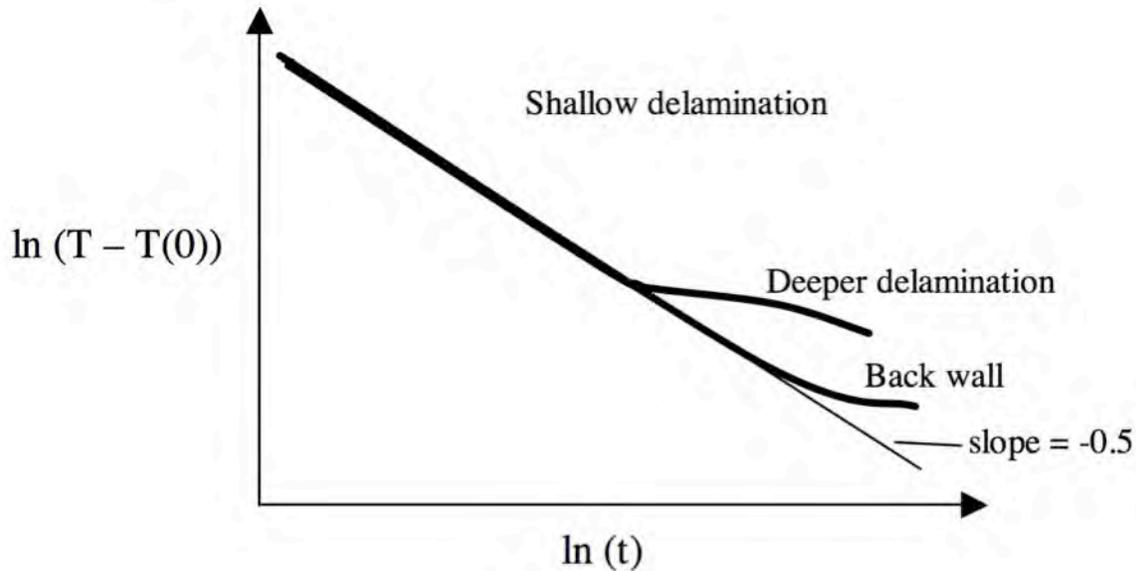
**Figure 52. Logarithmic time evolution of surface temperature is shown. Temperature decay is linear with slope  $-0.5$  until heat flow is obstructed by a subsurface defect or a boundary such as a wall. [Shepard 2005]**

With pulsed thermography, the laminate is heated for few seconds and the thermal decay response at the surface is measured by an infrared camera. Defect detectability strongly depends on the temperature contrast between the defect and good areas of the structure. Temperature contrast is a function of defect features, such as area, depth and orientation. The time-dependent surface temperature response to an instantaneous heat pulse reveals a characteristic linear profile with slope  $-0.5$  when plotted on a natural logarithm scale, as shown in Figure 52.

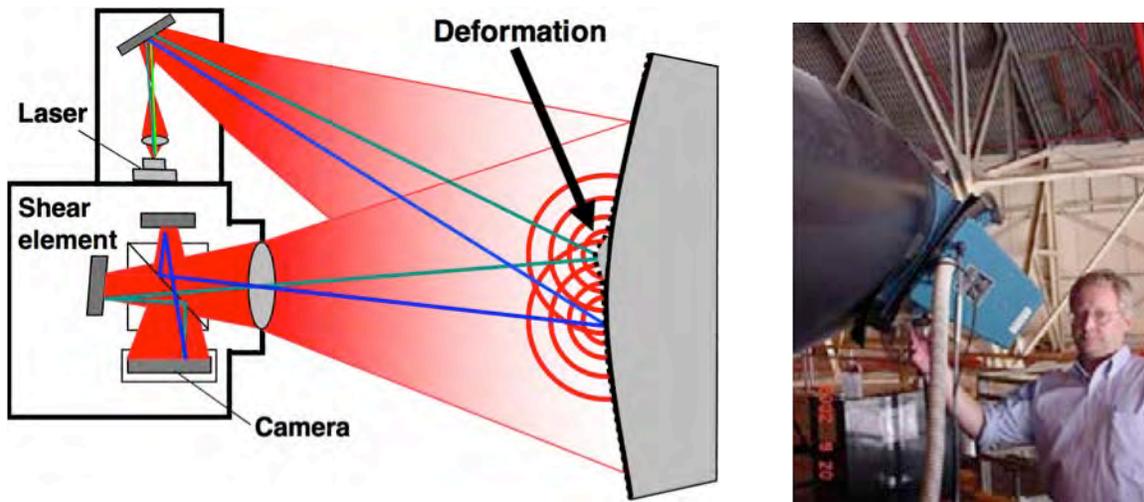
**Figure 53. Shearography principal [Collrep 2006] and portable shearography device [Newman 2009]**

Shearography cameras generally use a Michelson type interferometer with two essential modifications. First, one mirror may be precisely tilted to induce an offset, or sheared image, of the inspected structure with respect to a second image. The sheared amount is a vector with an angle and a displacement value. The shear vector determines the sensitivity of the interferometer to surface displacement derivatives. Figure 53 illustrates the shearography principal and a portable shearography device. [Newman 2009]

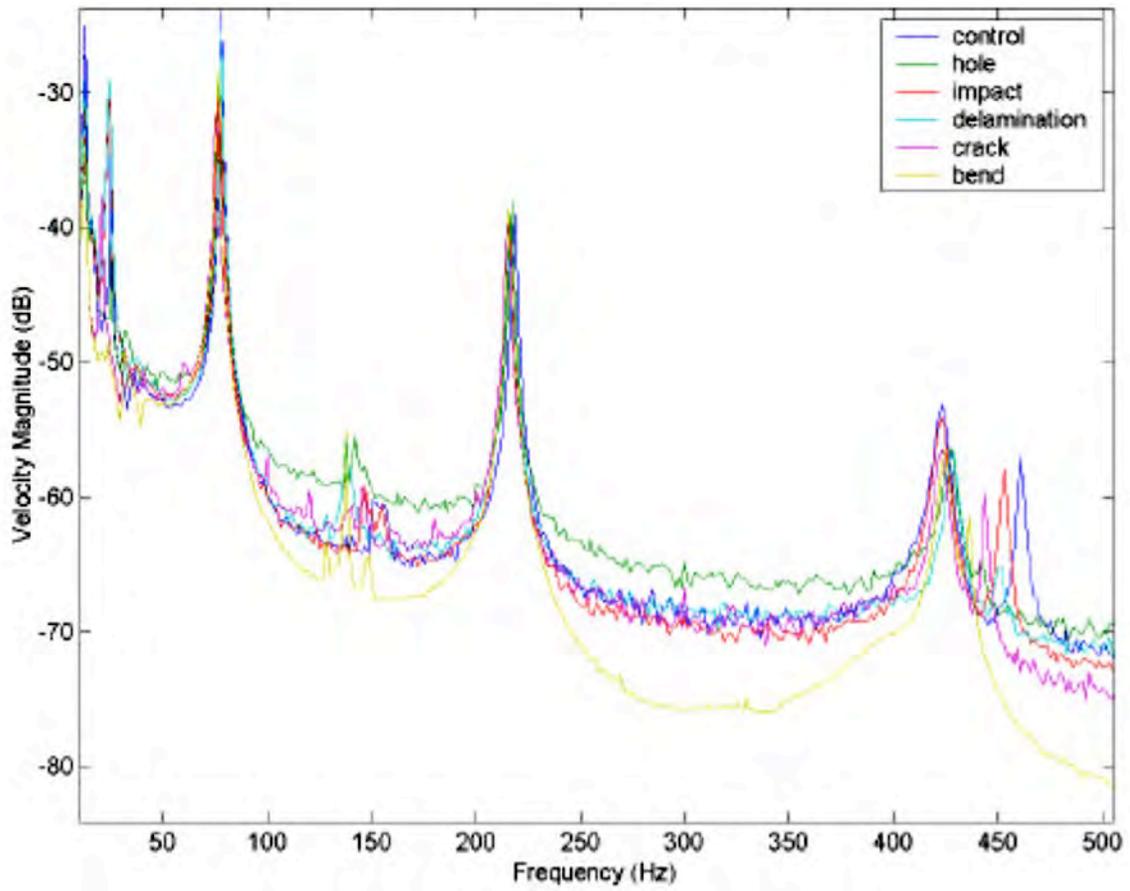
**Figure 54. Frequency response plot from vibrometer for all specimens, range of 0-500 Hz [Kessler 2001]**

To use modal analysis as an NDE tool, structures can be excited by ambient energy, an external shaker or embedded actuators. Embedded strain gauges, piezos or accelerometers are then used to monitor the structural dynamic response. Changes in normal vibrational modes can be correlated to loss of stiffness in a structure. Typically, analytical models or experimentally determined response-history tables are used to predict the corresponding location of damage. Interpretation of the data collected is often subjective without a detailed model of the structure. There are also detection limitations imposed by the resolution and range of the individual sensors chosen. Fidelity increases with the number of sensors mounted on the structure, but this is often cost-constrained. To illustrate the subtlety of data interpretation, Figure 54 displays the velocity magnitude response to a frequency range below 500 Hz for tested specimens. [Kessler 2001]

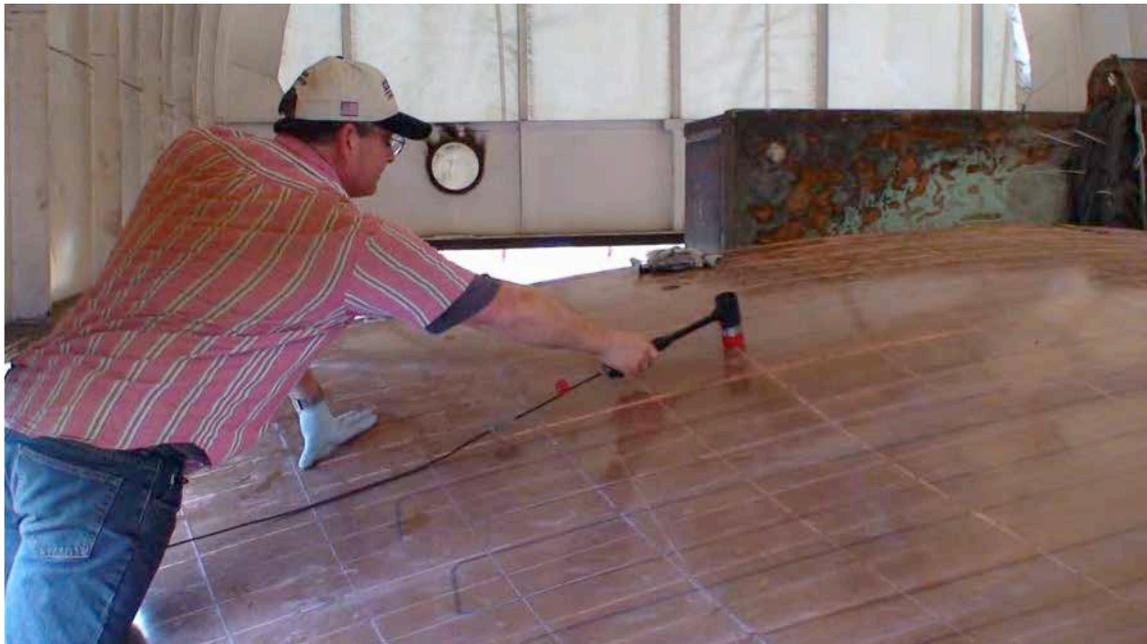
**Figure 55. An instrumented hammer is used to excite a composite destroyer rudder during SIDER examination [author photo]**

SIDER is a vibration-based inspection method that uses vibration waves that are totally invasive but not intrusive. The structure is excited at a mesh of test points (see Figure 55) and the acceleration response is measured at a few locations. Data is reduced to generate a contour map of structural stiffness irregularity. SIDER is designed for the rapid inspection of structures with large surface areas. A single inspection finds areas where there is structural variation/inconsistency associated with a localized change in stiffness. These are places with designed (deliberate) stiffness changes, manufacturing anomalies, and service-related damage. SIDER results are typically used to focus the attention of more detailed (but time consuming) inspections, e.g., UT and laser shearography. [Ratcliffe 2001] SIDER is a relatively new NDE technique that has only been conducted by the system developers and requires a carefully-trained analyst to interpret the nuanced inspection results.

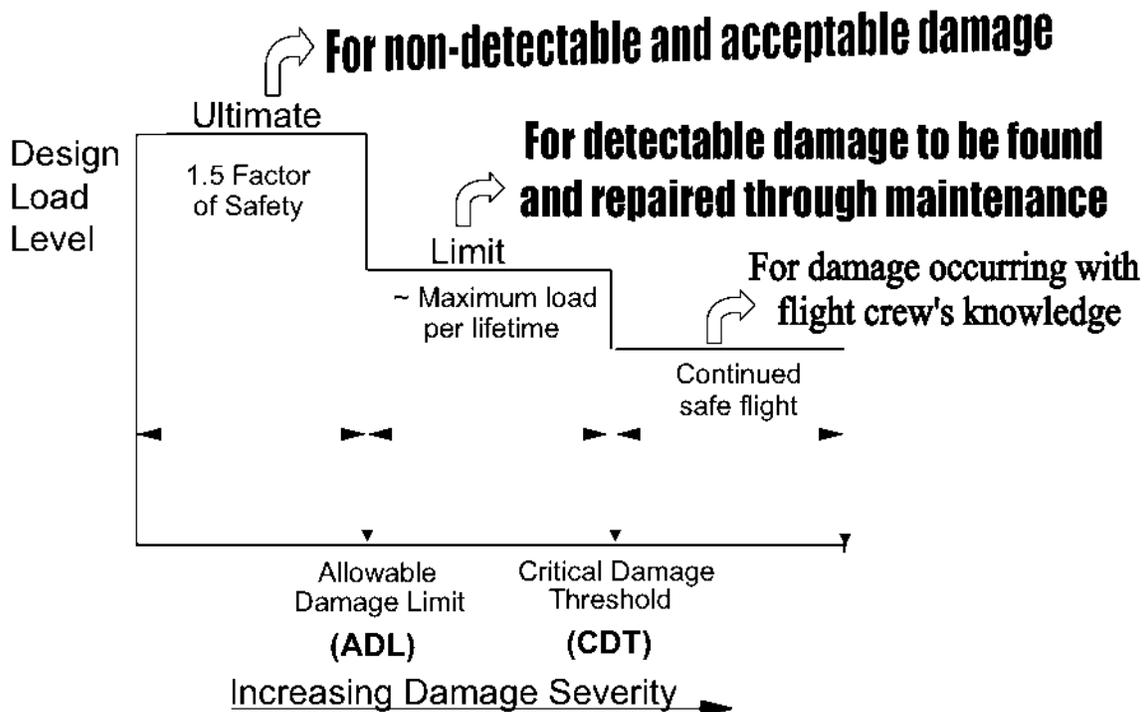
Figure 56. Aerospace structural design load and damage considerations [Ilcewicz 2009]

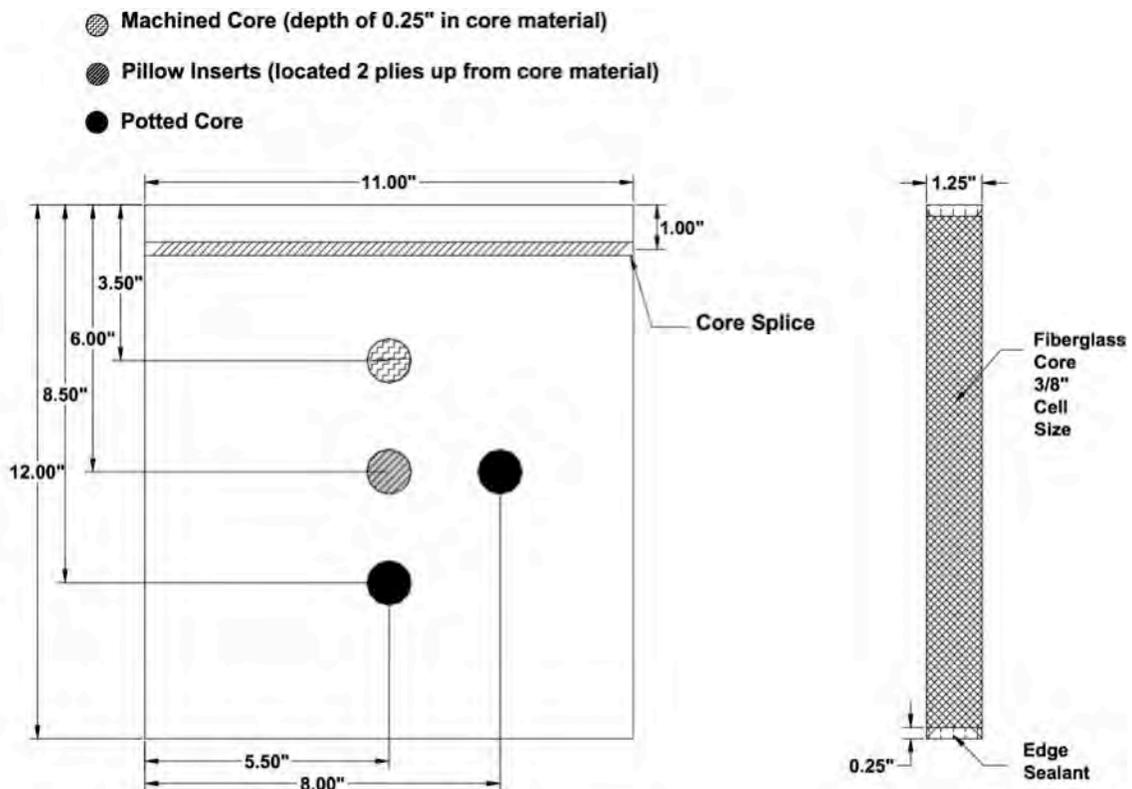
**Figure 57. Schematic of a reference standard used for NDE of honeycomb-cored panels [Tomblin 2004]**

Forty-four Nomex honeycomb core panels with either carbon/epoxy or fiberglass/epoxy skins were manufactured, with flaws ranging from 0.2 in<sup>2</sup> to 3 in<sup>2</sup> (1.29 cm<sup>2</sup> to 19.35 cm<sup>2</sup>). Figure 57 shows the configuration of honeycomb panels with imbedded flaws. The panels were shipped to airlines, third-party maintenance depots, aircraft manufacturers and NDE developer labs around the world. Industry-wide data was generated to quantify how well current inspection techniques are able to reliably find flaws in composite honeycomb structure. [Roach, 2010] The program developed Probability of Detection (PoD) curves for various laminates and NDE techniques. Figures 59 through 63 show some results from the “round-robin” study. Figure 64 shows some of the NDE devices used during the study.

The honeycomb-cored reference panel shown in Figure 57 has been incorporated into SAE International’s Aerospace Recommended Practice 5606, “Composite Honeycomb

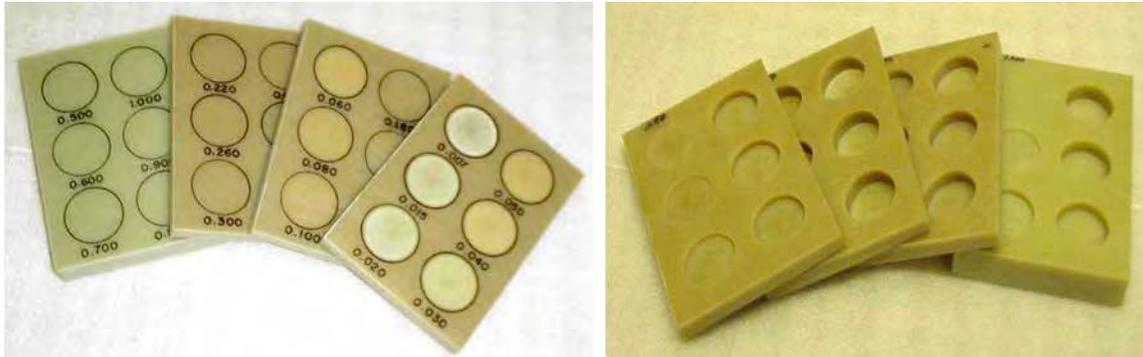
Figure 58. Reference standard used for NDE of solid laminates [Galella 2006]

NDI Reference Standards,” September 2001. A companion document for solid laminates published at the same time, Aerospace Recommended Practice 5605, “Solid Composite Laminate NDI Reference Standards,” uses reference laminates shown in Figure 58.

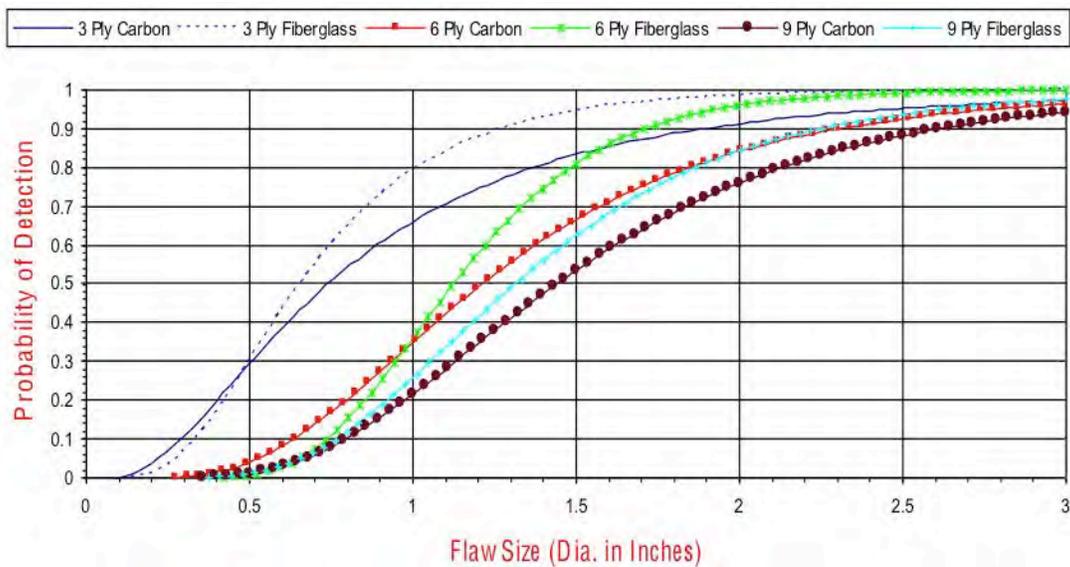
Figure 59. Probability of Detection (PoD) versus flaw size (diameter in inches) for composite sandwich panels with various skin architectures [Roach, 2008]

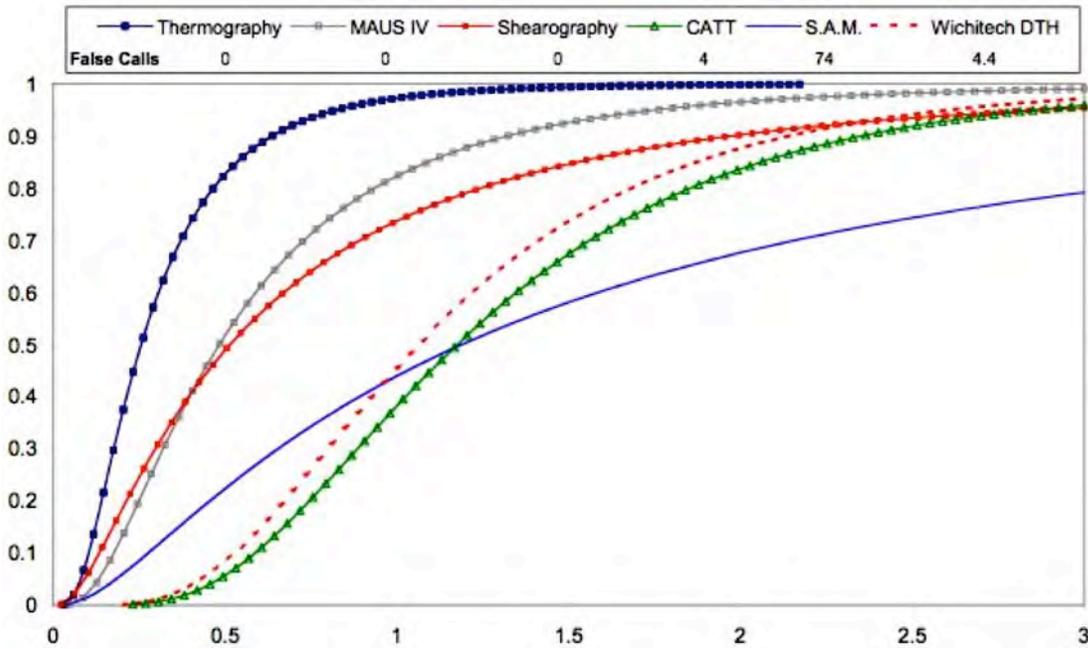
Figure 60. Probability of Detection (PoD) versus flaw size (diameter in inches) for a 9-ply carbon fiber-reinforced composite sandwich panel [Roach, 2008]

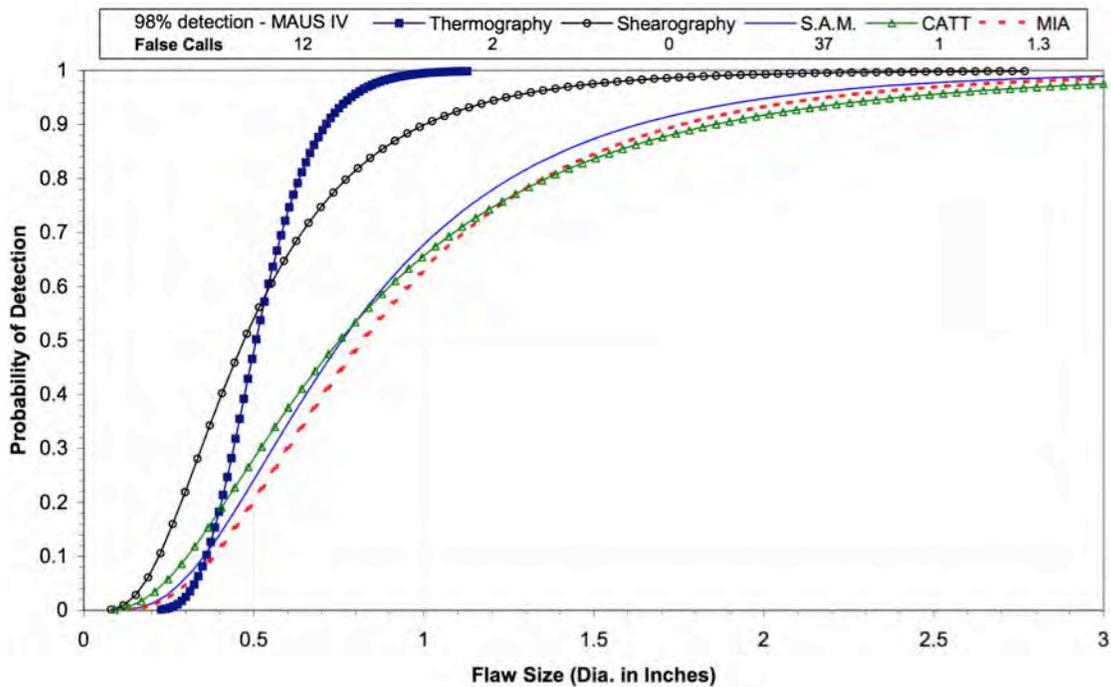
Figure 61. Comparison of advanced inspection techniques with best conventional NDE results on 6 Ply carbon [Galella 2006]

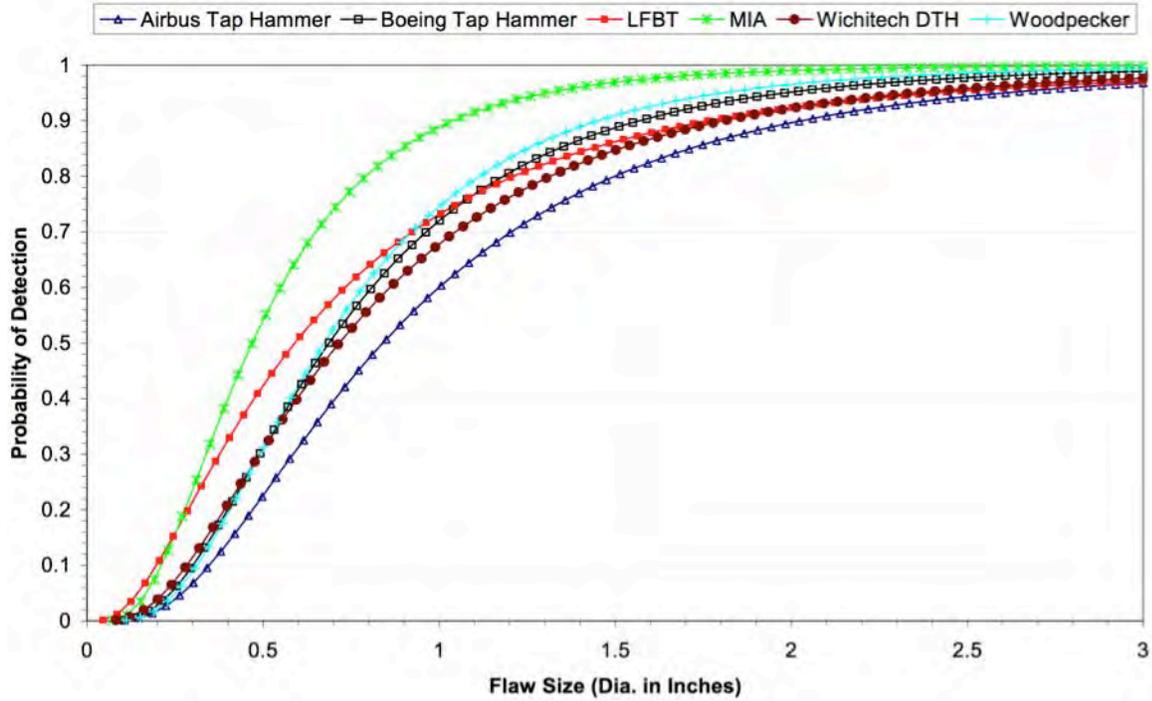
Figure 62. Cumulative PoD of all conventional NDE devices for 3 ply fiberglass honeycomb panels[Galella 2006]

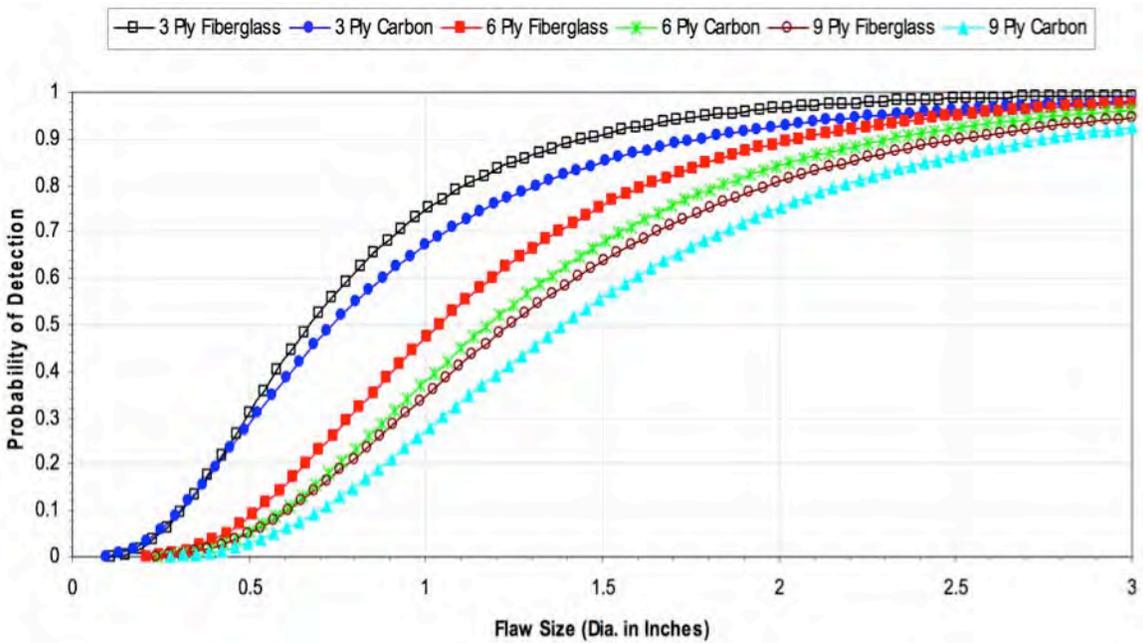
Figure 63. Cumulative PoD for Woodpecker device for all honeycomb panel types tested [Galella 2006]

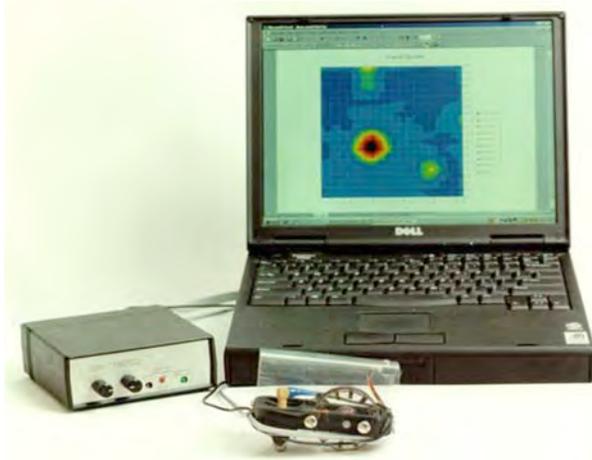
**Computer Aided Tap Tester (CATT)**

**Figure 64. Some NDE devices evaluated during the FAA's composite flaw detection experiments [Tomblin 2004 and Galella 2006]**

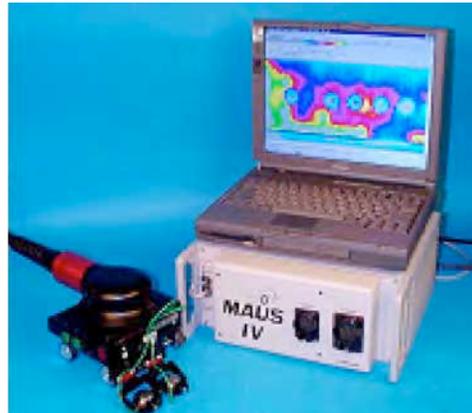
**Mobile Automated Scanner (MAUS IV) UT C-scan or Low-Frequency Bond Tests (LFBT)**

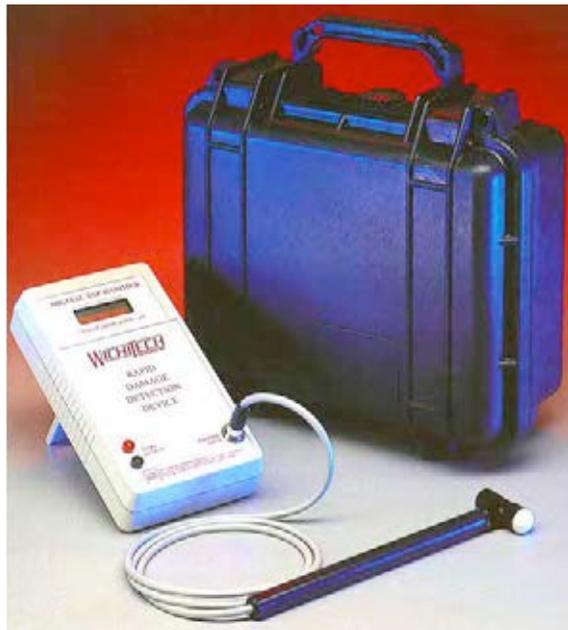
**Wichitech Digital Tap Hammer (DTH)**

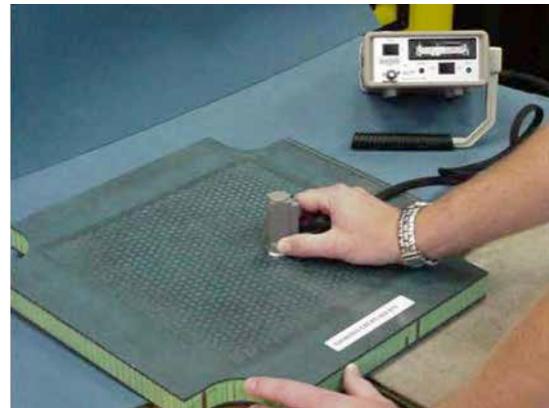
**Mechanical Impedance Analysis (MIA) V-95 Device**

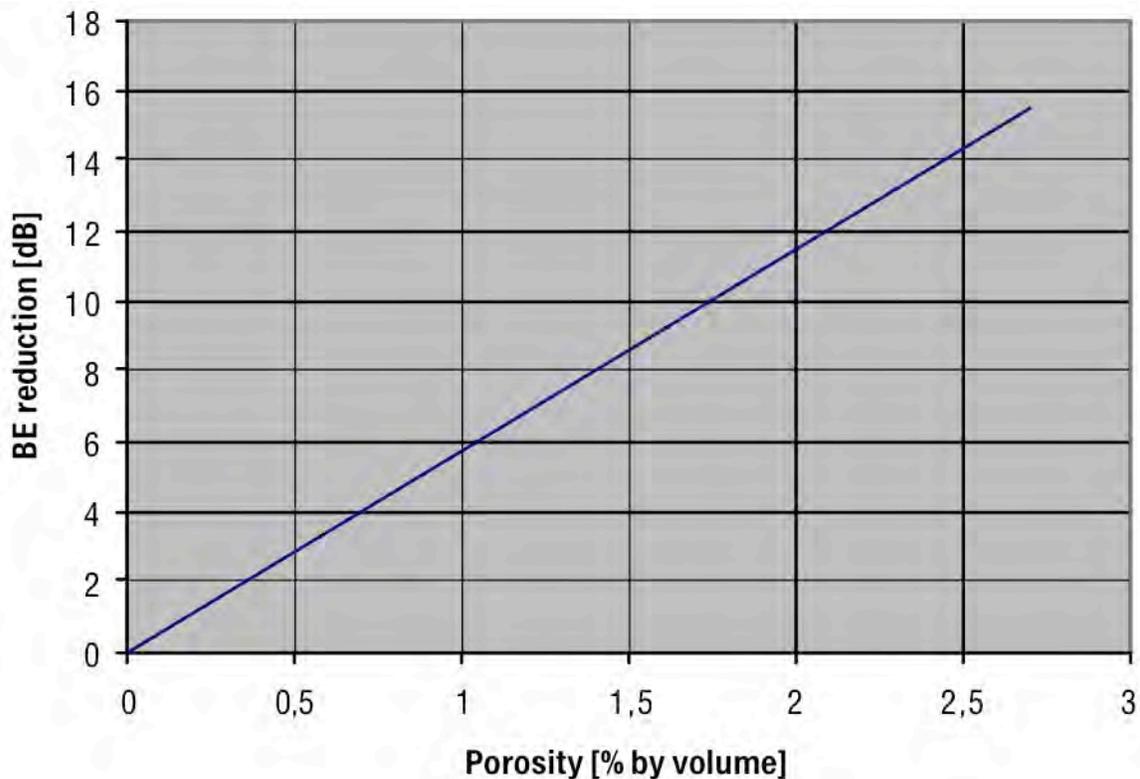
**Figure 65. Ultrasonic backwall echo reduction versus volume porosity**  
[Schnars 2006]

Porosity in aerospace composites may degrade the stiffness of the structure. Porosity has to be detected therefore in production. At Airbus Germany the requirement is that 2.5% volume porosity is the maximum allowed. An ultrasonic testing method has been developed and qualified to detect porous areas in carbon fiber laminates. In porous areas often no intermediate echo occurs, because pores may scatter the incident sound in all directions. It has been shown that there is a good correlation between backwall echo reduction and volume porosity, as determined by micrographic analysis, see Figure 65." [Schnars 2006]

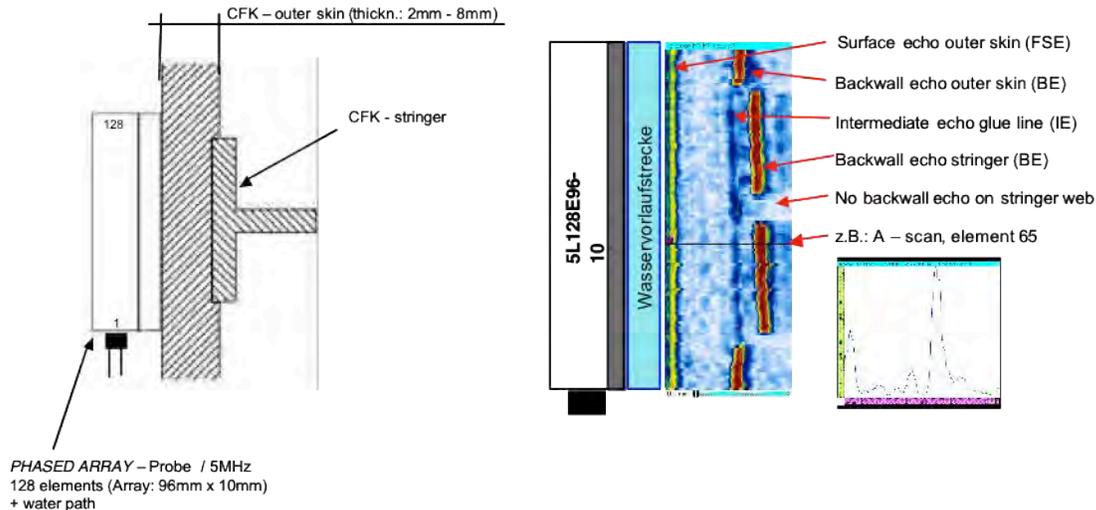
**Figure 66. Phased array inspection of stringer skin bonding [Schnars 2006]**

Ultrasonic phased array (PA) NDE systems can produce any desired wavefront electronically. PA techniques can be used to tilt and focus a sound beam for electronic scanning of a sound beam. Another advantage with respect to single element transducers is the availability of display images (B-scan, C-scan, S-scan) instead of only A-scans, which allows better interpretation of signals inside complex structures. An example of PA inspection of a bonded aircraft stringer is shown in Figure 66. [Schnars 2006]

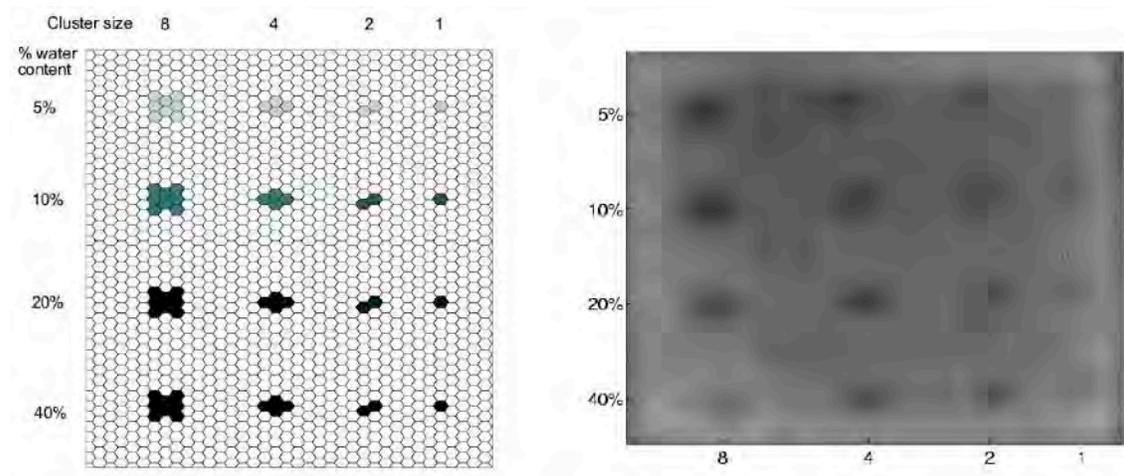
**Figure 67. Schematic (left) showing layout of entrapped water in a honeycomb panel, and a processed thermographic image (right) [Rajic 2010]**

To validate Flash Thermography (FT) as a valid NDE method for helicopter structure, a test sample was manufactured by bonding a 3 mm thick carbon-epoxy laminate to aluminum honeycomb core with a 3/16" (5 mm) cell size. Varying amounts of water were injected into clusters of cells arranged as shown in Figure 67. The defect was detectable for all of the considered cases, including the 5% fill volume in a single cell, suggesting a detection threshold near that level. [Rajic 2010]

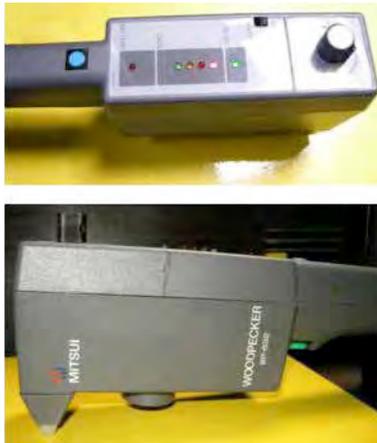
Mitsui Woodpecker

Figure 68. Various NDE technologies evaluated by Airbus [Bisle 2010]

Airbus evaluated various NDE methods, some of which are illustrated in Figure 68. An extensive PoD exercise was done, that gives a clear view about the capabilities NDE procedures. Figure 69 provides an overview of the Airbus assessment of various NDE methods.

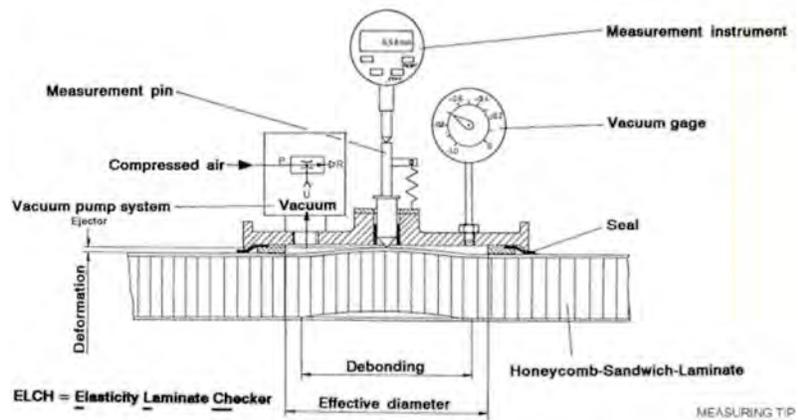
Elastic Laminate Checker (ELCH)

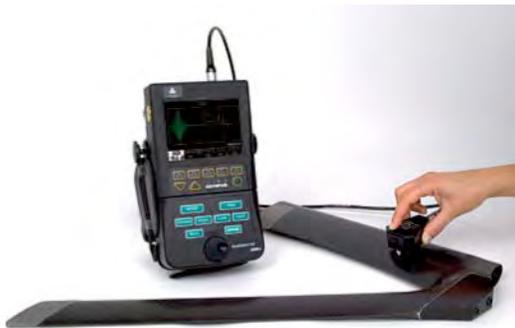
BondMaster 1000

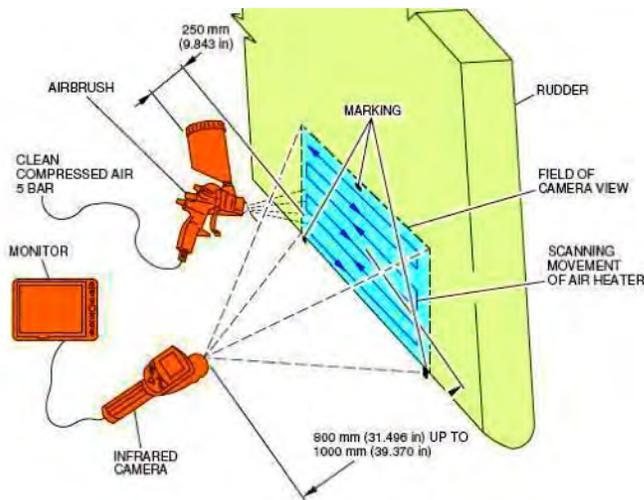
Thermography Evaluation Arrangement

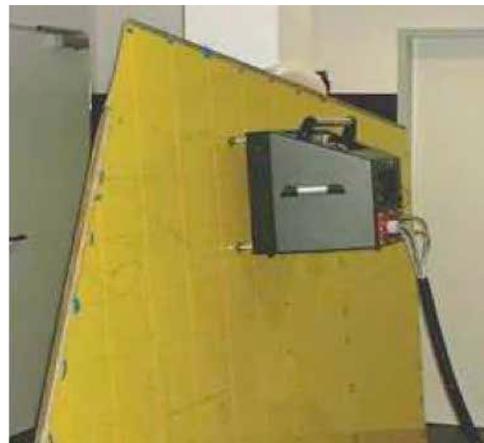
Shearography Evaluation Arrangement
