**SSC-463**

**INSPECTION TECHNIQUES FOR  
MARINE COMPOSITE  
CONSTRUCTION AND NDE**

**SHIP STRUCTURE COMMITTEE**  
**2012**

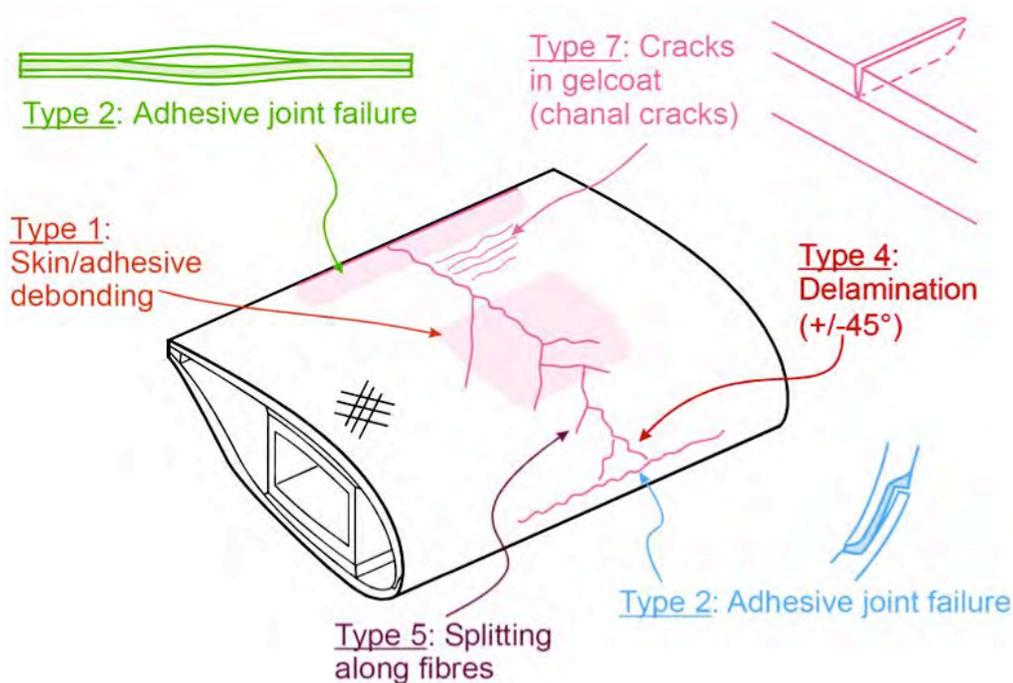
**Figure 70. Blade damage Types 1 (skin/adhesive debonding) and 2 (adhesive joint failure between skins) at the leading as well as the trailing edge. Types 4 (delamination driven by a buckling load), 5 (laminare failure in compression) and 7 (gel-coat cracking and gel-coat/skin debonding) [Sørensen 2004]**

Blade strength and fatigue life is related to the degradation of the composite material and the manufacture of the blade. These degradations may include delaminations and debonding. The blades are also susceptible to environmental damage such as leading edge erosion and lightning strikes. Various blade degradations and damage are shown in Figures 70 through 72.

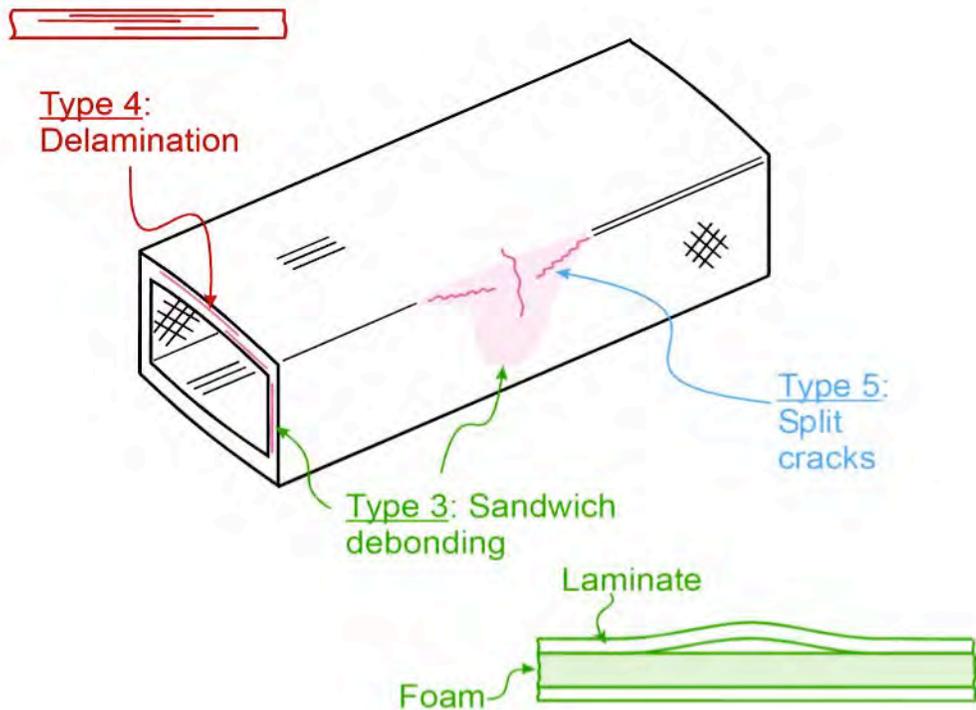
Figure 71. Blade damage types 4 (delamination driven by buckling load) in upper flange and 5 (fiber failure in tension; laminate failure in compression) in the web [Sørensen 2004]

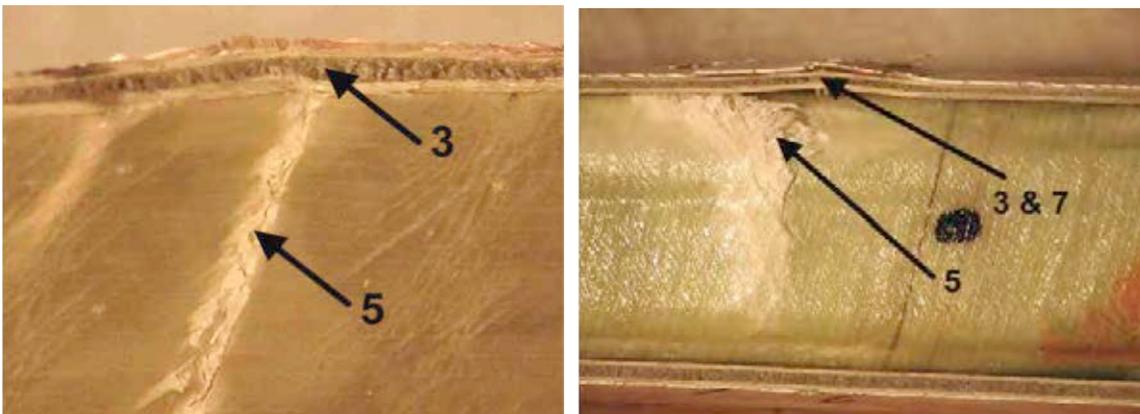
Figure 72. 3 – Blade damage formation and growth at the interface between face and core in sandwich panels in skins and main spar web (sandwich panel face/core debonding); 5 - Splitting and fracture of separate fibers in laminates of the skin and main spar (fiber failure in tension; laminate failure in compression) and 7 - Formation and growth of cracks in the gel-coat; debonding of the gel-coat from the skin (gel-coat cracking and gel-coat/skin debonding) [Sørensen 2004]

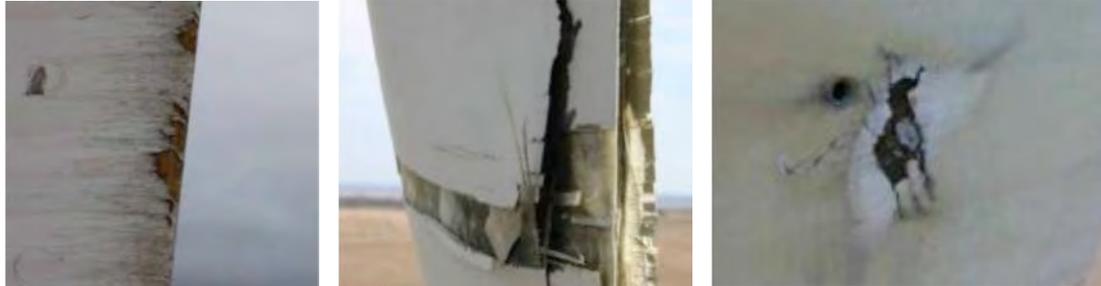
**Figure 73. Wind blade damage showing: Leading Edge Erosion, Severe Blade Damage (left) , Delamination (center) and Lightning Damage to Blade [Knight & Carver]**

Of particular interest is how blades respond to an offshore environment and what degradations affect them. Figure 73 shows the kind of mechanisms that affect blades leading to erosion and other blade damage that should be identified as part of an inspection program. [Sheppard 2010]

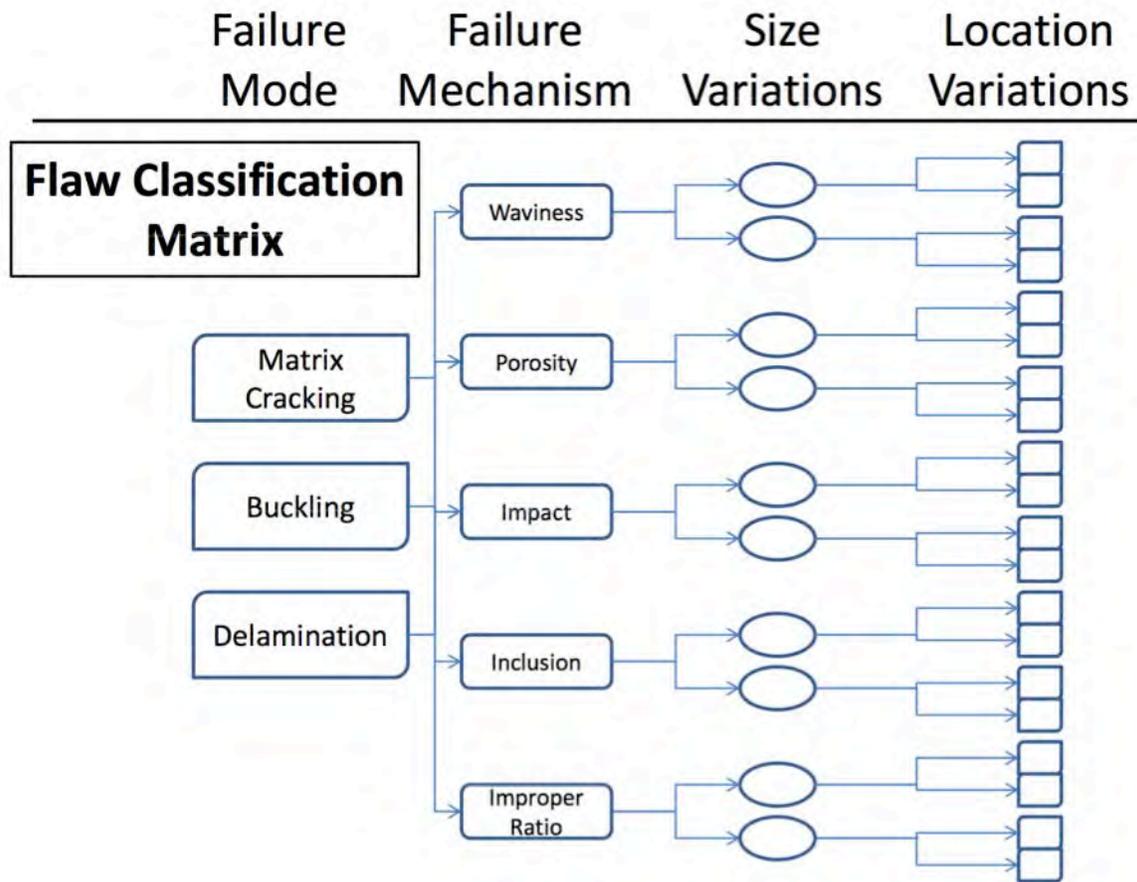
Figure 74. Classification and quantification of blade defects [Cairns 2010]

Figure 74 shows the classification system developed to define the critical geometric parameters of blade manufacturing flaws. [Cairns 2010]

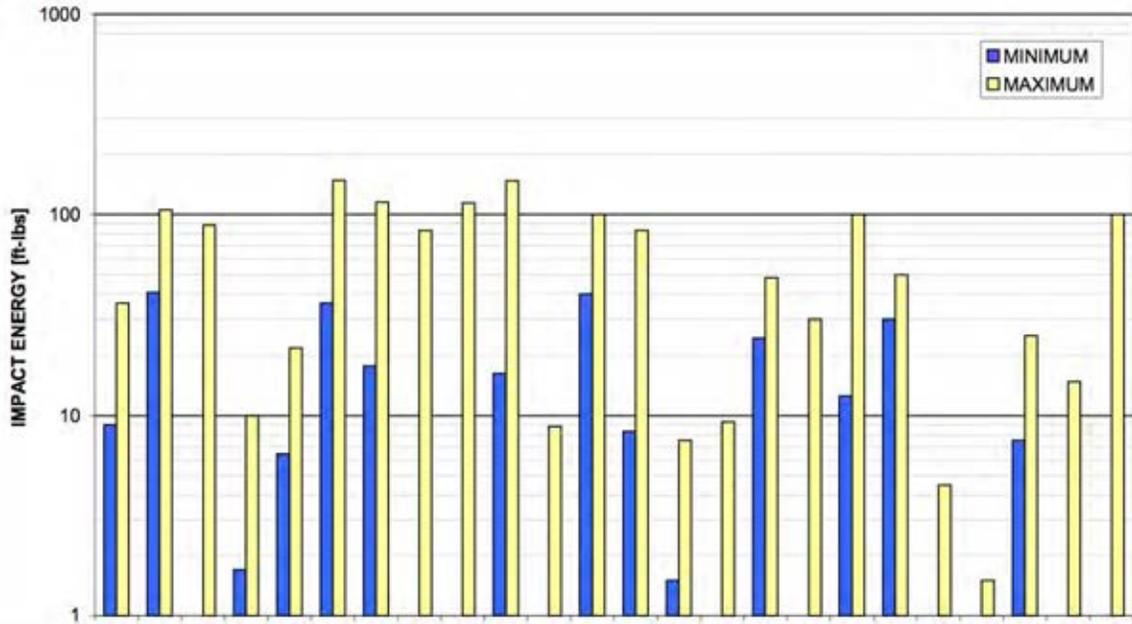
**Figure 75. Impact energies used for previous aerospace sandwich laminate impact test studies [Tomblin 2001]**

Typical sandwich laminates used in the aerospace industry use thin gage composite facesheets (0.020" to 0.045") that are co-cured to honeycomb and foam cores. The Federal Aviation Administration investigated the impact damage resistance of sandwich laminates as well as testing and inspection methods. [Tomblin 2001] They determined that a larger diameter impactor produces a very benign appearing damage state, wherein, no surface fracture/cracks nor visually perceptible levels of indentation exist, but the subsequent NDE did indicate a very large damaged region. The investigators examined a number of previous impact studies and noted impact energies up to 100 ft-lbs were used, as shown in Figure 75.

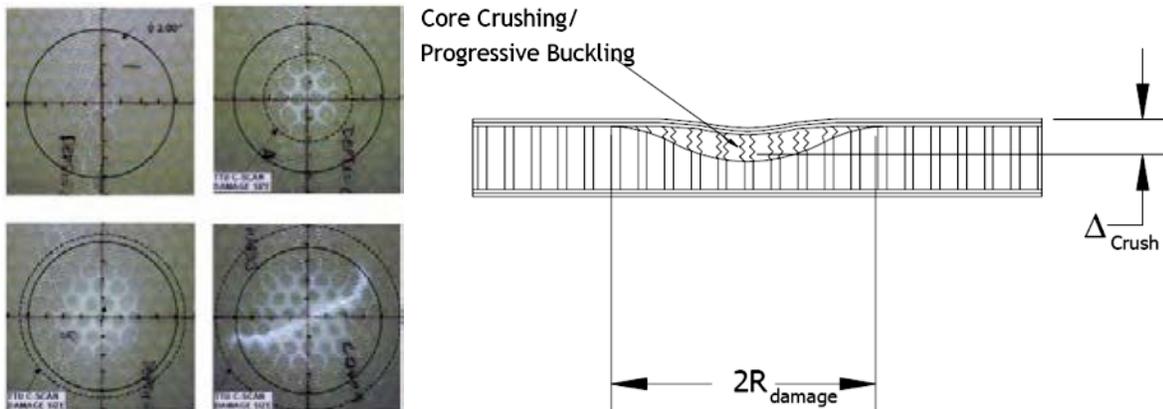
**Figure 76. Impact damage apparent only with NDE (left) and core crushing process (right) [Tomblin 2001]**

Since the investigators did not want produce visible impact damage, impact energies from 85 to 150 *inch-lbs* were used. Impactor diameters of 1, 2 and 3 inches were used that resulted in NDE-detected damage ranging from 0.10 to 3.31 inches in diameter. The curvatures in the contact region tended to equal that of the impactor, which clearly explains the onset of skin fracture at lower impact energies for the small diameter impactor. Figure 76 shows the NDE pattern damage a schematic representation of the core crushing phenomenon.

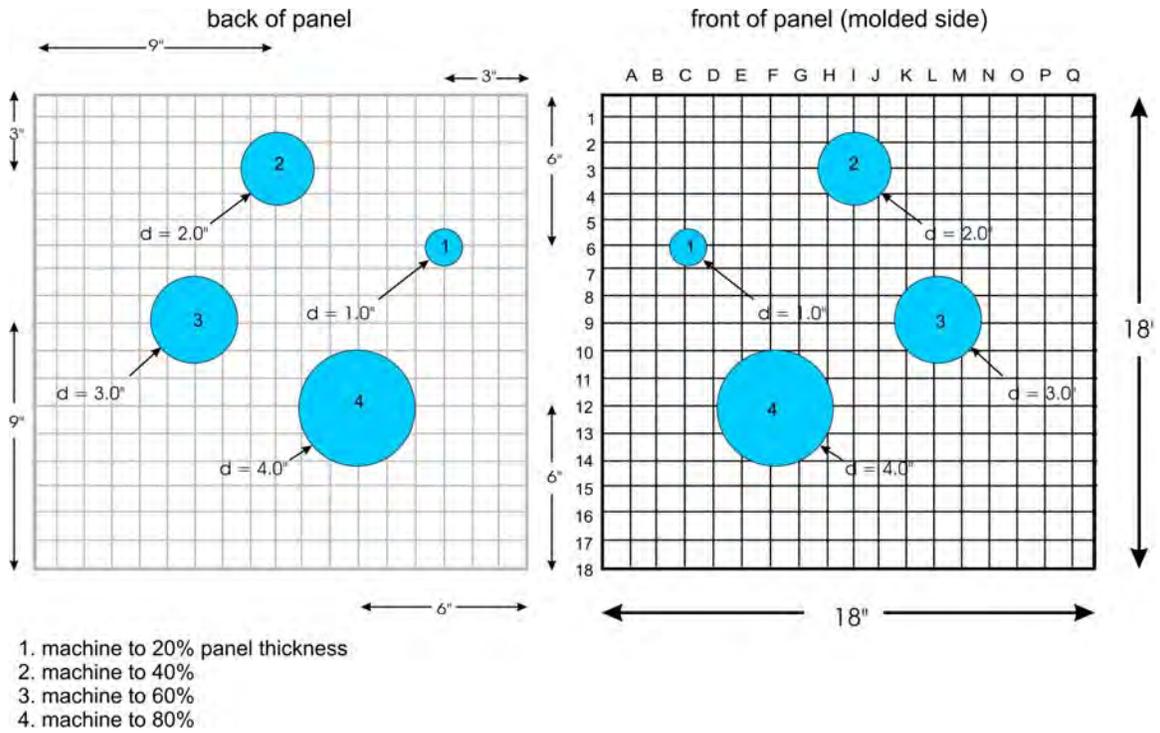
Figure 77. Void simulation cavity machining diagram for Pearson 4 test panel

Because the panels were fabricated with clear gel coat, it was very easy to visibly identify where the machining was done, as light is easily transmitted through these regions. Pieces of foam board were cut and placed in the cavities and another piece of foam board was adhered to the back of the panel. It was still possible to notice where the panel defects were so the front face of the panels was painted with several layers of white polyurethane paint and a reference grid was applied.

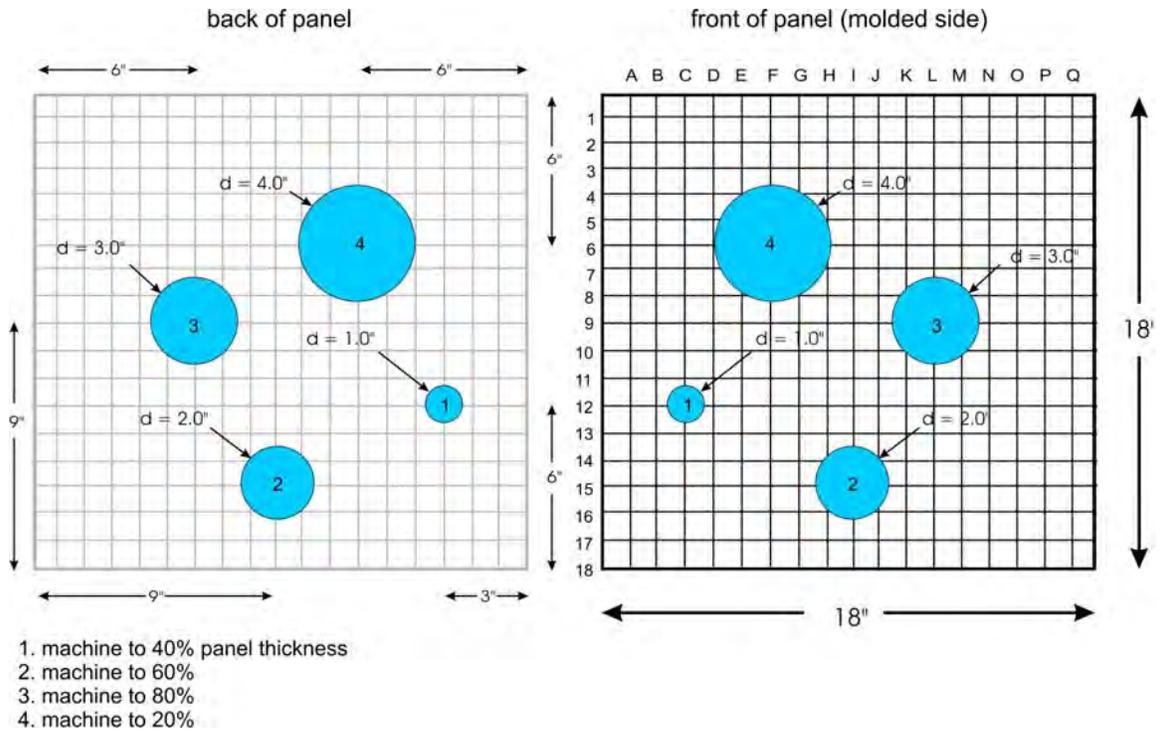
Figure 78. Void simulation cavity machining diagram for Pearson 5 test panel

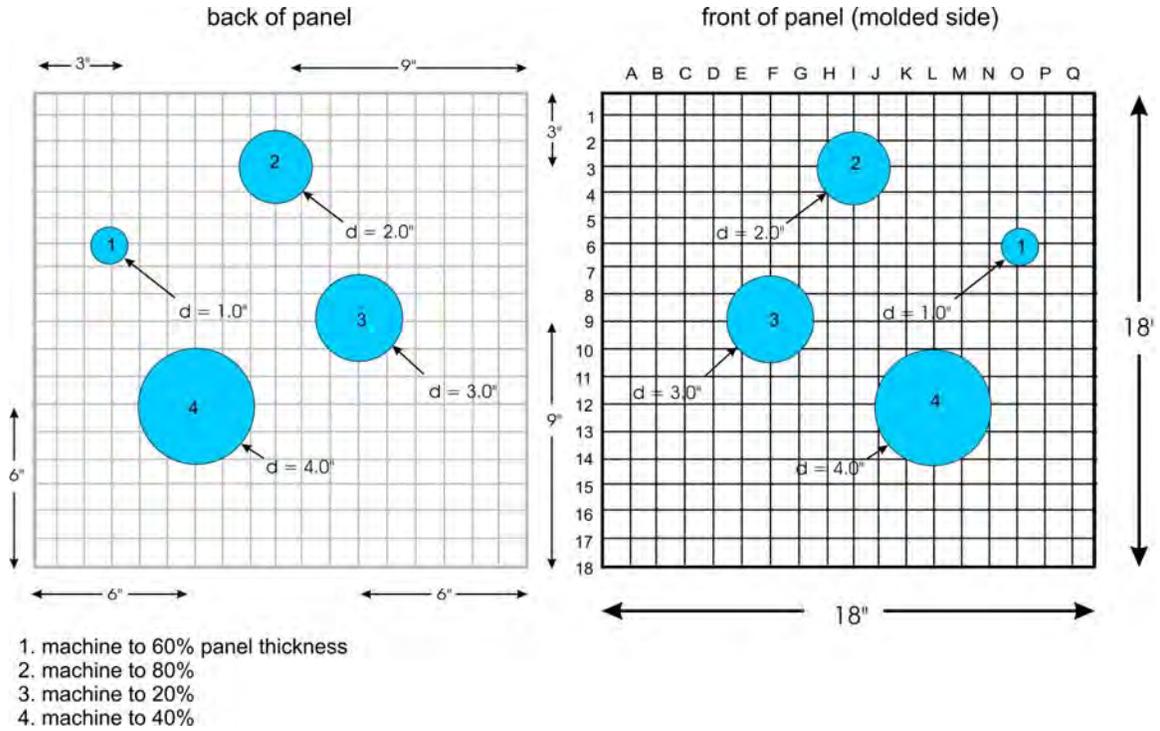
Figure 79. Void simulation cavity machining diagram for Pearson 6 test panel

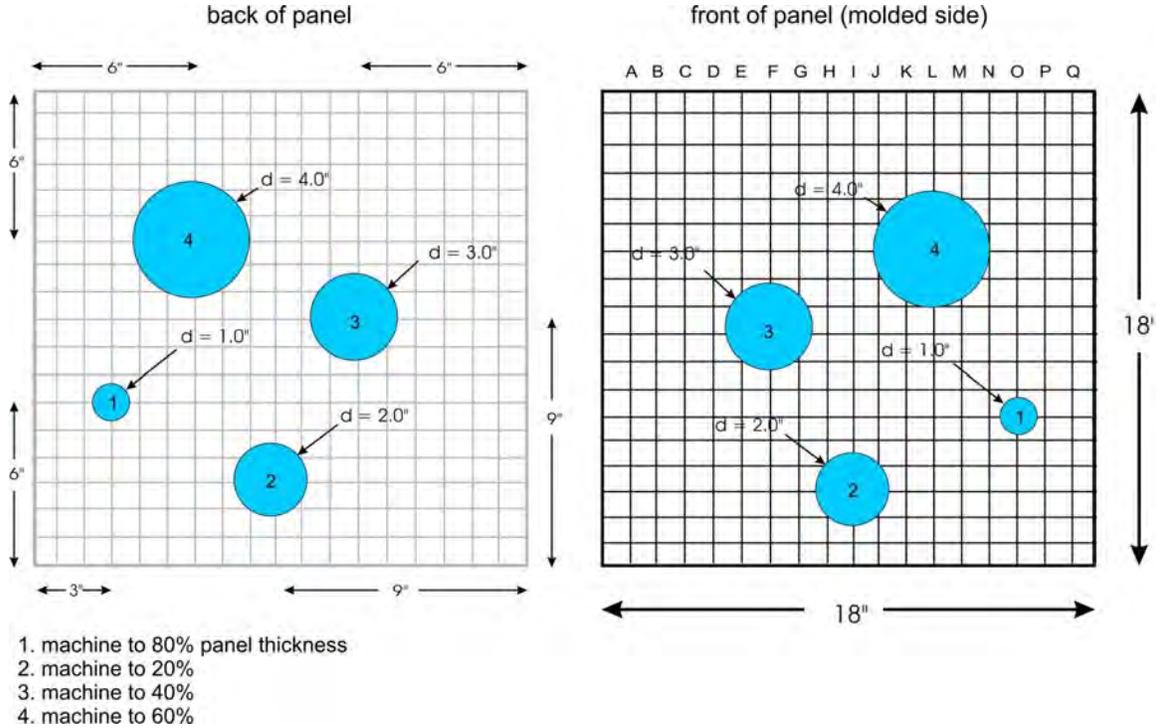
Figure 80. Void simulation cavity machining diagram for Pearson 7 test panel

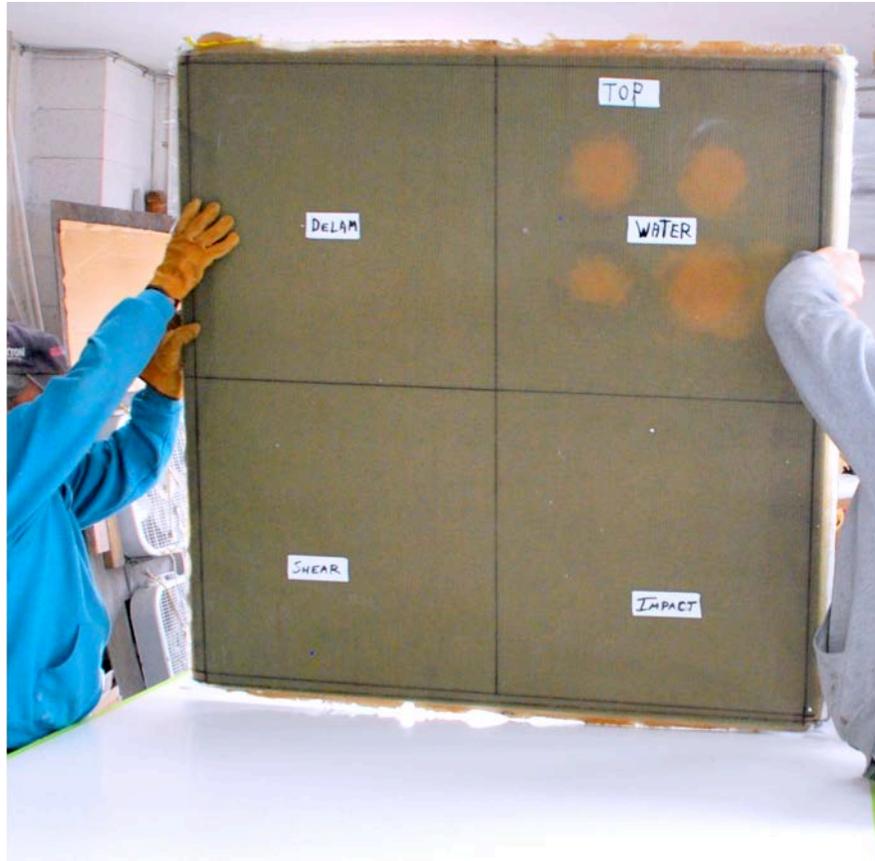
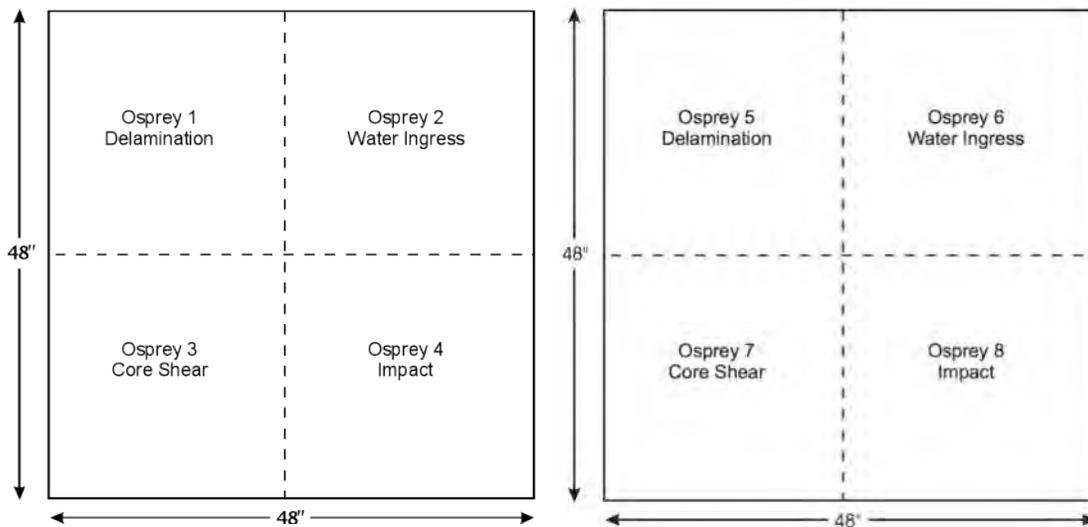
**Figure 86. Layout of E-glass @ 3.29 lbs/ft<sup>2</sup> test panel (left) and carbon fiber panel @ 2.16 lbs/ft<sup>2</sup> (right). Note in photograph that the area where water ingress was simulated is clearly visible before being covered.**

Figure 86 shows how four panels were cut from each of the four-foot by four-foot laminated panels. Figure 87 shows how peel ply material was placed strategically in the laminate to simulate delaminations. Figure 90 shows the cut peel ply material. This was done for panels Osprey 1 and Osprey 5. Mylar material was considered to simulate delamination but this material has shown to have a distinct ultrasonic signature, which may easier to detect than an actual delamination or kissing bond.

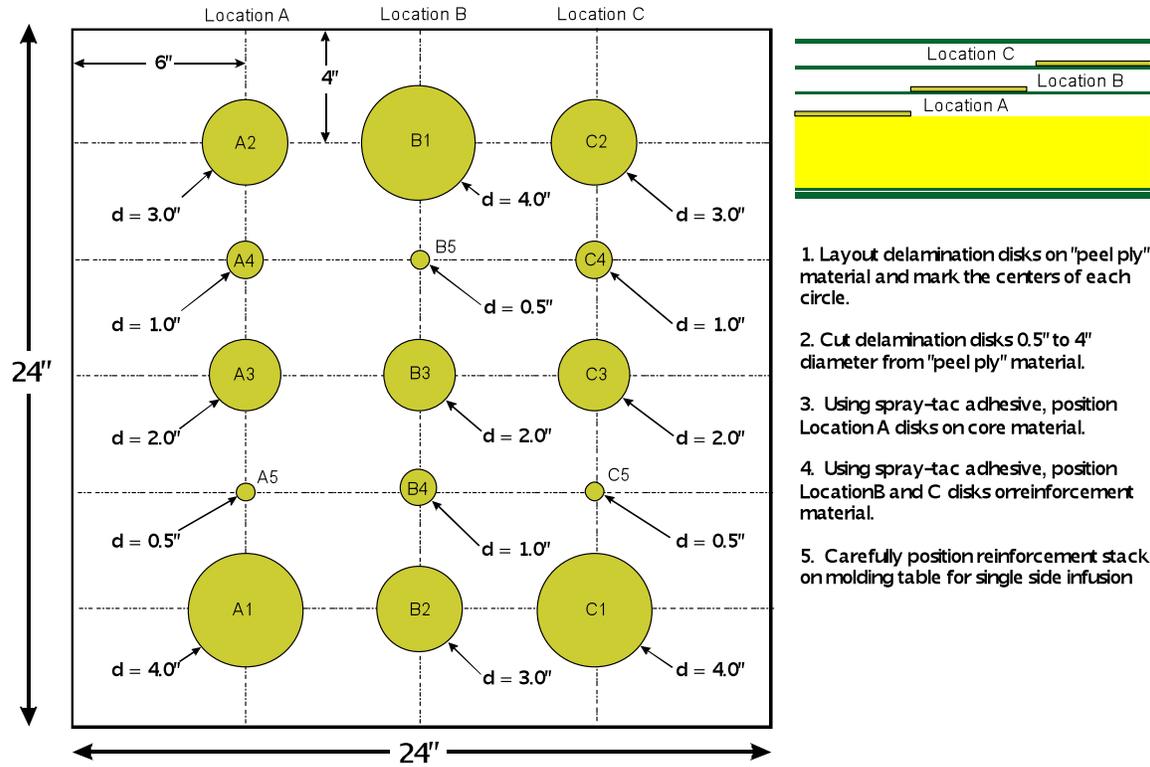
Figure 87. Test panel delamination arrangement

1. Layout delamination disks on "peel ply" material and mark the centers of each circle.
2. Cut delamination disks 0.5" to 4" diameter from "peel ply" material.
3. Using spray-tac adhesive, position Location A disks on core material.
4. Using spray-tac adhesive, position Location B and C disks on reinforcement material.
5. Carefully position reinforcement stack on molding table for single side infusion

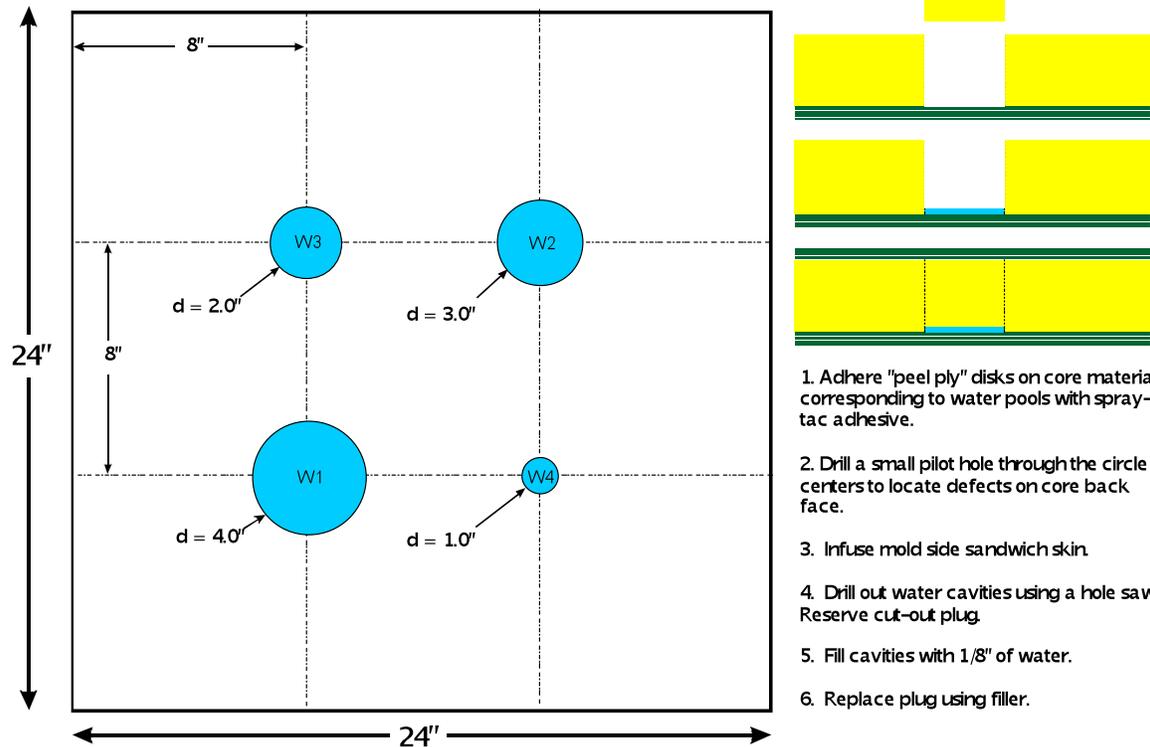
Figure 88. Test panel water ingress arrangement

1. Adhere "peel ply" disks on core material corresponding to water pools with spray-tac adhesive.
2. Drill a small pilot hole through the circle centers to locate defects on core back face.
3. Infuse mold side sandwich skin.
4. Drill out water cavities using a hole saw Reserve cut-out plug.
5. Fill cavities with 1/8" of water.
6. Replace plug using filler.

Figure 88 shows the locations and fabrication schematic for simulating water trapped under the outer skin of a hull laminate. After the outer skin was laminated to the core, a hole-saw was used to cut one to four inch diameter cavities (see Figure 91), where about ¼ inches of water was poured. The core plug was then replaced using bonding putty to ensure watertight integrity.

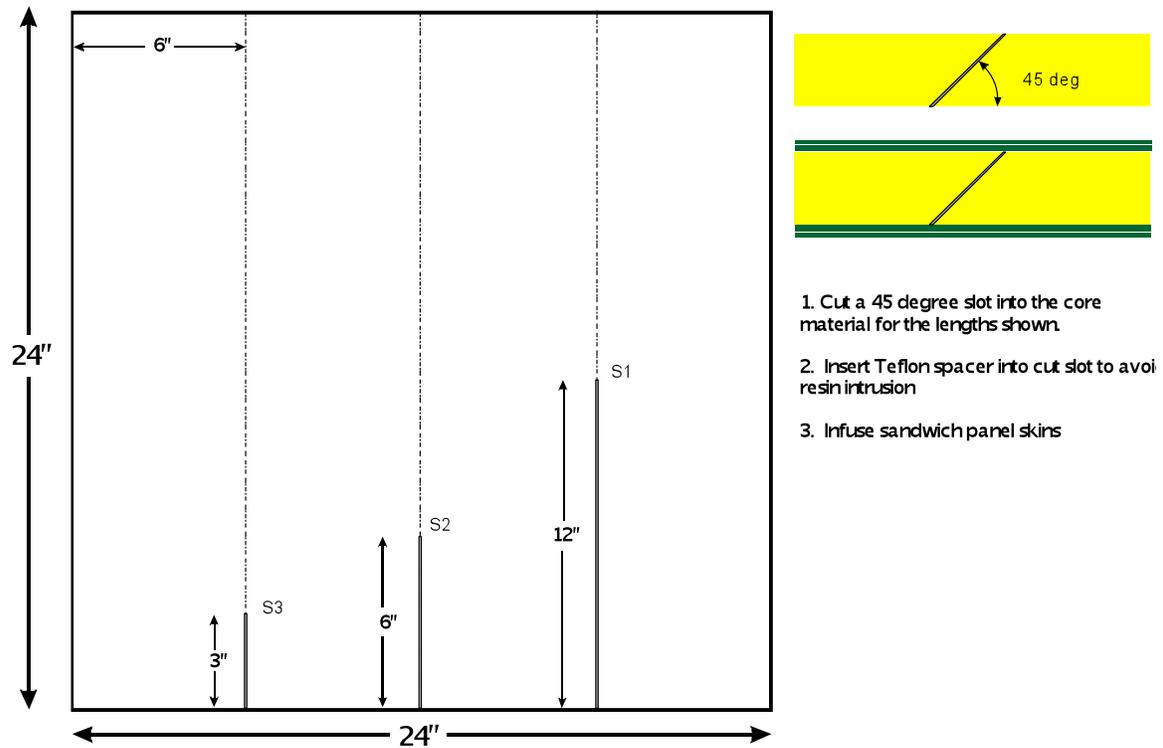
Figure 89. Test panel shear defect arrangement

Many of the panels that were subjected to impact loads incurred some degree of core shear damage. However, we don't have a priori knowledge of the damage location sites and severity before NDE inspection. Therefore, core shear was simulated by cutting the core prior to panel fabrication, as shown in Figure 89. It was not feasible to cut the balsa core cleanly at 45° so peel ply was placed along the kerf cuts at 90° to the skins.

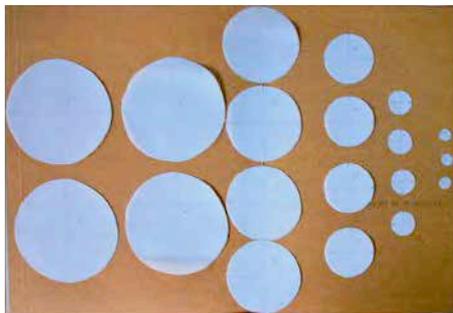
Peel ply 0.5, 1, 2, 3, and 4 inches diameter used to simulate delamination

Figure 90. Test panel construction

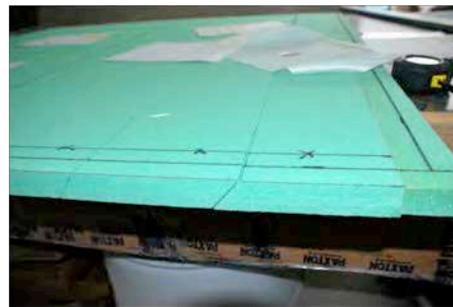
45° saw cuts (3, 6 and 12 inches long) in core used to simulate core shear failure

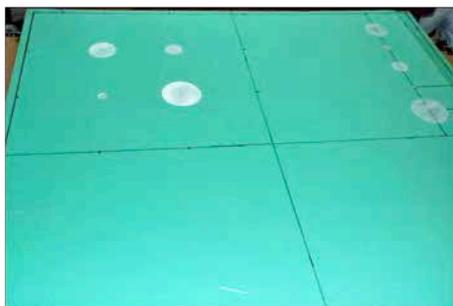
Peel ply used to create water void (left) and for delamination (right)

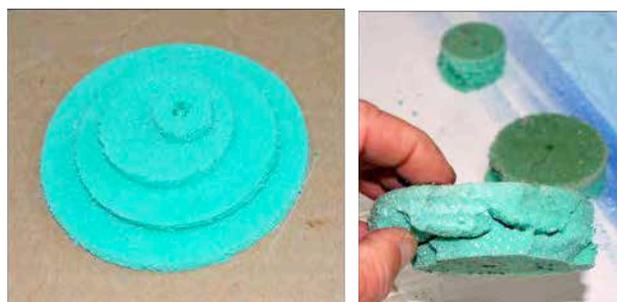
Removed core (left) and replacement plugs (right) used to entrap water behind skin

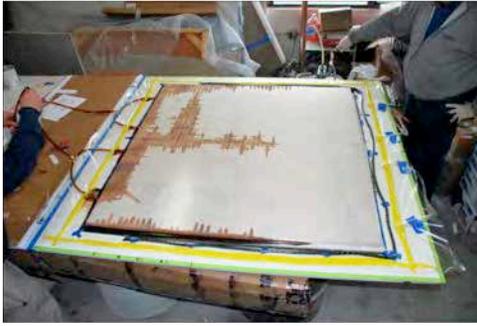
Beginning of infusion process used to wet-out the outer skin

**Figure 91. Test panel construction (continued)**

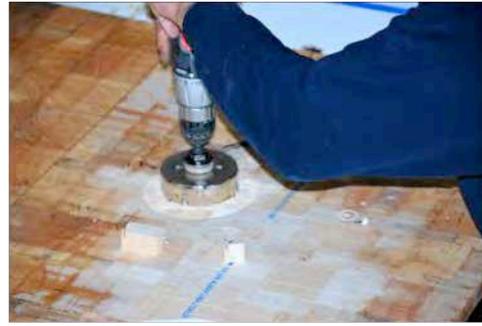
Hole saw is used to create a 1/8 inch deep void for water to be encapsulated

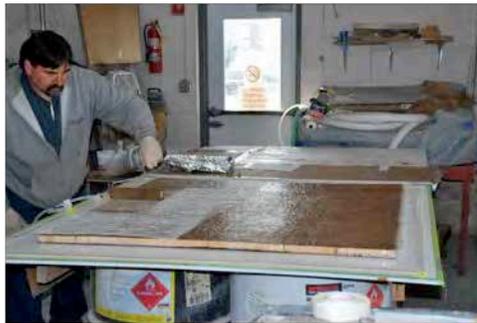
Inner skin is laminated by hand

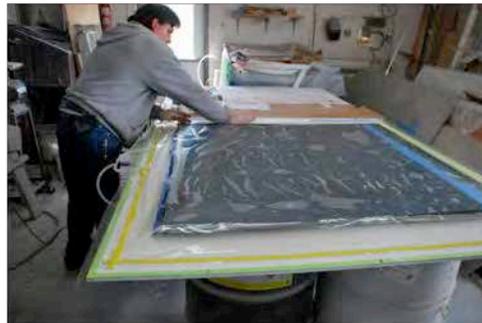
Vacuum bag is used to consolidate hand-laminated inner skin

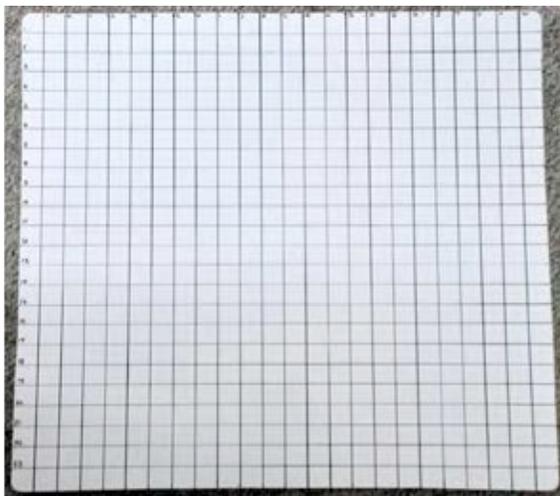
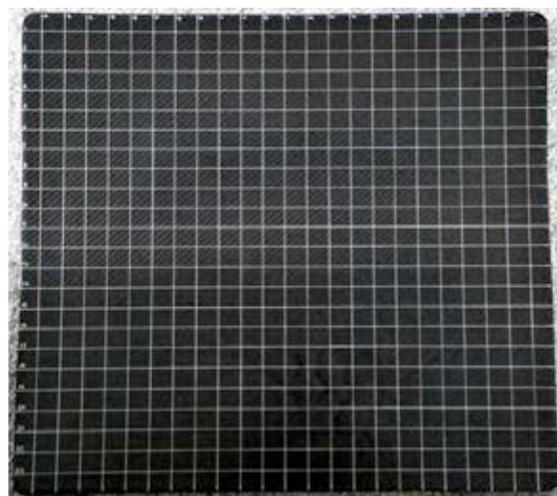
**Figure 92. E-glass panel (left) and carbon panel (right) with 1-inch grid drawn on outer skin to serve as reference for damage location identification.**

Figure 91 shows the one-inch reference grid that was drawn on the E-glass and carbon fiber test panels built by Osprey Marine.

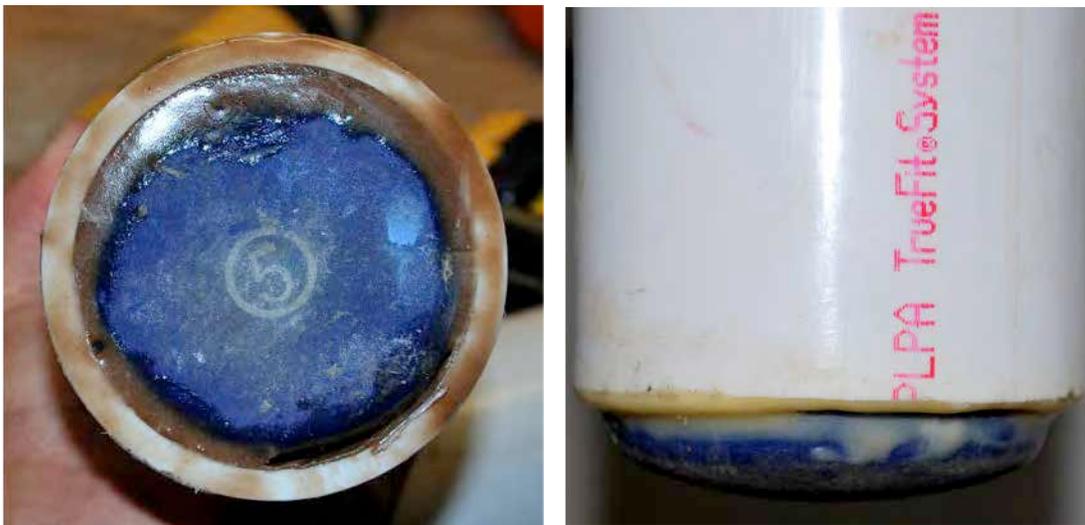
**Figure 93. Rubber coated barbell is epoxied into PVC tube to form impactor**

Based on studies reported earlier in this section, an impact test apparatus was designed that could deliver impact energies up to about 250 foot-pounds. Previous investigations [Hildebrand 1996] have shown that the shape of the impactor tip greatly influences the resulting surface damage. Since our goal was to avoid visible damage, an oval shaped impactor head was used. A rubber coated barbell weight was epoxied into a PVC tube to create the desired impactor, as shown in Figure 93.

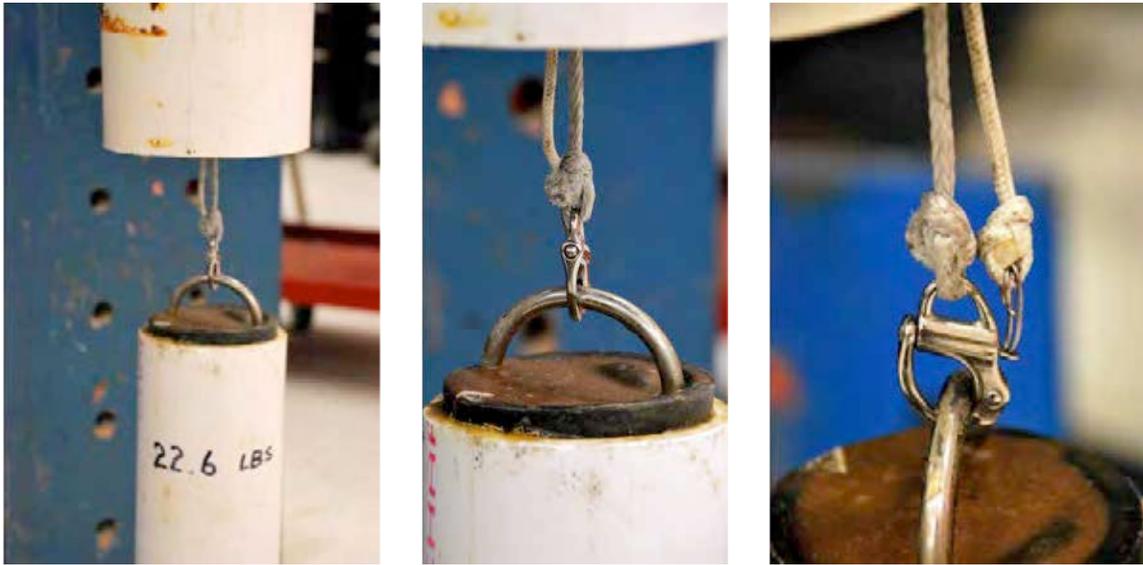
Figure 94. Detail of impactor release mechanism

The impactor delivery tube was made from a larger diameter PVC tube that accommodated a maximum drop height of 12 feet. The impactor was held in place by a halyard and snap shackle, as shown in Figure 94. Once the impactor was raised to the desired height, a separate lanyard was used to allow the weight to freefall. The impactor was allowed to completely exit the delivery tube, so secondary impacts were not direct hits on the target area. The delivery tube made it possible to accurately focus the impact event over a precise location on the grid pattern drawn on the surface of the test panels. Figure 95 shows the impact tester attached to the reaction frame in the Naval Academy’s Structures Laboratory. Note the added ceiling clearance in way of the tester that made it possible to accommodate a twelve foot drop height.

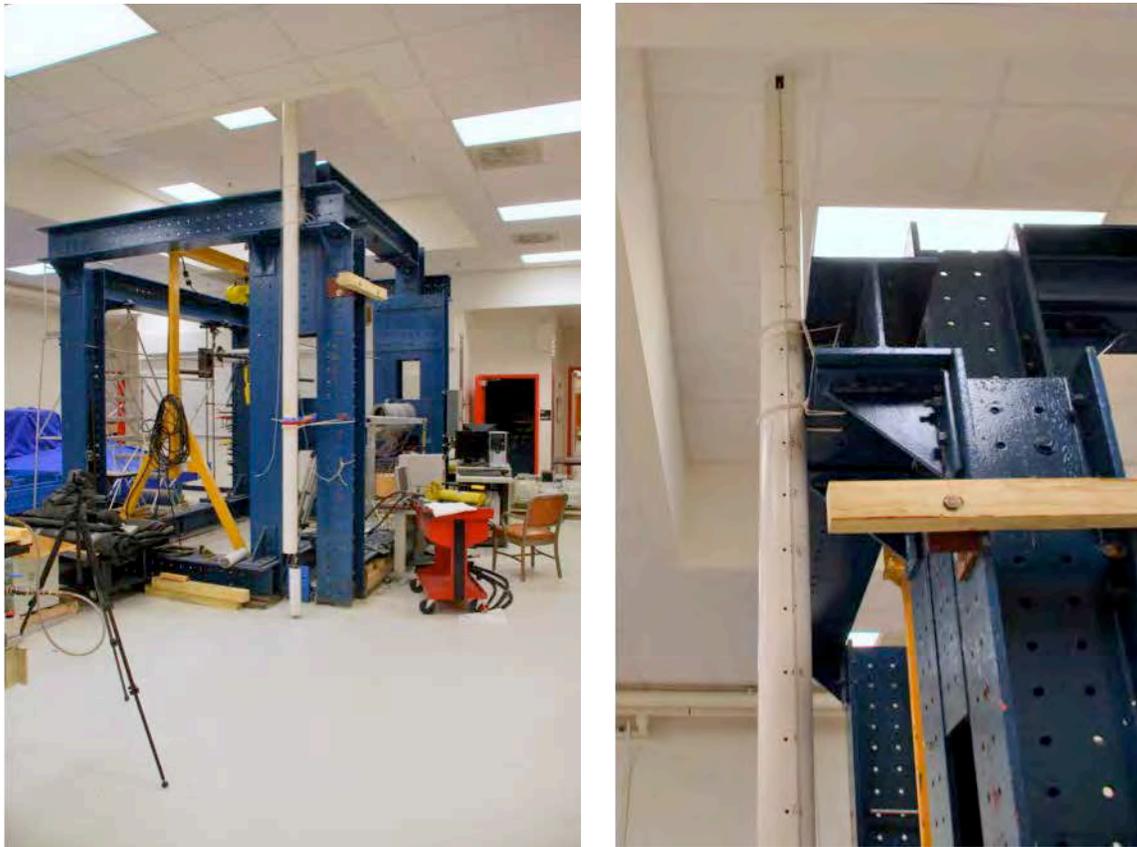
Figure 95. Impact tester at the US Naval Academy Structures Laboratory

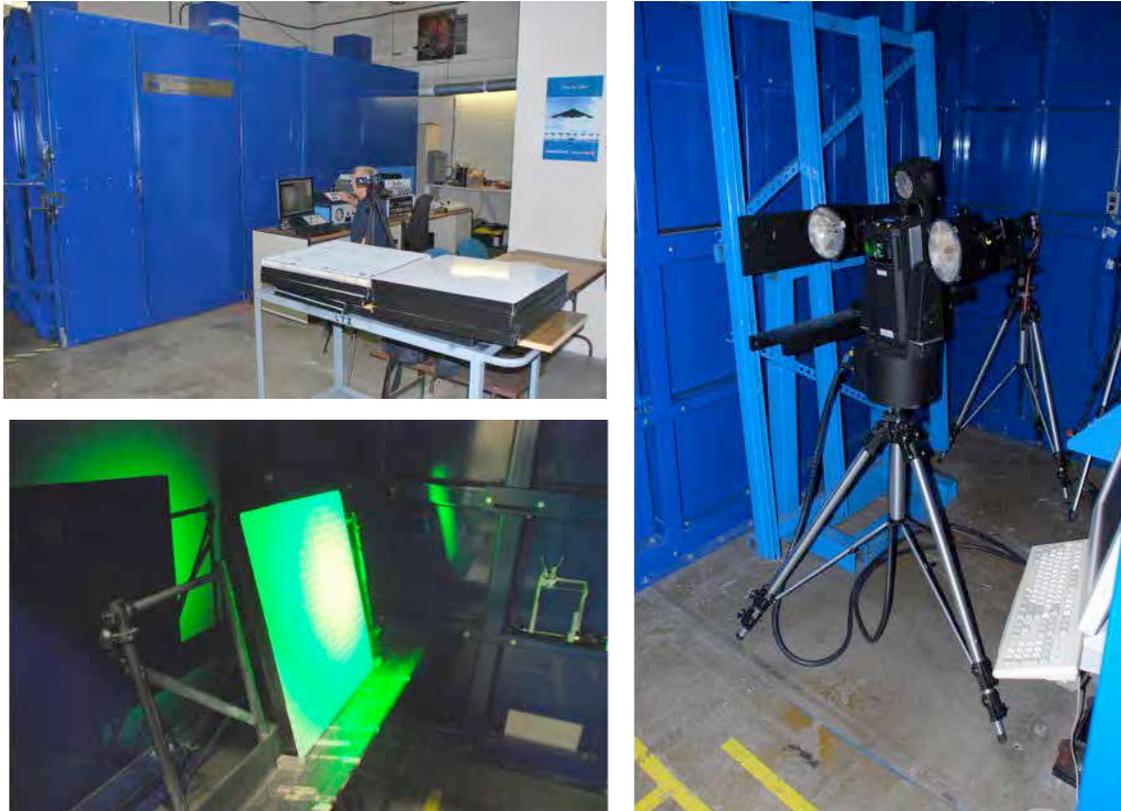
**Figure 96. Vacuum chamber used to stress parts of various geometries (upper left); test panel with laser shearography optics focused on the surface (lower left); and laser shearography camera (right) [author photos]**

Panels were examined using laser shearography on September 8, 2011 at Laser Technology, Inc. The testing was conducted in their vacuum chamber, as shown in Figure 96. The panels were stressed either by vacuum or with heat lamps. All of the equipment was remotely operated (including positioning) from outside of the chamber.

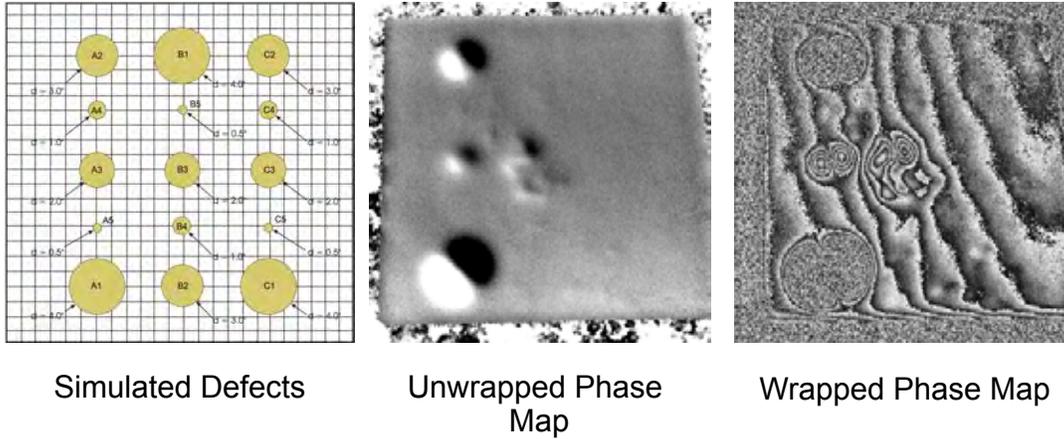
Figure 97. Panel "Osprey 1" with simulated delaminations and shearograms

Figure 97 through 105 illustrate the defects in the evaluated test panels and the results of the laser shearography evaluation effort. Shearography proved to be a very effective NDE tool for marine composite construction, except with panels built using clear gel coat that required the application of a coating to restrict the laser light from transmitting through the laminate.

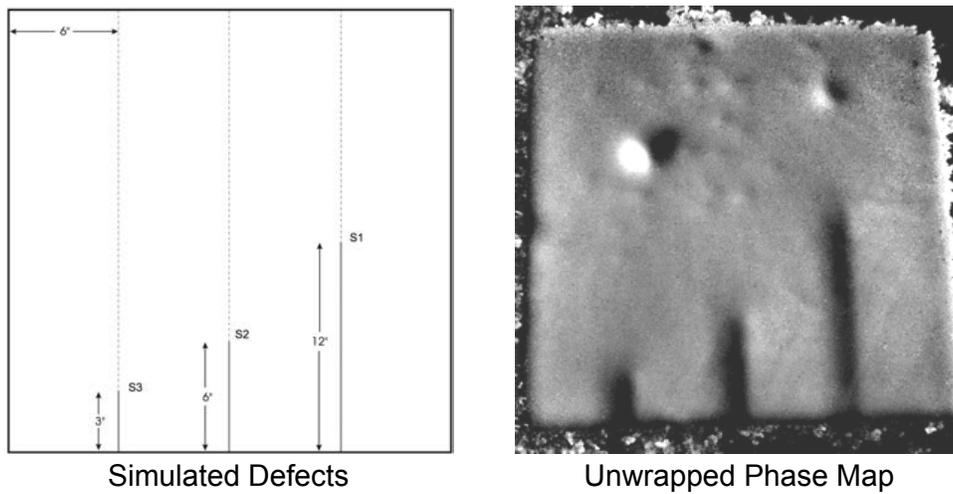
Figure 98. Panel "Osprey 3" with simulated core shear and shearograms

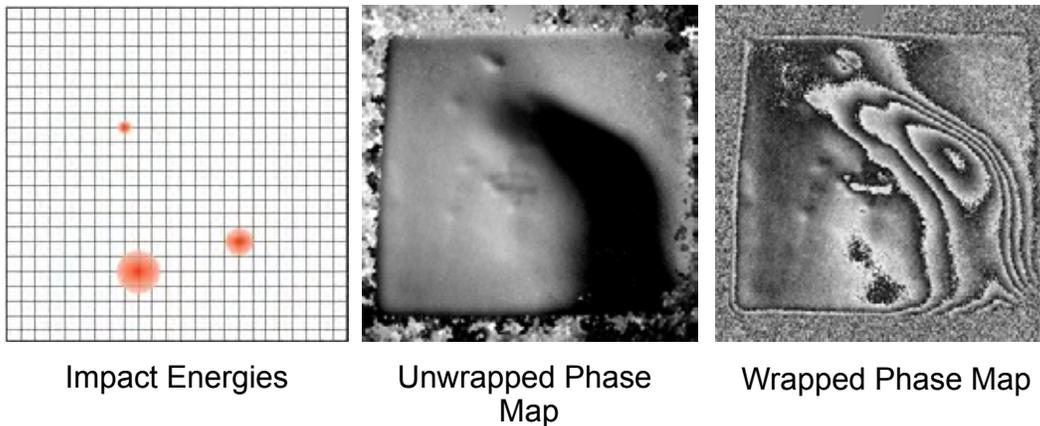
Figure 99. Panel "Osprey 4" with induced impact damage and shearograms

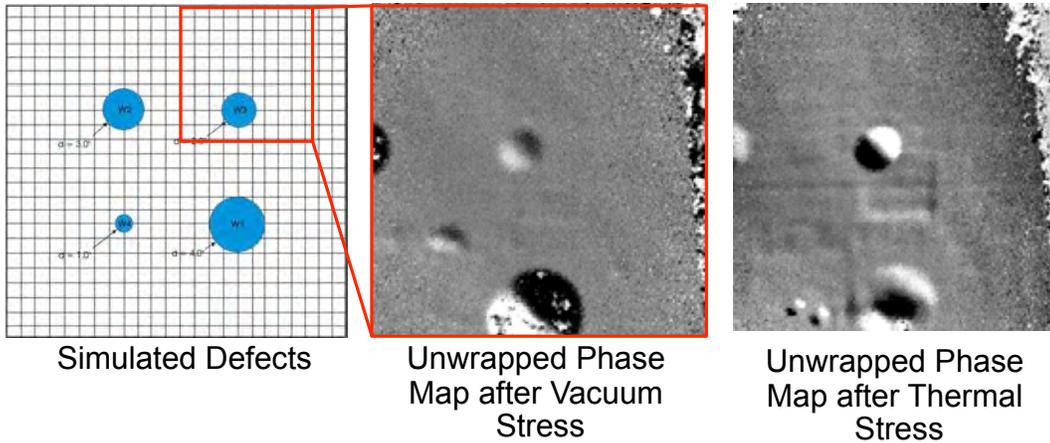
Figure 100. Panel “Osprey 6” with simulated water ingress and shearograms

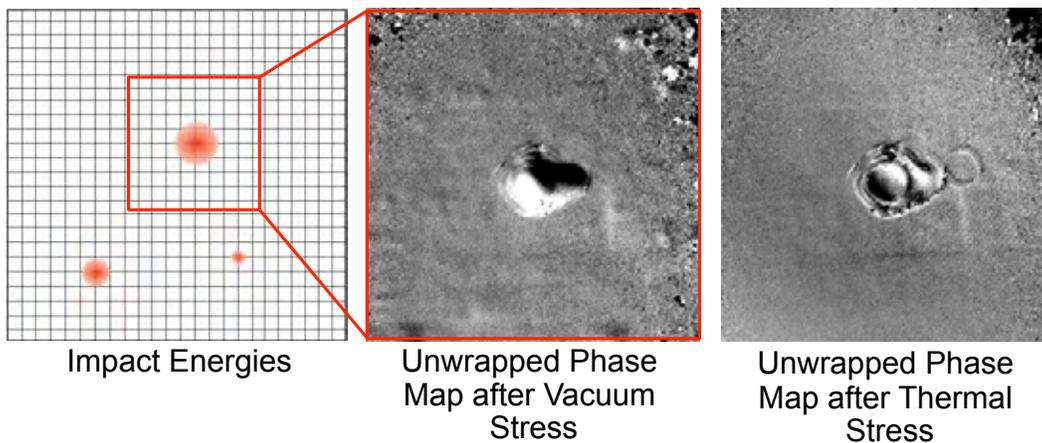
Figure 101. Panel “Osprey 8” with induced impact damage and shearograms

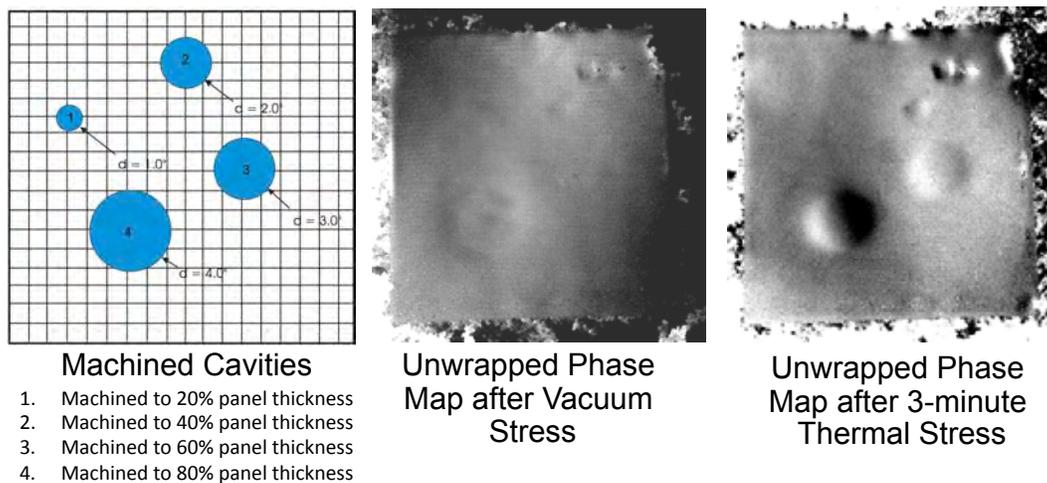
Figure 102. Panel “Pearson 4” with machined back-face cavities and shearograms

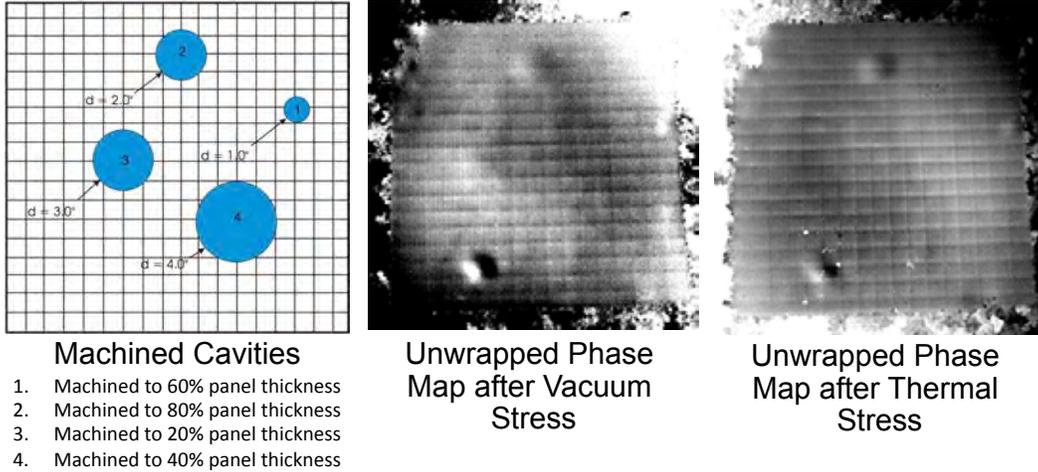
Figure 103. Panel “Pearson 6” with machined back-face cavities and shearograms
