**SSC-463**

**INSPECTION TECHNIQUES FOR  
MARINE COMPOSITE  
CONSTRUCTION AND NDE**

**SHIP STRUCTURE COMMITTEE**  
**2012**

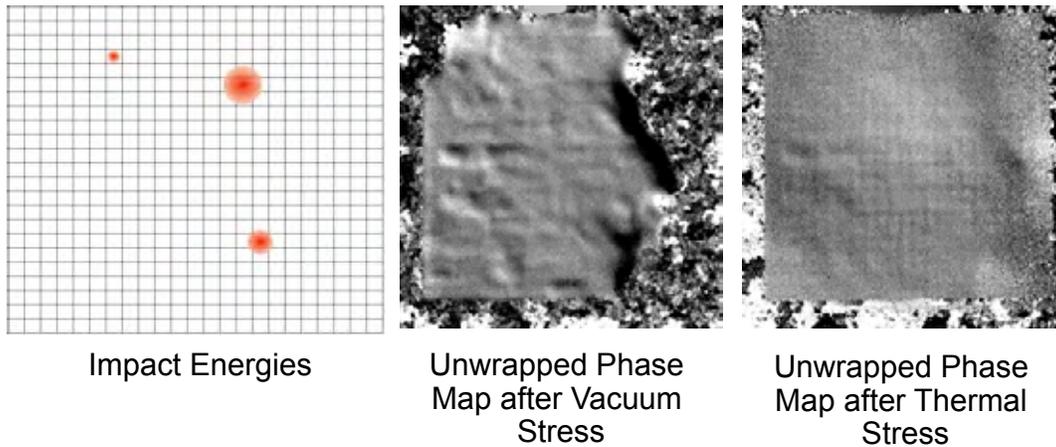
Figure 104. Panel “USNA 3” with induced impact damage and shearograms

Figure 97 through 105 illustrate the defects in the evaluated test panels and the results of the laser shearography evaluation effort. Shearography proved to be a very effective NDE tool for marine composite construction, except with panels built using clear gel coat that required the application of a coating to restrict the laser light from transmitting through the laminate.

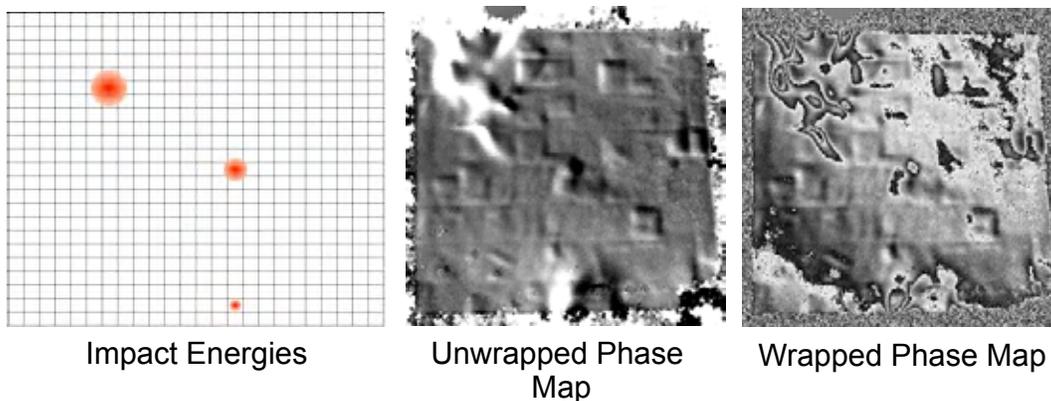
Figure 105. Panel “USNA 10” with induced impact damage and shearograms

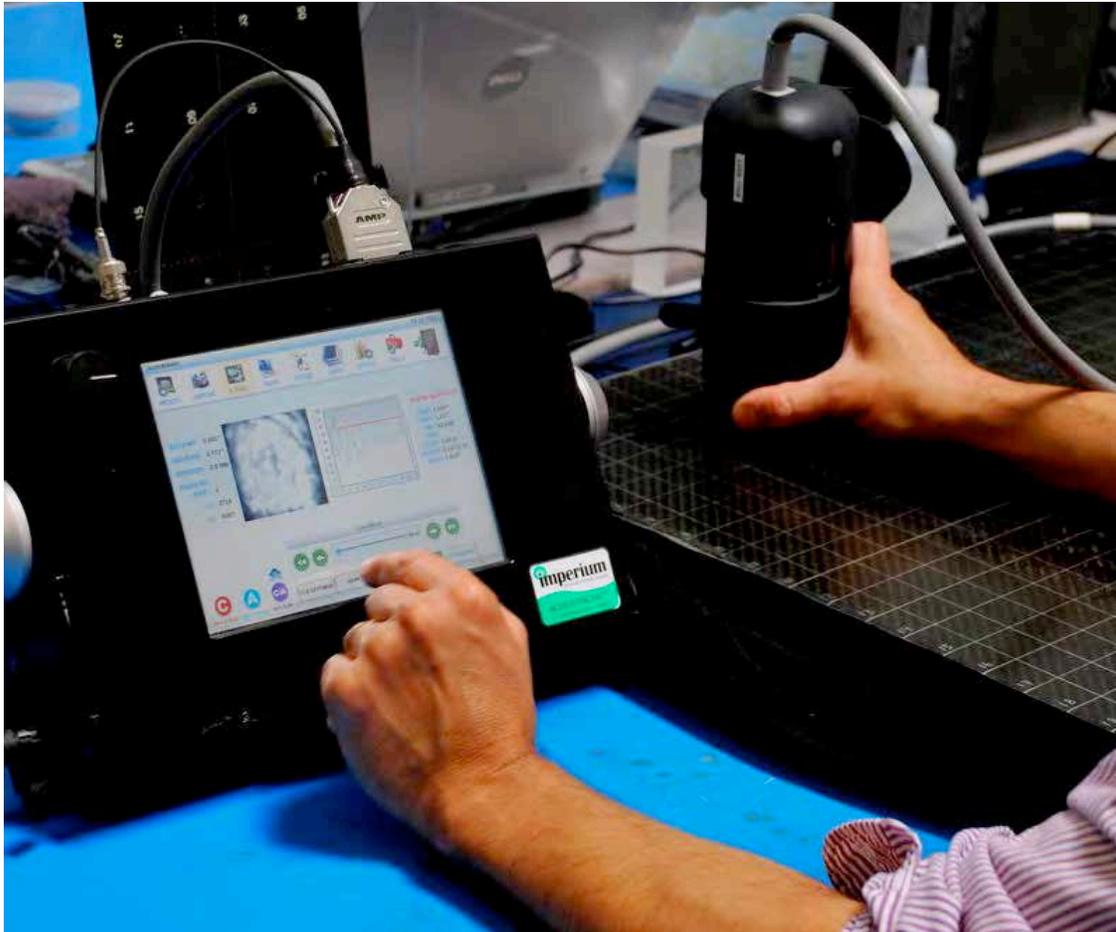
Four test panels were evaluated on September 13, 2011 at Imperium, Inc. using their i600 Acoustocam PE portable ultrasonic NDE equipment based on digital acoustic video camera technology. The i600 uses a patented Application Specific Integrated Circuit (“ASIC”) called DAV. This chip is an imaging array for ultrasound similar to the approach used for conventional digital cam recorders. The Acoustocam is designed for non-specialized users featuring a touch-screen graphical user interface that operates on top of Microsoft Windows<sup>®</sup> XP. Figure 106 shows the Acoustocam equipment being used to evaluate

**Figure 106. Acoustocam i600 used to inspect a project carbon fiber panel with simulated delaminations [author photo]**

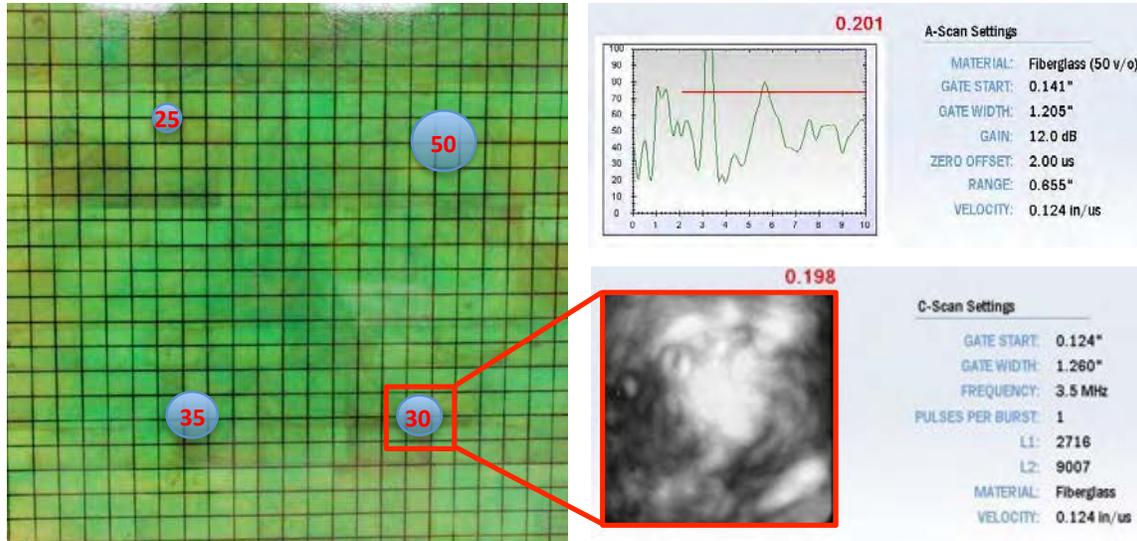
Figures 107 through 109 show saved A-scan and C-scan images for the defects shown in the figures.

Figure 107. Impact energies on E-glass laminate (left) and corresponding ultrasonic NDE data (right) [data courtesy of Imperium, Inc.]

In general, UT was not shown to be an effective method for surveying large areas of marine composite construction but was effective to quantify the extent and depth of defects at known damage sites.

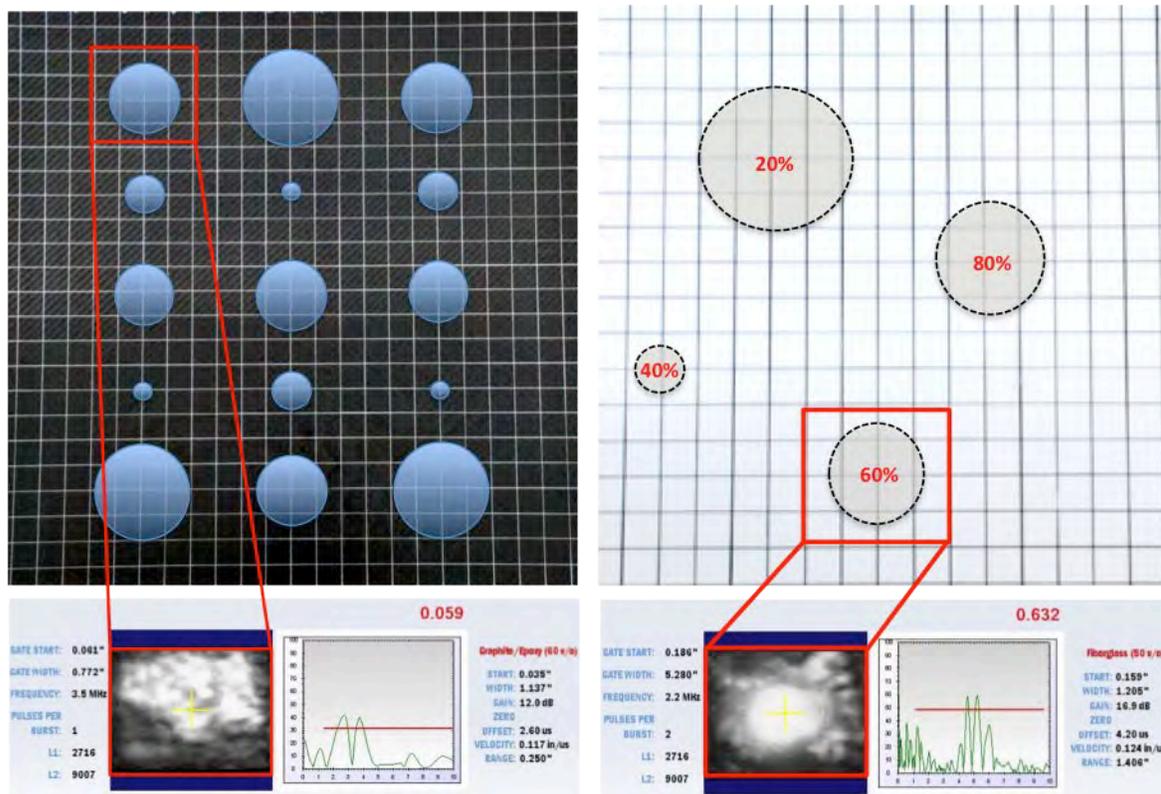
Figure 108. Simulated delamination damage (top) and corresponding ultrasonic NDE data (bottom) [data courtesy of Imperium, Inc.]

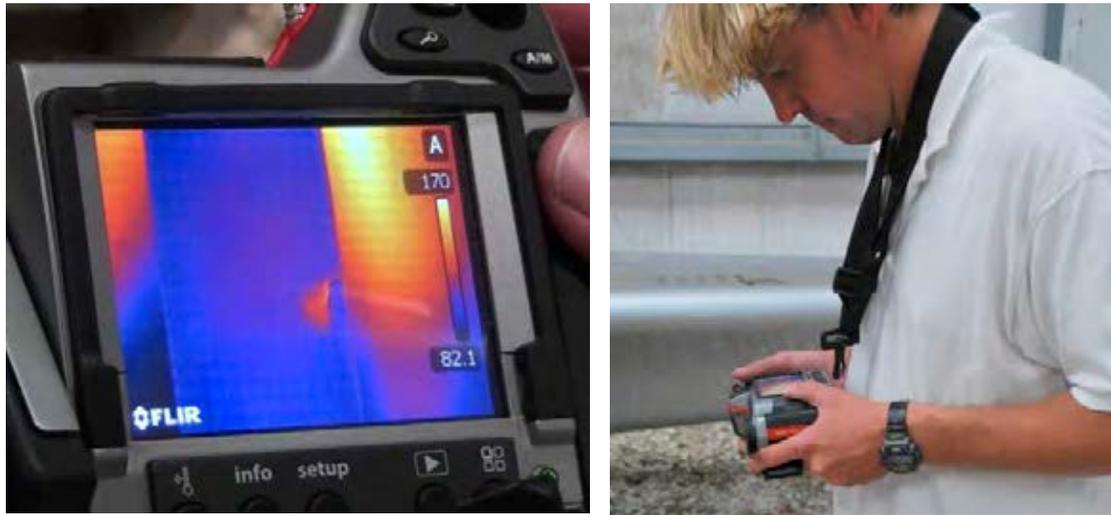
Fourteen test panels were examined using infrared thermography by Mark Ashton of Independent Marine Systems on September 26, 2011. The inspection took place in a storage shed at the New England Boatworks facility in Portsmouth, RI to ensure a uniform ambient temperature and minimize reflected light on the panels. The panels were uniformly heated and analyzed with an FLIR T300 infrared camera, as shown in Figure 110.

**Figure 110. Mark Ashton is shown capturing (left) and analyzing the IR image (right) [author photos]**

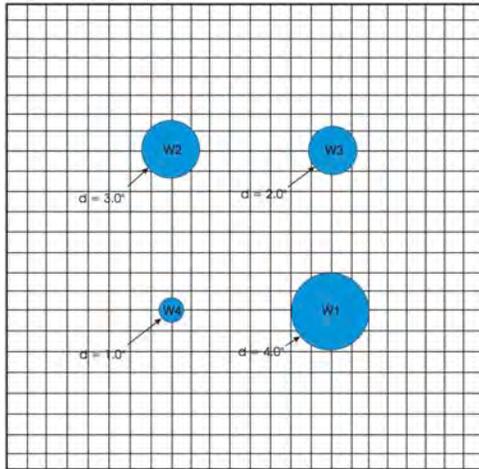
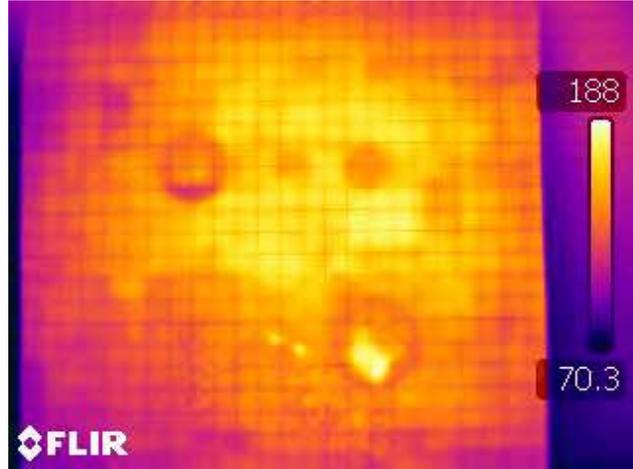
Simulated Defects

Thermogram

Figure 111. Panel “Osprey 6” with simulated water ingress and thermogram

Figures 111 through 114 show photographs and diagrams of damaged panels and the resulting infrared thermograms from Independent Marine Systems. The heat was applied to the panels in a uniform manner but over varying timeframes to achieve optimal thermal response. The edges of the panels are not representative of most marine composite structures and therefore produced some anomalies in the IR data.

Figure 111 shows that moisture ingress was easily detected using infrared thermography. All of the water pockets embedded in the core showed up in the thermogram. Figure 112 illustrates that IR NDE was also very effective for finding delaminations in thick laminates, even over  $\frac{3}{4}$  of an inch below the surface. Figure 113 and 114 showed that IR can be an effective tool to determine the extent of impact damage when the surface has been punctured. We did not have as much success finding internal impact damage when there was no visible surface damage. IR NDE also had a difficult time finding “kissing bonds,” which were simulated in Osprey panels 1 and 5 by placing peel ply in the laminate stack.

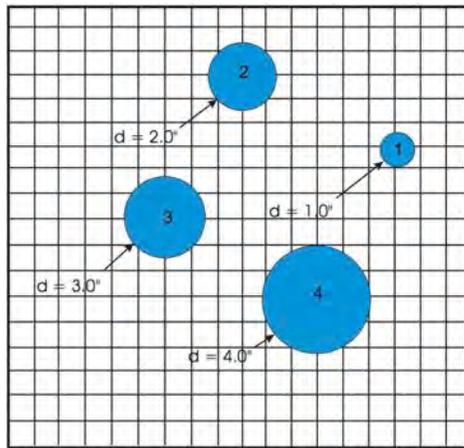
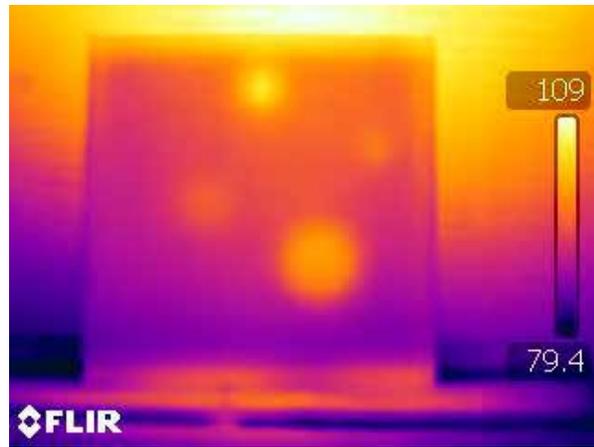
Machined Cavities

Thermogram

1. Machined to 60% panel thickness
2. Machined to 80% panel thickness
3. Machined to 20% panel thickness
4. Machined to 40% panel thickness

Figure 112. Panel “Pearson 6” with machined back-face cavities and thermogram

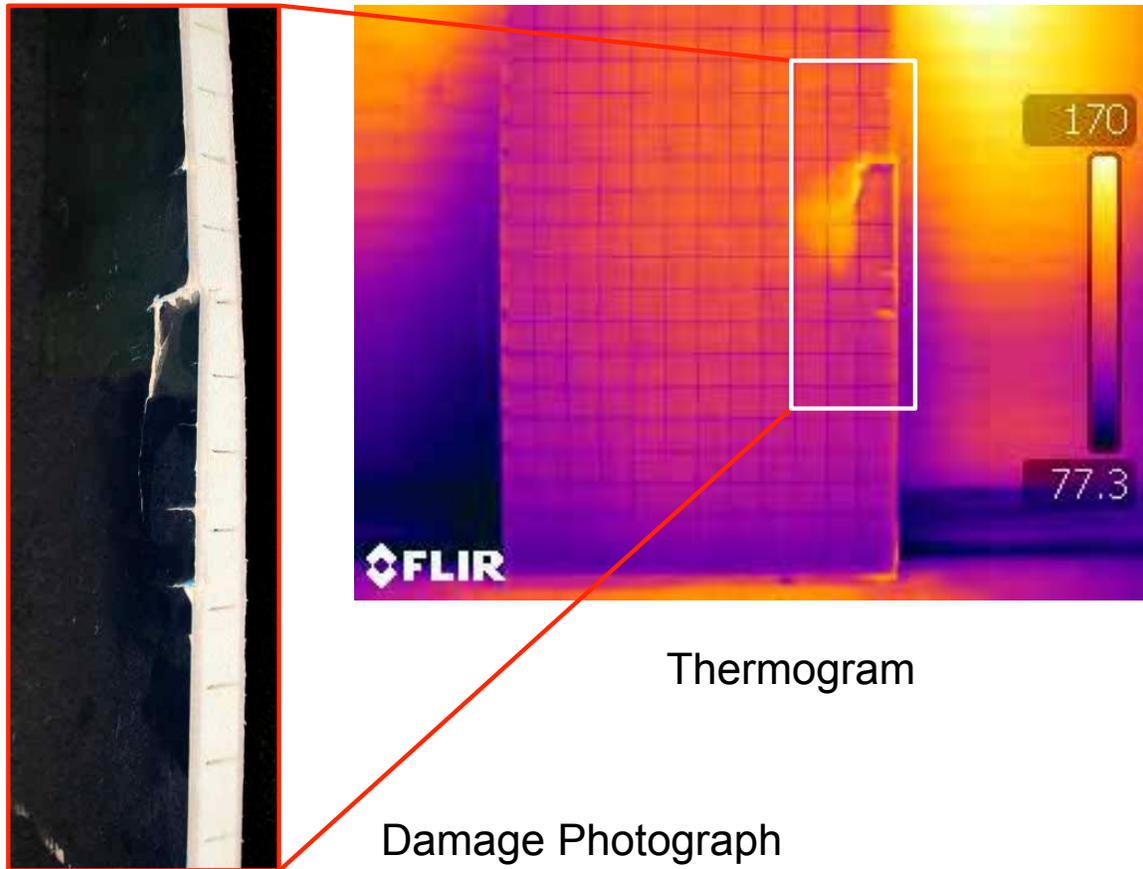
Figure 113. Panel "USNA 3" with impact damage and thermogram

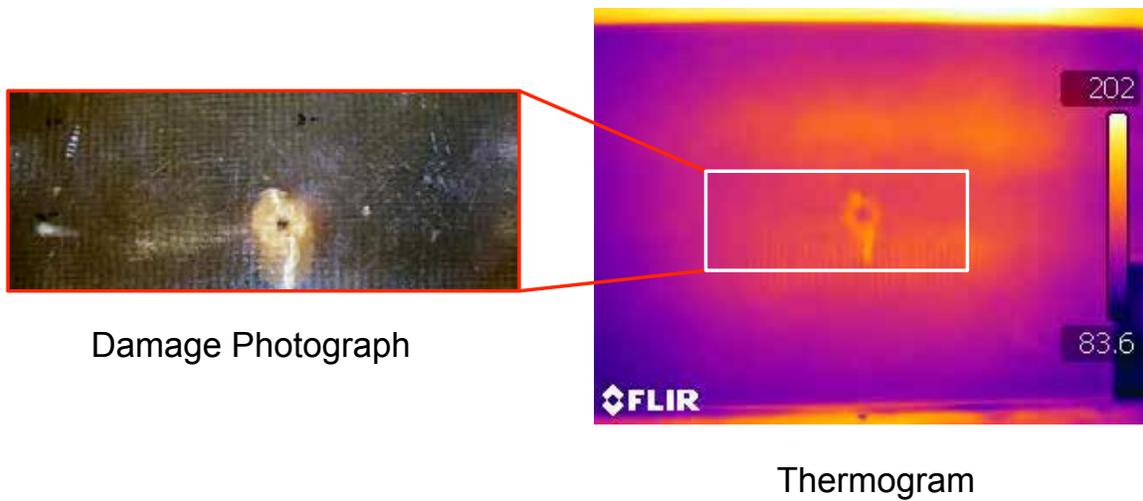
Figure 114. Panel "USNA 6" with impact damage and thermogram

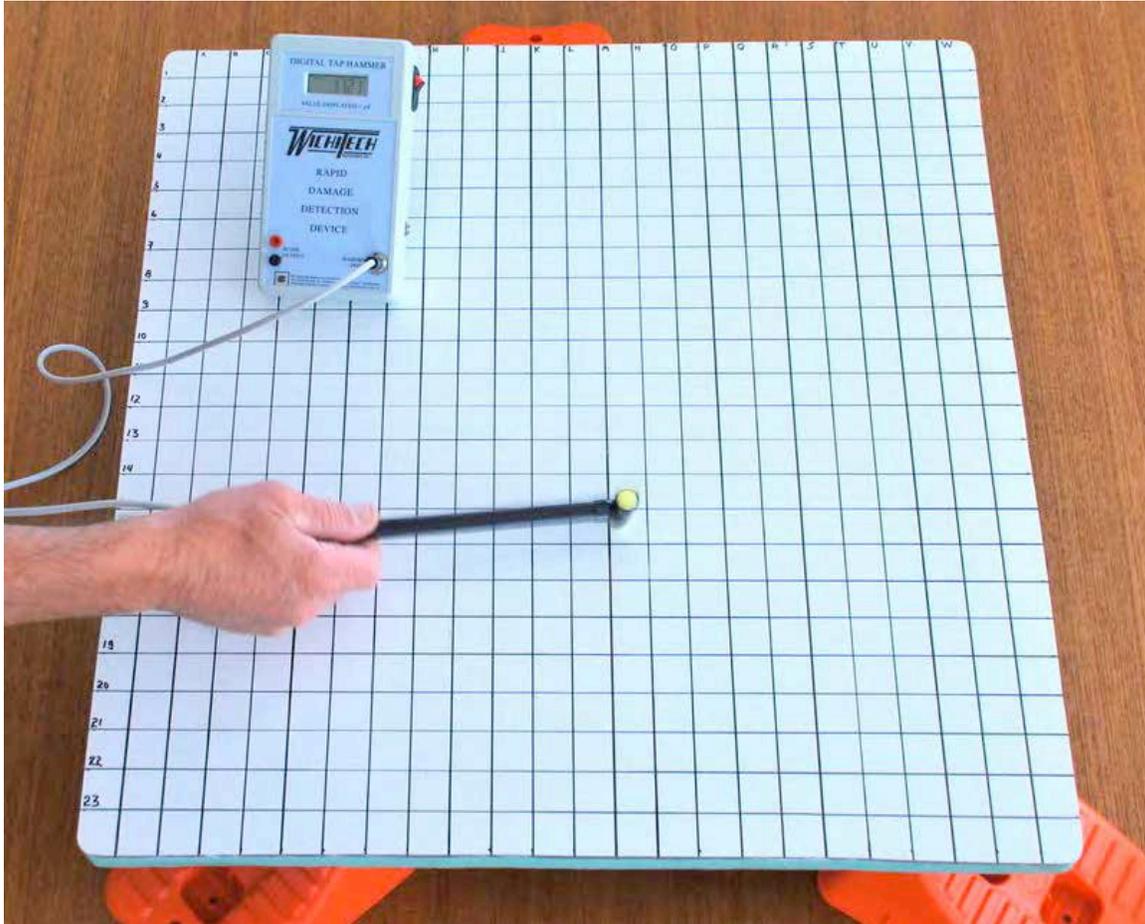
Figure xx shows the digital tap hammer being used to evaluate an Osprey E-glass panel. Note that the panels were supported by plastic stands at three points.

**Figure 115. Digital tap hammer being used to evaluate an Osprey E-glass panel [author photo]**

The results observed were similar to experience the author observed in the field. Namely, only delaminations of at least two by two inches are detectable with the device. The digital tap hammer is particularly effective for detecting skin to core separations in sandwich laminates and is certainly an improvement over conventional coin or hammer tapping methods.

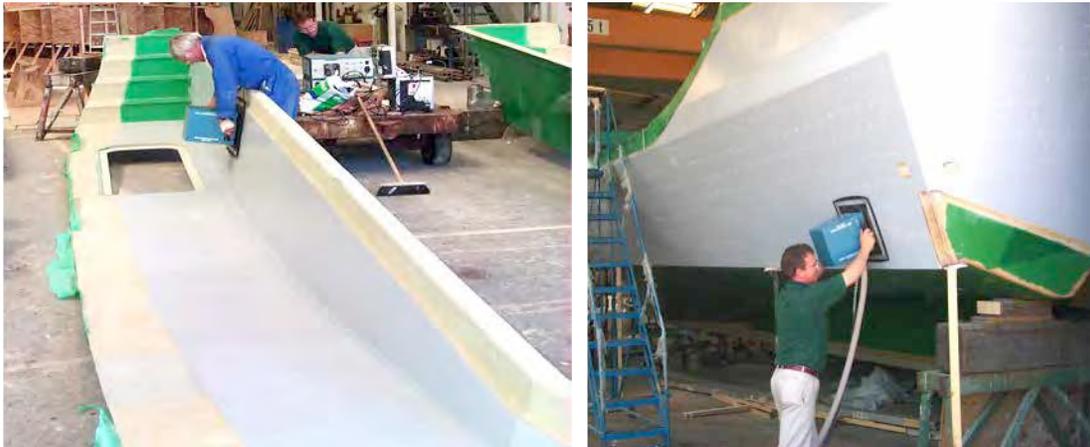
Where possible a vacuum hood is used to induce stress into the test surface, as shown in Figure 116. This is because the hood anchors firmly to the test surface and prevents de-correlation of the image caused by any movement of the test subject relative to the inspection head. A free-standing camera and stressing by heat is used on the smaller hulls and where the highly curved geometry limits the use of a vacuum hood.

**Figure 116. Vacuum hood used to test flat panel portions of RNLI lifeboat hulls [Laser Technology, Inc.]**

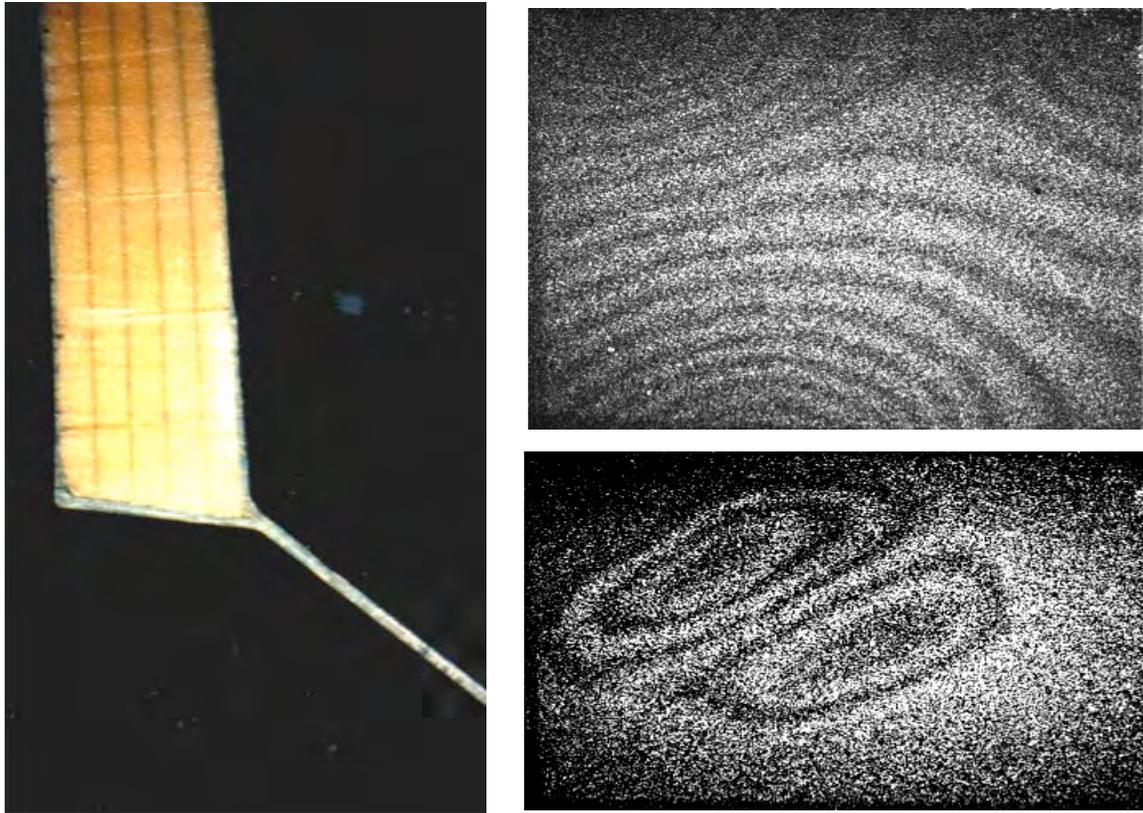
The builder of the RNLI Severn class lifeboat, Green Marine, has found that it is cost effective to find and repair faults immediately after joining of the hull sides before internal bulkheads and equipment are fitted. Figure 117 shows laser shearography

images for bonded and disbonded portions of the topside laminate, also shown in the figure. Figure 118 illustrates how NDE can be used as a Quality Assurance tool during fabrication.

**Figure 117.** RNLi Severn class topside hull section (left) along with bonded (top) and disbonded (bottom) shearography images [Laser Technology, Inc.]

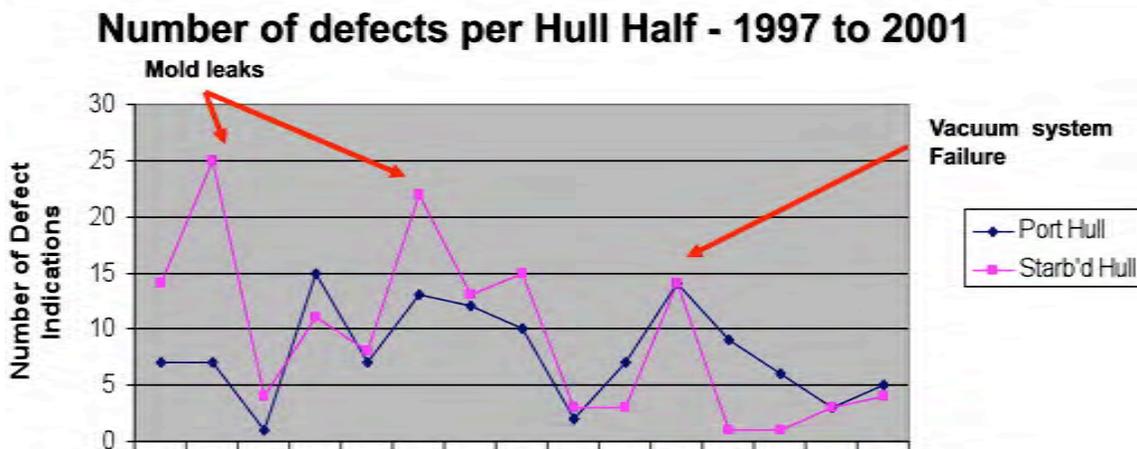
**Figure 118.** RNLi Severn class detected hull defects over time highlights systematic process failures during fabrication [Laser Technology, Inc.]

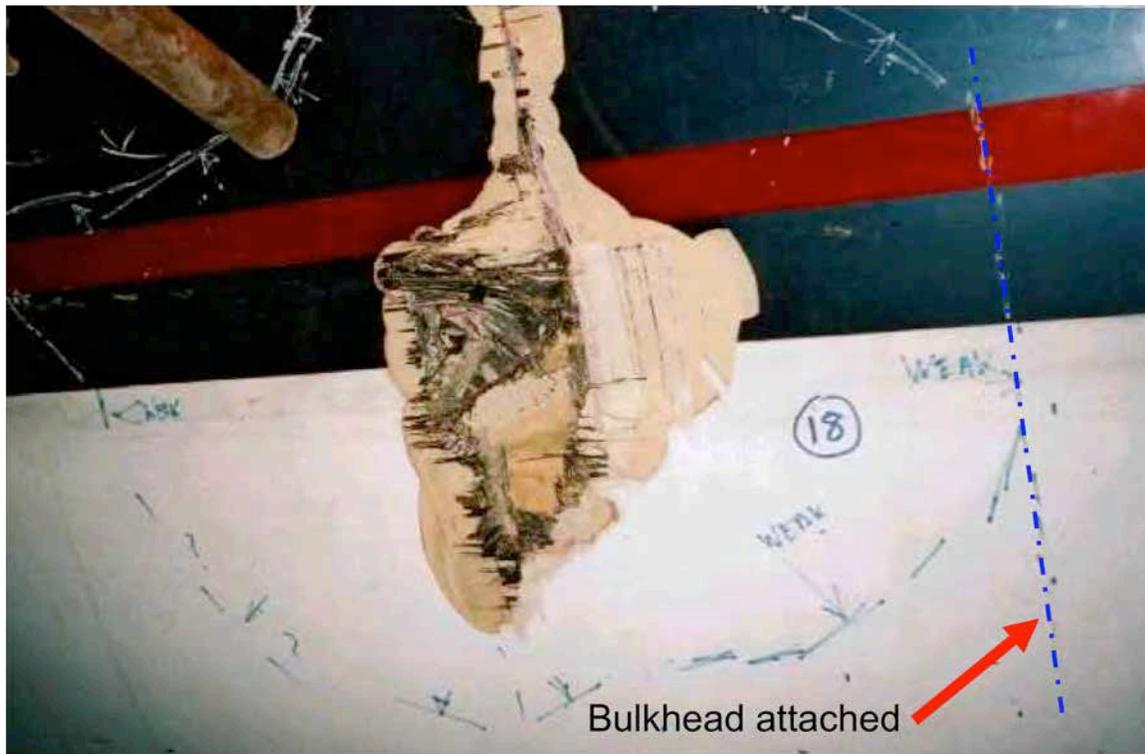
A maxi sailing yacht was severely damaged during a storm while being transported as deck cargo. Laser shearography was used to help determine the extent of damage in order to develop a repair plan. While there was clearly visible damage to the exterior of the sandwich hull laminate, shearography NDE revealed that the extent of damage was much greater than originally anticipated. Figure 119 shows the visible damage and the extent of damage discovered using shearography.

**Figure 119. Full extent of internal damage to hull sandwich construction [Laser Technology, Inc.]**

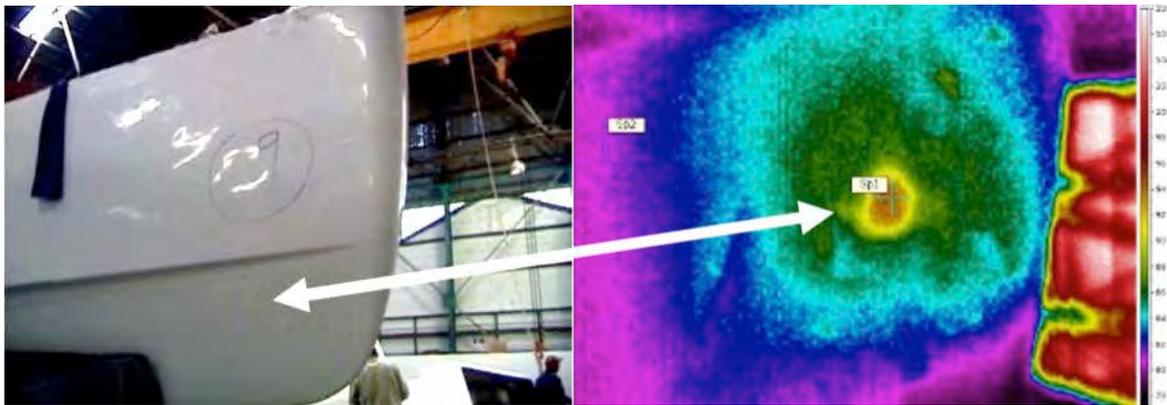
Thermography can be used as part of a Quality Control program to quickly and effectively locate and document voids in Fiberglass Reinforced Plastic laminates. The surface temperature of the FRP is artificially raised in discrete sections with a gentle stream of warm air (approximately 45°C) supplied by an electric hot air heat gun, while the surface is simultaneously scanned with an infrared camera that is capable of capturing radiometric images either as single images or in burst recording mode. As each section of the hull surface is “painted” with a gentle, rhythmic sweeping motion of warm air, the “real time” differences in the surface temperature of the laminate is visually observed on the infrared camera’s LCD screen. Areas where voids are present in the FRP laminate warm quickly while the homogeneous and “void free” laminate surrounding the void remain cooler due to its ability to act as a more effective heat sink. [Allinson, 2007] Figures 120 and 121 show examples of thermography used to find voids in a newly constructed yacht.

**Figure 120. The surface looks free of defects using visible NDE (left) but thermal pattern shows anomaly when the hull is gently warmed by an electric hot air gun [J.N. Allinson Associates, Inc.]**

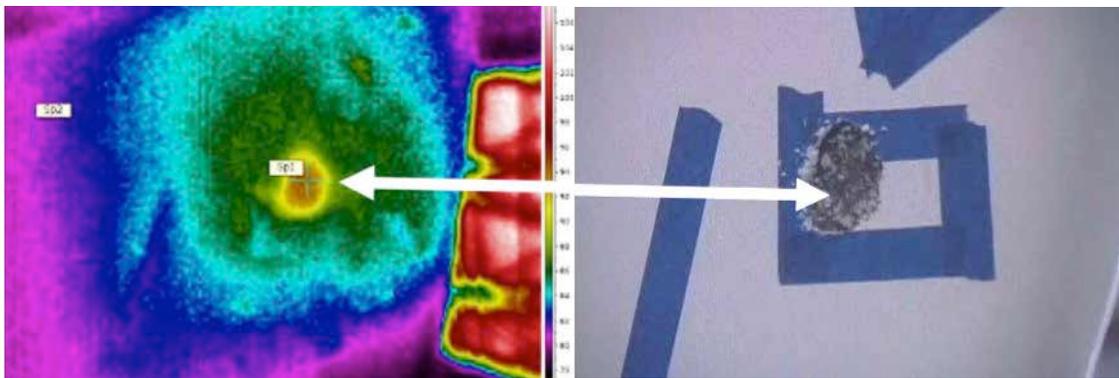
**Figure 121. Thermographic image of void in gel coat confirmed by percussion sounding followed by grinding it out for repair [J.N. Allinson Associates, Inc.]**

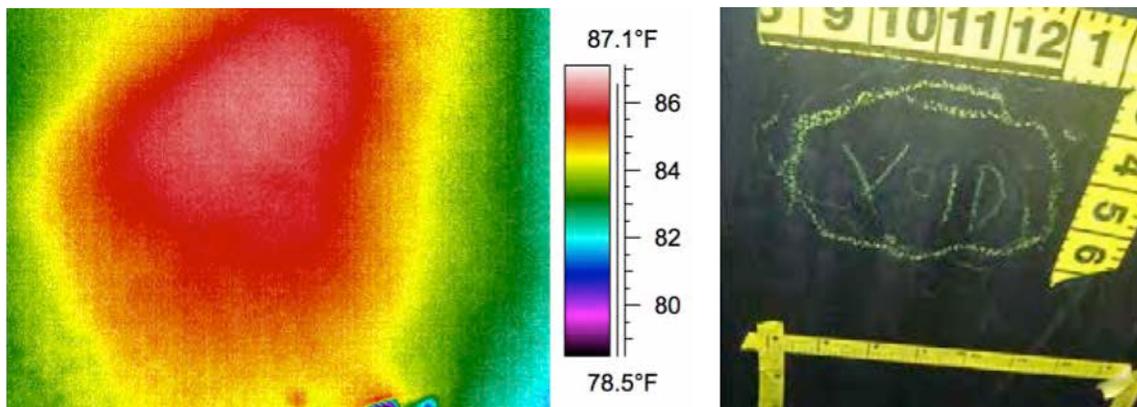
Thermography can also be an effective NDE tool for determining the extent of damage to a composite boat hull prior to repair. In the following example, hull shell laminate failures were noted in areas near the engine girders. The vessel was undergoing a total rebuild of the engine girder support system and the extent of the hull damage needed documentation in order to develop a repair plan. The infrared imaging conducted on the boat revealed subsurface anomalies consistent with delamination of the core from the hull outer skin or intra-laminate delamination due to excessive hull flexure. The IR survey also showed areas of good laminate that were previously marked as suspect based on percussion sounding. Figures 122 and 123 show IR and visual images of the hull laminate.

**Figure 122. Red and white areas indicate anomalies consistent with warm air trapped between hull skin and core or between layers of the laminate [Todd Associates, Inc.]**

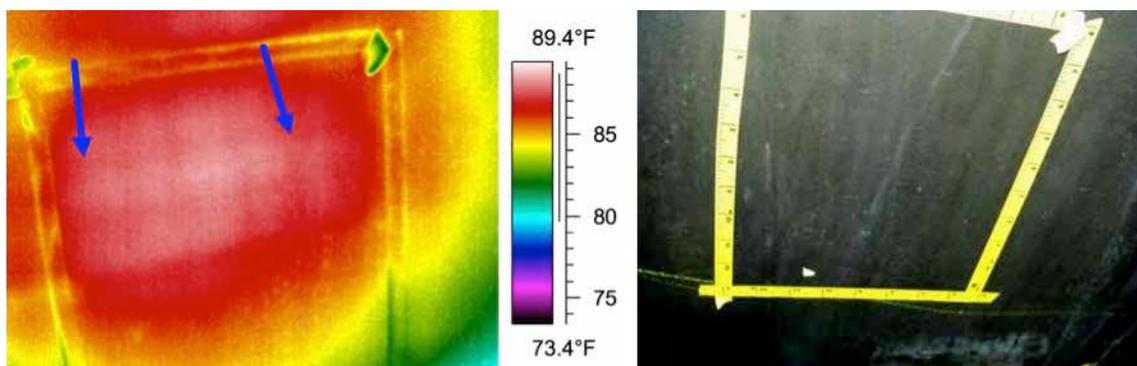
**Figure 123. Infrared image above indicates good contact between outer skin and core as indicated by clearly visible nondestructive kerf lines. [Todd Associates, Inc.]**

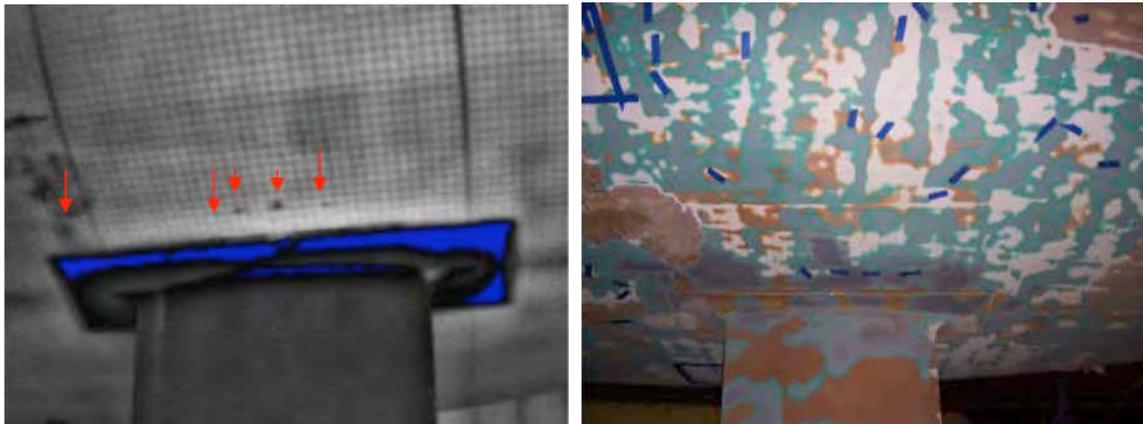
The majority of composite boats are now built using sandwich construction to minimize weight. All penetrations of the sandwich skins are potential areas for water ingress, making this a major defect of concern to vessel owners. Numerous yachts have been examined by Independent Marine Systems of Newport, RI with a Raytheon Pro 400D digital thermal infrared camera to determine the extent of water ingress in hull laminates. Figures 124 through 126 show thermographic images that indicate the extent of water ingress for a variety of yachts. In many instances, water ingress was confirmed by either destructive testing (hole saw samples) or during the course of repair.

**Figure 124.** This IR image shows that moisture ingress on the starboard side of the keel box has not migrated further than the local area. The red arrows show laminate anomalies that were confirmed to be “resin starved” areas. [Independent Marine Systems]

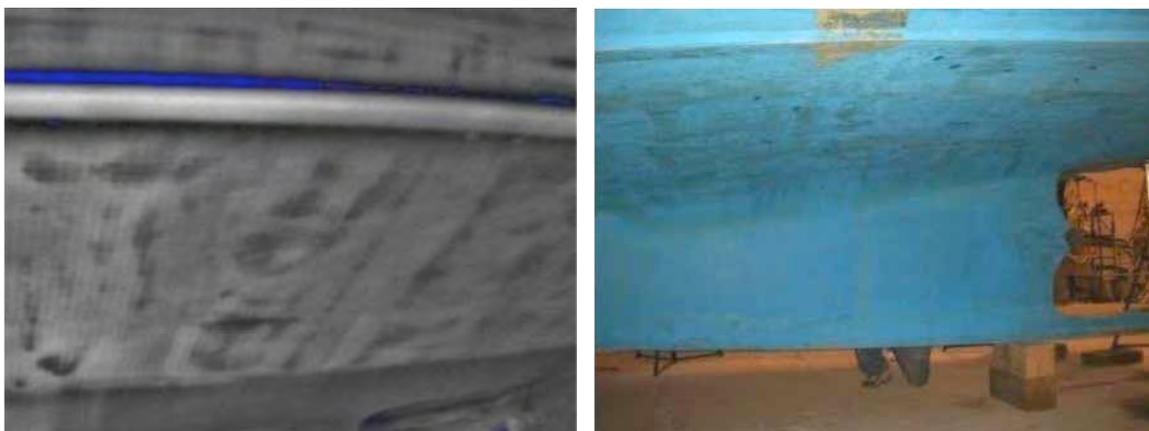
**Figure 125.** This vessel had anomalies on the entire port side of the hull bottom that were characteristic of moisture ingress. Two hole saw samples were taken and both sampled areas produced water when drilled into. [Independent Marine Systems]

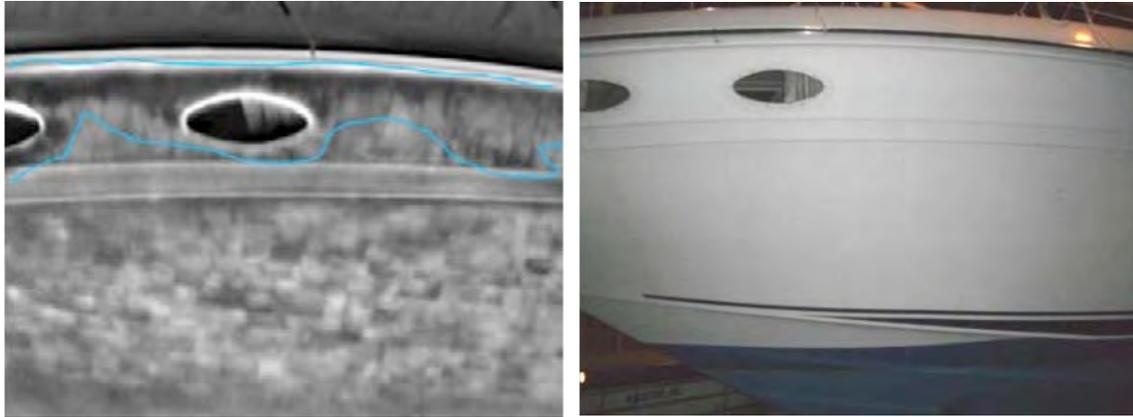
**Figure 126. The dark colored anomaly noted with the blue lines is characteristic of moisture (moisture ingress was first found when the hull ports were removed).  
[Independent Marine Systems]**

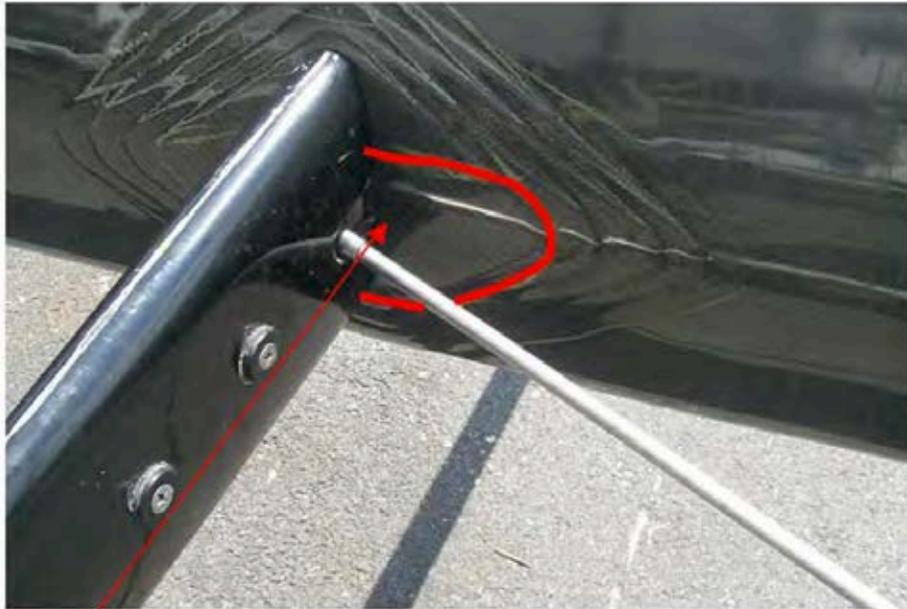
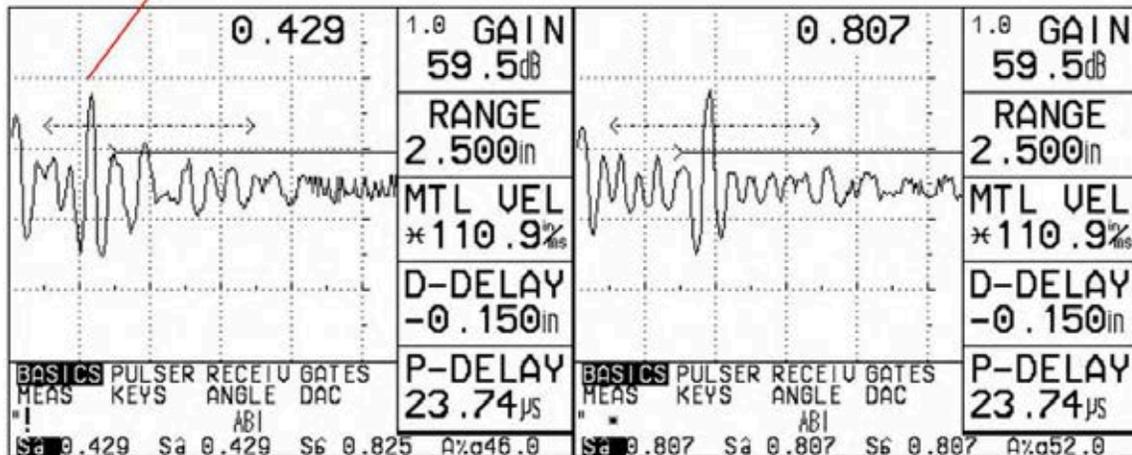
Two areas were determined to contain delaminations. The first area was located at the attachment point of the second spreader bar on the starboard side. It was determined that delamination occurred between the mast and the internal sleeve directly below the external reinforcement, as shown in Figure 127. The second area containing delamination was the secondary reinforcement at the masthead spinnaker halyard sheave box, shown in Figure 128. [Bandos, 2002]

**Figure 127. The captured UT waveform from directly beneath the second starboard spreader (left) indicates the delamination is 0.429 inch from the surface, which is between the mast and the internal sleeve. The waveform from the port spreader (right) shows no ultrasonic reflections from any interfaces [Bandos, 2002]**

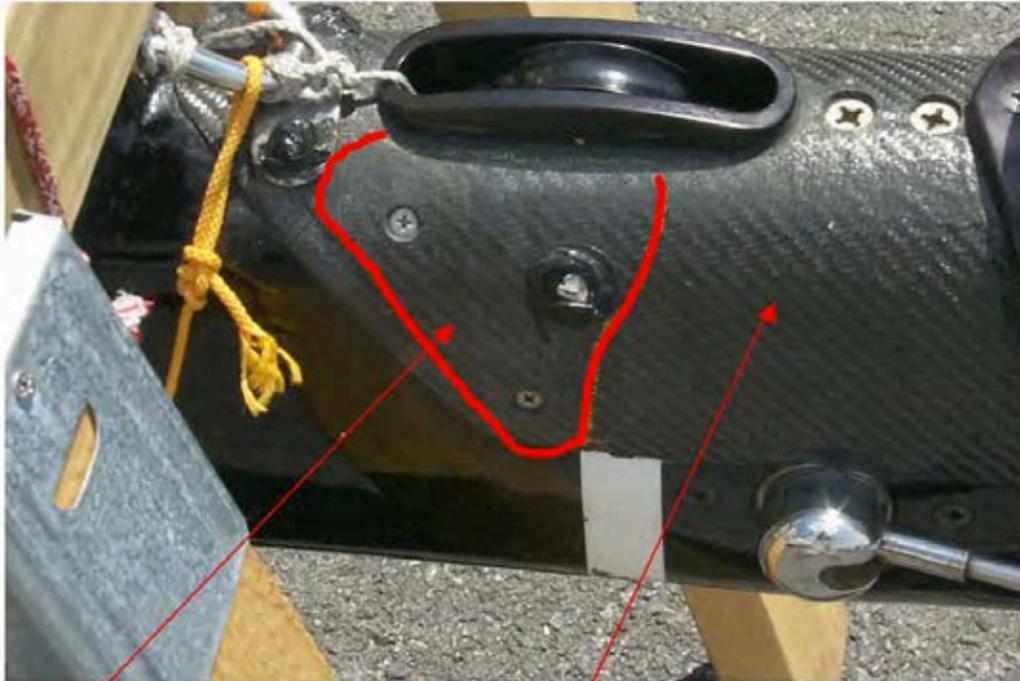
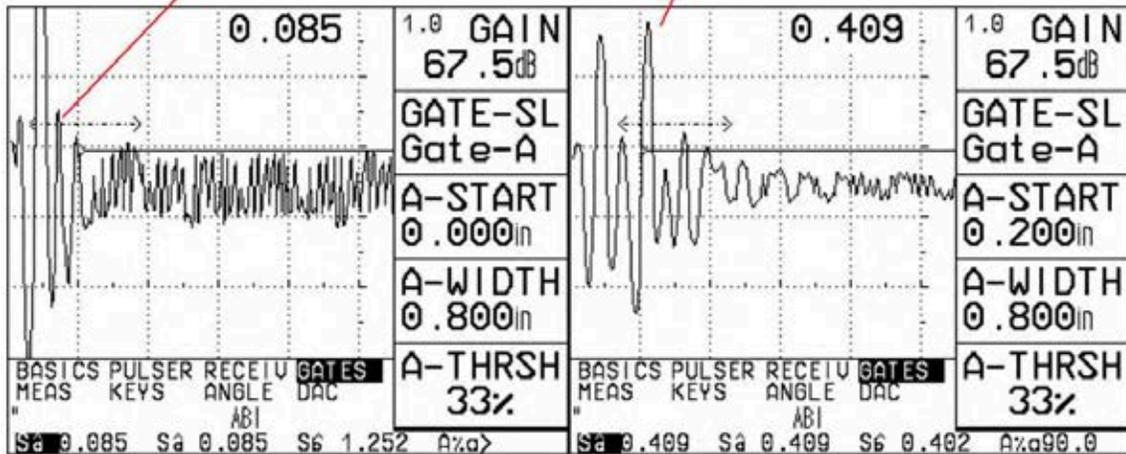
**Figure 128. The top reinforcement layer in this area is delaminated (left), which precluded NDE of the underlying laminate. The second UT scan (right) showed full penetration through the reinforcement and primary mast with no detected anomalies. [Bandos, 2002]**
